Dell PowerVault ME4 Series Storage System

Owner's Manual

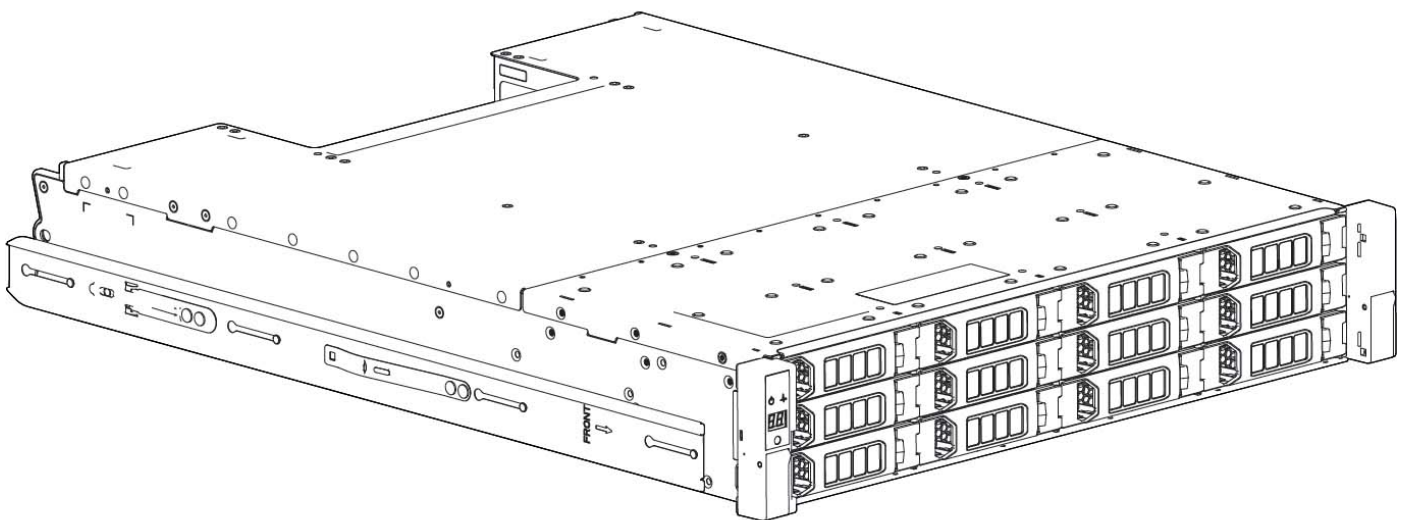
Figure 1. 2U12 enclosure system—front orientation

The 2U12 controller enclosure is equipped with dual-controllers.

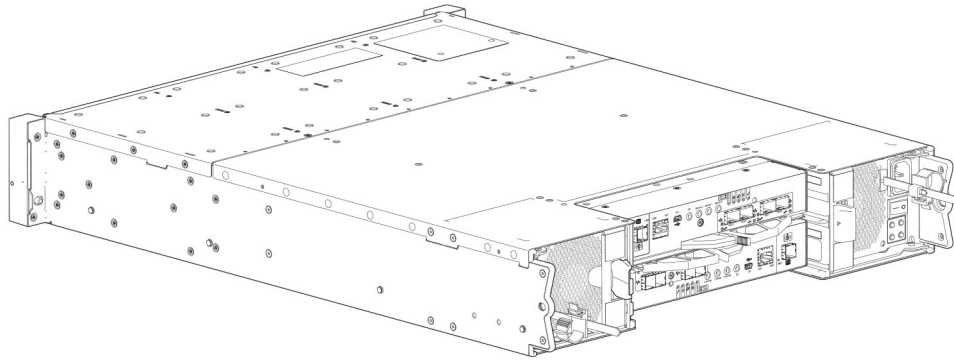
Figure 2. 2U12 enclosure system—rear orientation

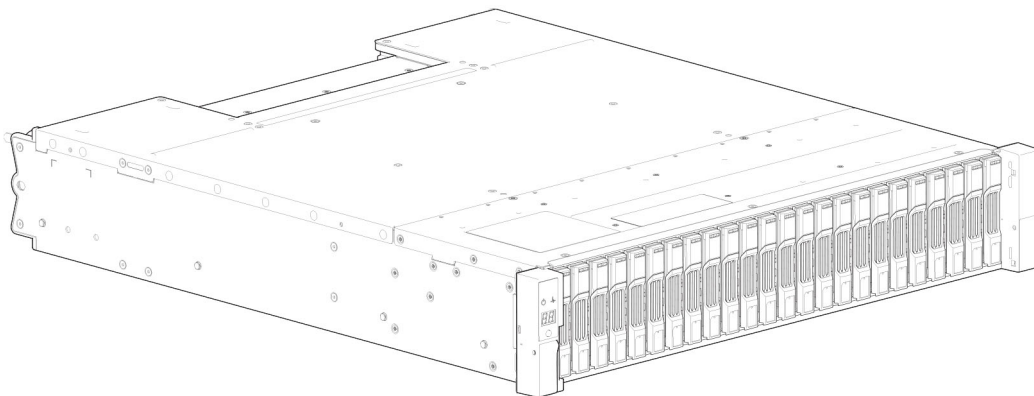
Figure 3. 2U24 enclosure system—front orientation

The 2U24 controller enclosure is equipped with dual-controllers.

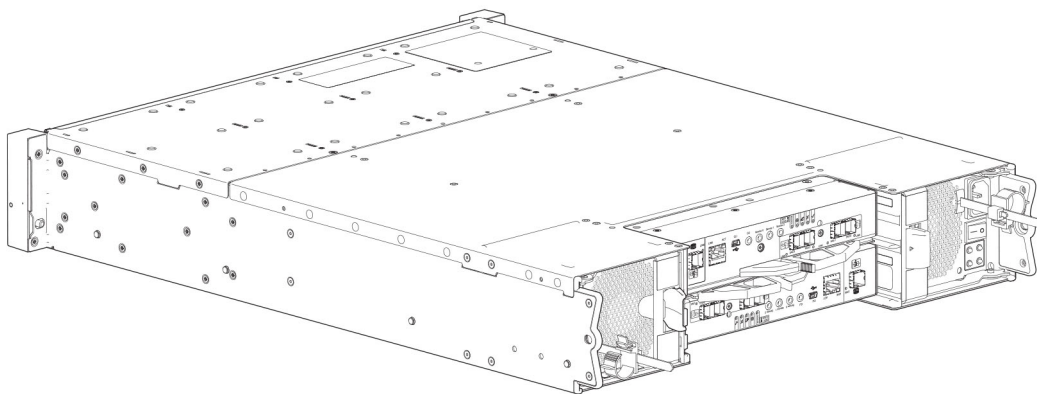
Figure 4. 2U24 enclosure system—rear orientation

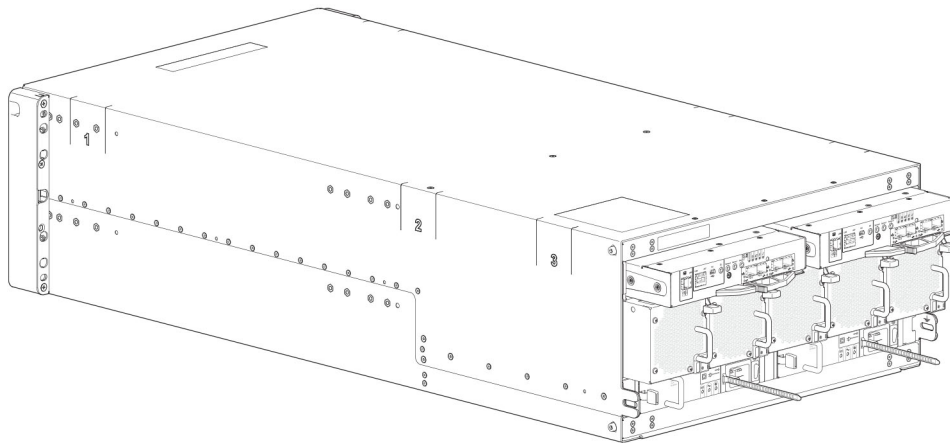
Figure 6. 5U84 enclosure system—rear orientation

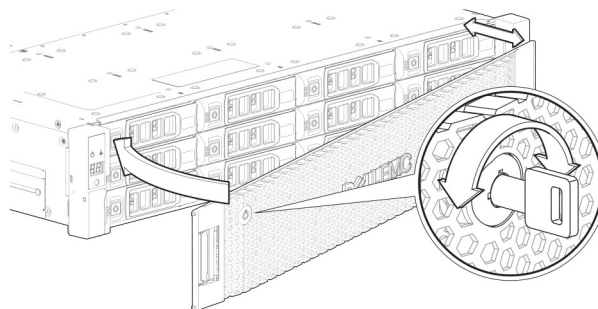
The following figure shows a partial view of a 2U12 enclosure:

Figure 7. Attaching or removing the 2U enclosure front bezel

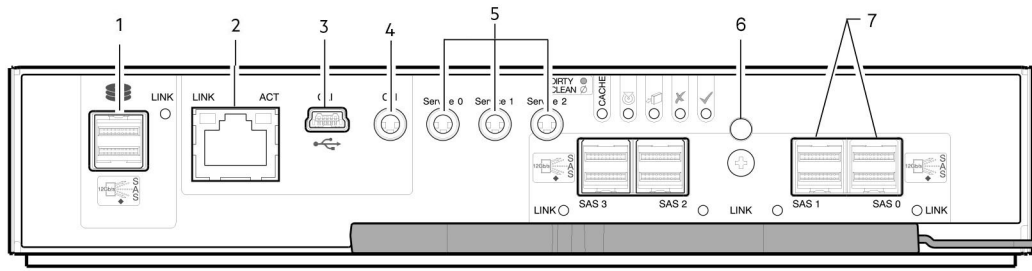
The following figure shows SAS host interface ports that ship configured with 12 Gb/s mini-SAS HD (SFF-8644) external connectors.

Figure 16. 4-port mini-SAS HD controller module detail

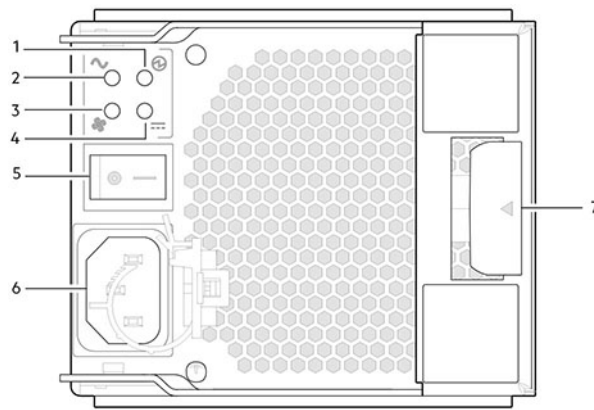
The following figure shows the power cooling module (PCM) used in controller enclosures and optional expansion enclosures. The PCM includes integrated cooling fans. The example shows a PCM oriented for use in the left PCM slot of the enclosure rear panel.

Figure 18. Power cooling module (PCM)

| 1. PCM OK LED (Green) | 2. AC Fail LED (Amber/blinking amber) |
| 3. Fan Fail LED (Amber/blinking amber) | 4. DC Fail LED (Amber/blinking amber) |

- If any of the PCM LEDs are illuminated amber, a module fault condition or failure has occurred.
- For a detailed description of PCM LED behavior, see [2U enclosure LEDs](#).

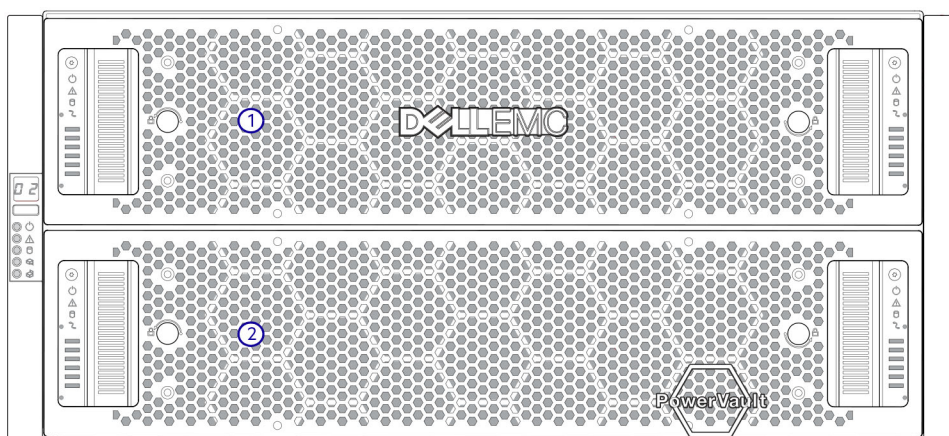
Figure 19. 5U84 enclosure—front panel components

1. 5U84 enclosure drawer (slot 0 = top drawer)

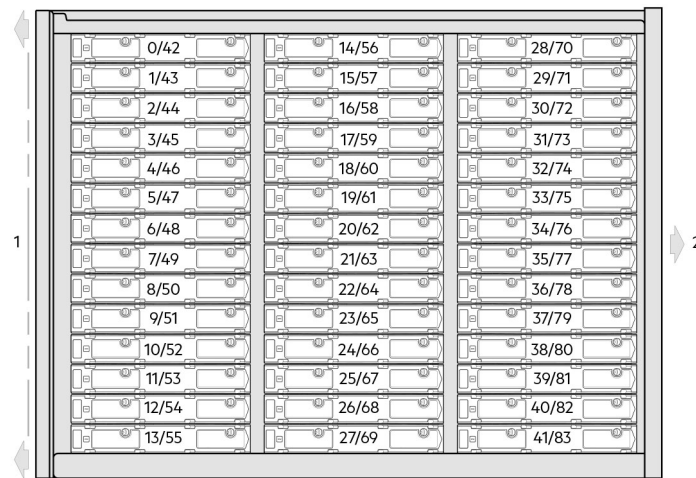
This figure shows a plan view of an enclosure drawer that is accessed from the enclosure front panel. The conceptual graphics are simplified for clarity.

Figure 20. 5U84 enclosure system - plan view of drawer accessed from front panel

1. Drawer front panel (shown as an edge in plan view)
2. Direction into the enclosure drawer slot (slot 0 or 1)

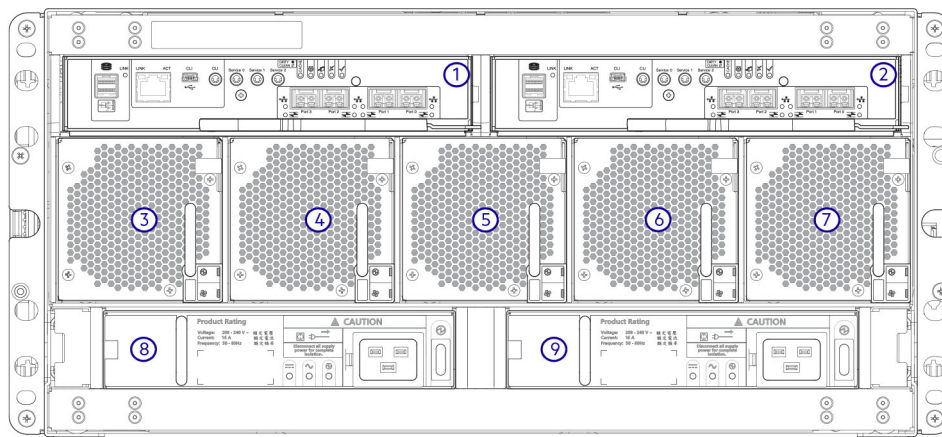
Figure 21. 5U84 controller enclosure—rear panel components (4-port FC/iSCSI)

| 7. FCM slot 4 | 8. PSU slot 0 |
| 9. PSU slot 1 | |

Alphabetic designators on controller modules and IOMs, and numeric designators on PSUs (Power Supply Units) and FCMs (Fan Control Modules) indicate slot sequencing for modules used in 5U84 enclosures. Controller modules, IOMs, PSUs, and FCMs are available as CRUs.

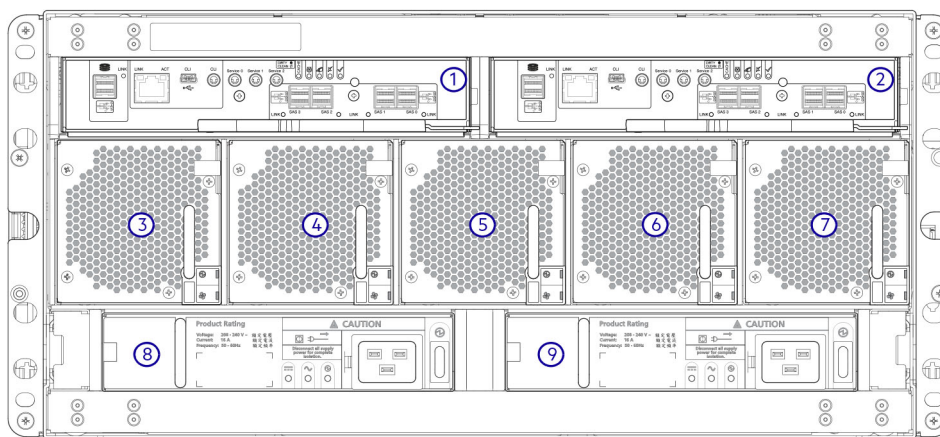
Figure 22. 5U84 controller enclosure—rear panel components (4-port SAS)

| 7. FCM slot 4 | 8. PSU slot 0 |
| 9. PSU slot 1 | |

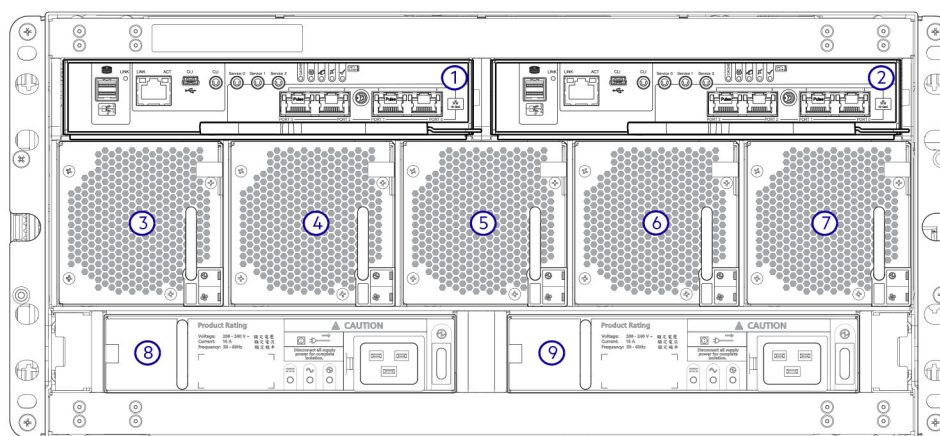
Figure 23. 5U84 controller enclosure—rear panel components (4-port iSCSI 10Gbase-T)

| 7. FCM slot 4 | 8. PSU slot 0 |
| 9. PSU slot 1 | |

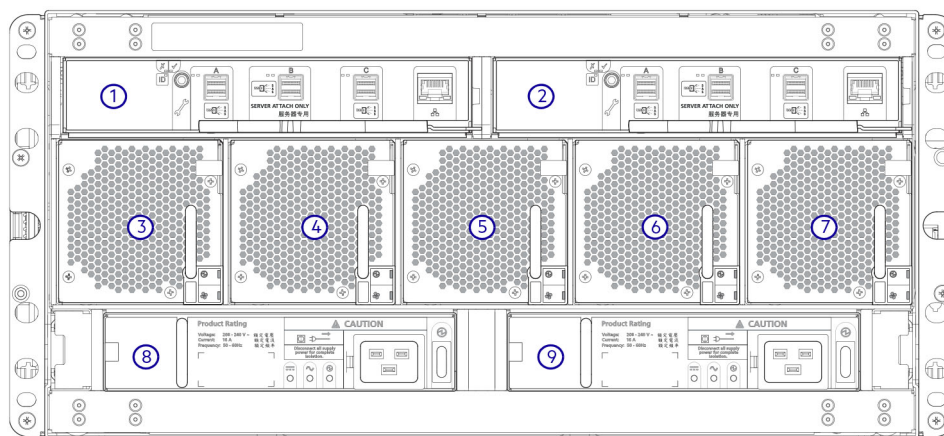
Figure 24. 5U84 expansion enclosure—rear panel components

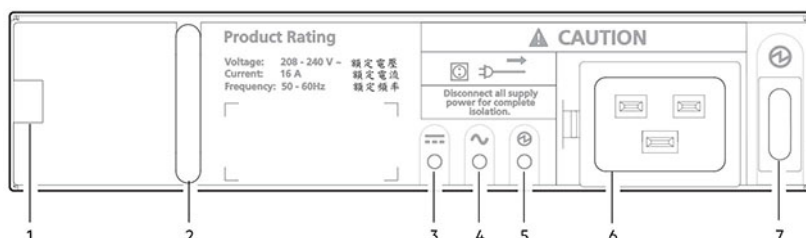
This figure shows the power supply unit that is used in 5U controller enclosures and optional 5U84 expansion enclosures.

Figure 25. Power supply unit (PSU)

| 3. PSU Fault LED (Amber/blinking amber) | 4. AC Fail LED (Amber/blinking amber) |

- If any of the PSU LEDs are illuminated amber, a module fault condition or failure has occurred.
- For a detailed description of PSU LEDs, see [FCM LED states](#).

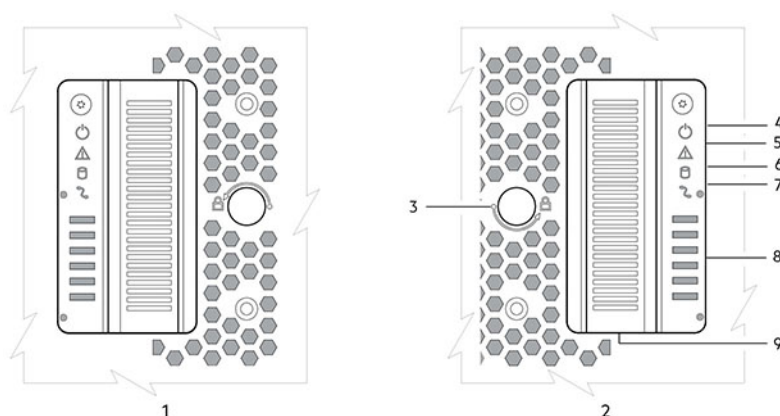
Each drawer can be locked shut by turning both anti-tamper locks clockwise using a screwdriver with a Torx T20 bit (included in your shipment). The anti-tamper locks are symmetrically placed on the left and right sides of the drawer bezel. Drawer status and activity LEDs can be monitored by two drawer LEDs panels located next to the two drawer-pull pockets located on the left and right side of each drawer.

Figure 27. Drawer bezel details

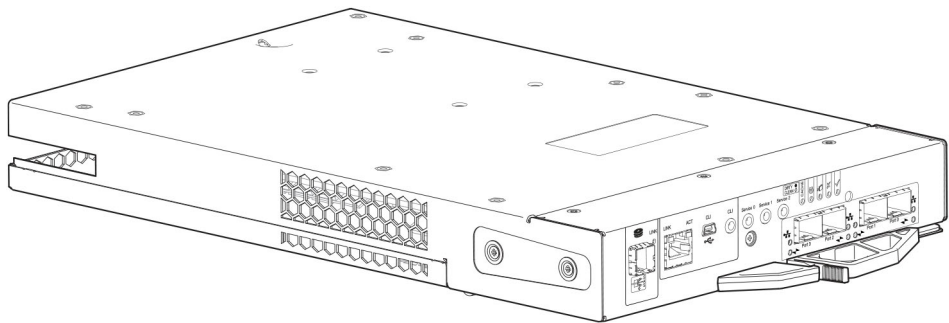
The following figure shows a 4-port FC/iSCSI controller module aligned for use in the top slot located on the 2U enclosure rear panel. The controller module is also properly aligned for use in either slot located on the 5U84 enclosure rear panel.

Figure 30. Controller module – rear orientation

Each controller module maintains VPD (Vital Product Data) in EEPROM devices. In a dual-controller module system, controller modules are interconnected by SBB-defined I2C buses on the midplane. In this way, the SBB module can discover the type and capabilities of the partner SBB module, and vice versa, within the enclosure.

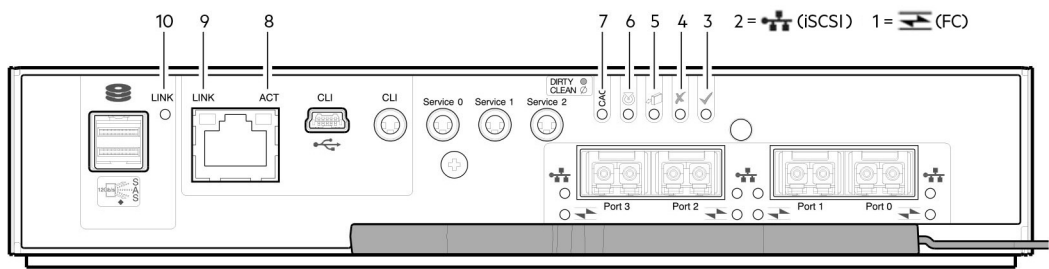
Figure 31. ME4 Series Storage System FC/iSCSI controller modules (FC and 10GbE SFPs) LEDs

Table 6. ME4 Series controller modules (FC and iSCSI SFPs) LEDs

⁴Cache Status LED supports power on behavior and operational (cache status) behavior. See also [Cache Status LED – power on behavior](#).

⁵When port is down, both LEDs are off.

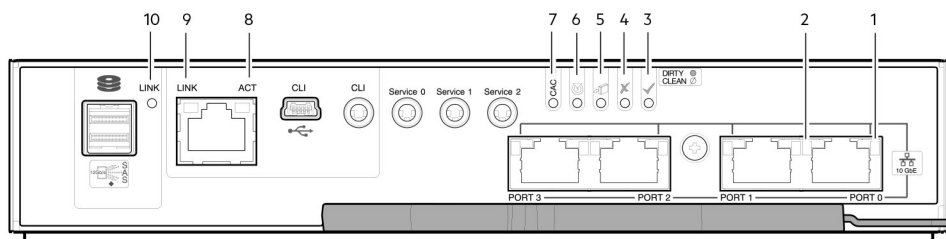
Figure 32. ME4 Series 10GbE-T controller module LEDs

Table 7. ME4 Series 10Gbase-T controller module LEDs

6	Identify	White—The controller module is being identified.
7	Cache status ³	<ul style="list-style-type: none"> Green—Cache is dirty (contains unwritten data) and operation is normal. The unwritten information can be log or debug data that remains in the cache, so a green cache status LED does not, by itself, indicate that any user data is at risk or that any action is necessary. Off—In a working controller, cache is clean (contains no unwritten data). This is an occasional condition that occurs while the system is booting. Blinking green—A CompactFlash flush or cache self-refresh is in progress, indicating cache activity.
8	Network Port Activity Status ⁴	<ul style="list-style-type: none"> Off—The Ethernet link is not established, or the link is down. Green—The Ethernet link is up (applies to all negotiated link speeds).
9	Network Port Link Speed ⁴	<ul style="list-style-type: none"> Off—Link is up at 10/100base-T negotiated speeds. Amber—Link is up and negotiated at 1000base-T.

³Cache Status LED supports power on behavior and operational (cache status) behavior.

⁴When port is down, both LEDs are off. See also [Cache Status LED – power on behavior](#).

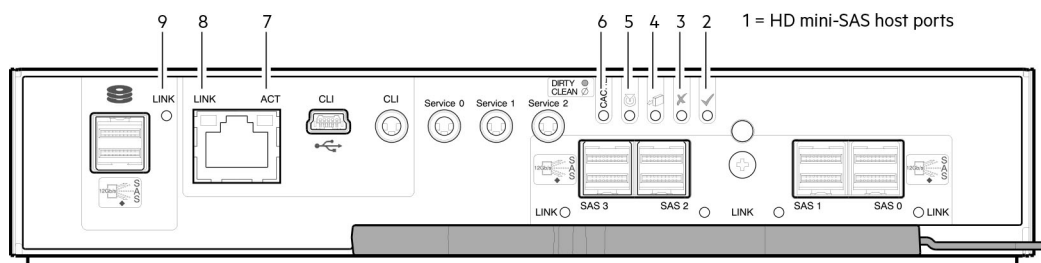
Figure 33. ME4 Series SAS controller module LEDs

Table 8. ME4 Series SAS controller module LEDs

6	Cache status ³	<ul style="list-style-type: none"> Green—Cache is dirty (contains unwritten data) and operation is normal. The unwritten information can be log or debug data that remains in the cache, so a green cache status LED does not, by itself, indicate that any user data is at risk or that any action is necessary. Off—In a working controller, cache is clean (contains no unwritten data). This is an occasional condition that occurs while the system is booting. Blinking green—A CompactFlash flush or cache self-refresh is in progress, indicating cache activity.
7	Network Port Activity Status ⁴	<ul style="list-style-type: none"> Off—The Ethernet link is not established, or the link is down. Green—The Ethernet link is up (applies to all negotiated link speeds).
8	Network Port Link Speed ⁴	<ul style="list-style-type: none"> Off—Link is up at 10/100base-T negotiated speeds. Amber — Link is up and negotiated at 1000base-T.

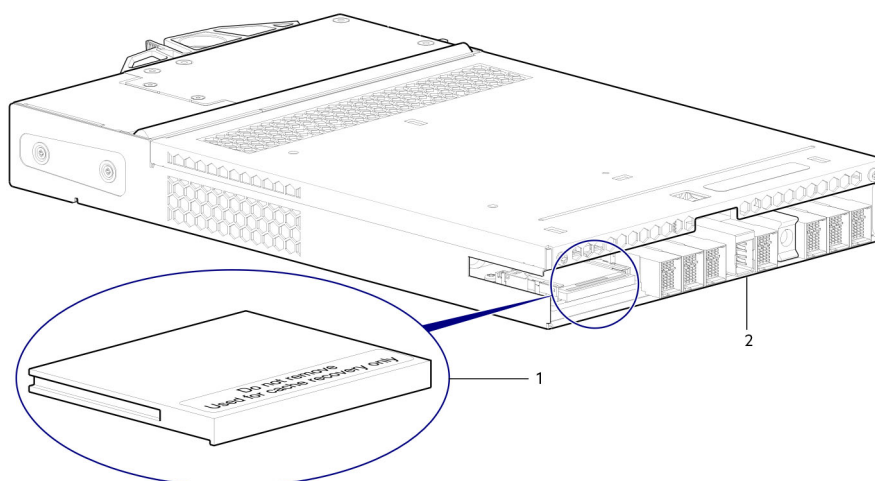
During a power loss or controller failure, data stored in cache is saved off to non-volatile memory (CompactFlash). The data is restored to cache, and then written to disk after the issue is corrected. To protect against writing incomplete data to disk, the image stored on the CompactFlash is verified before committing to disk. The CompactFlash memory card is located at the midplane-facing end of the controller module. Do not remove the card; it is used for cache recovery only.

**Figure 34. CompactFlash memory card**

1. CompactFlash memory card
2. Controller module viewed from back

In single-controller module configurations, if the controller module has failed or does not start, and the Cache Status LED is on or blinking, the CompactFlash needs to be transported to a replacement controller to recover data not flushed to the disk.

CAUTION: For single-controller module configuration only, to preserve the existing data stored in the CompactFlash, you must transport the CompactFlash from the failed controller module to the replacement controller module. This procedure is outlined in the *Dell PowerVault ME4 Series Storage System Owner's Manual* within the procedure for replacing a controller module. Failure to use this procedure will result in the loss of data stored in the cache module. The CompactFlash must stay with the same enclosure. If the CompactFlash is used/installed in a different enclosure, data loss/data corruption will occur.

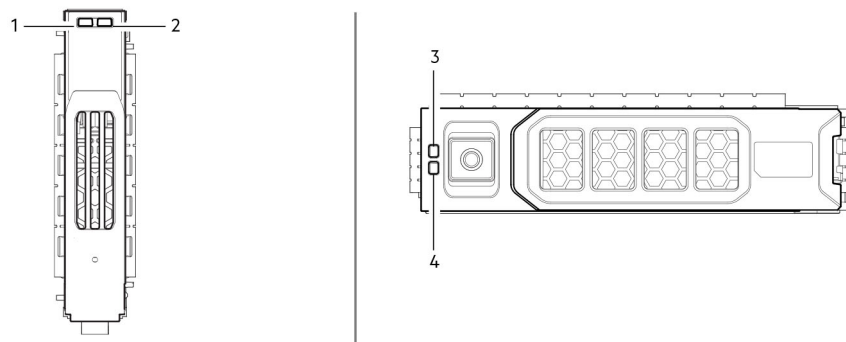
The drive module LEDs are identified in the figure, and the LED behavior is described in the table following the figure.

- In normal operation, the green LED are on, and flicker as the drive operates.
- In normal operation the amber LED will be:
 - Off if there is no drive present.
 - Off as the drive operates.
 - On if there is a drive fault.

Figure 35. LEDs: Drive carrier LEDs (SFF and LFF modules) used in 2U enclosures

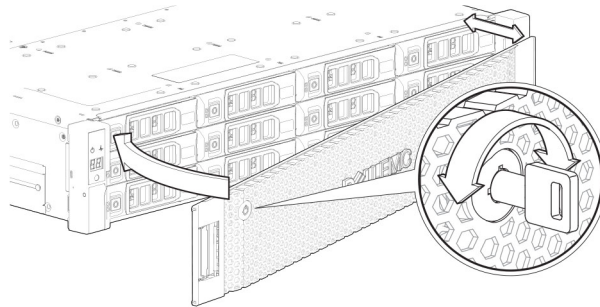
The following figure shows a partial view of a 2U12 enclosure:

Figure 37. Attaching or removing the 2U enclosure front bezel

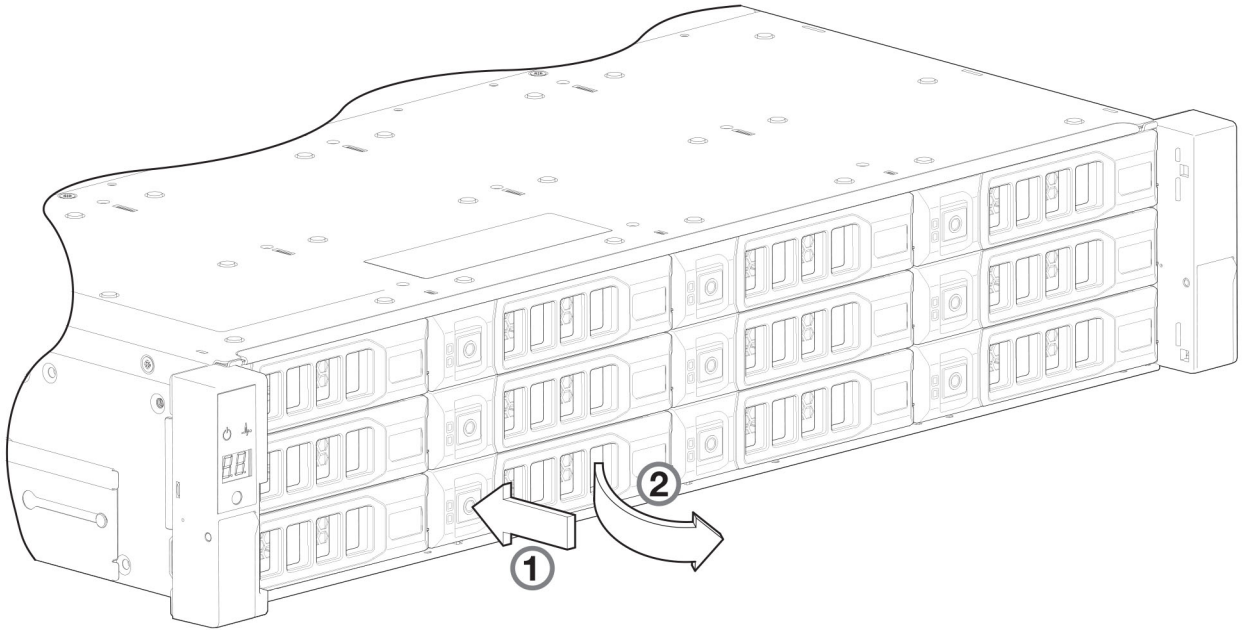
1. Press the latch on the drive module carrier to open the handle.

Figure 38. Removing an LFF drive carrier module (1 of 2)

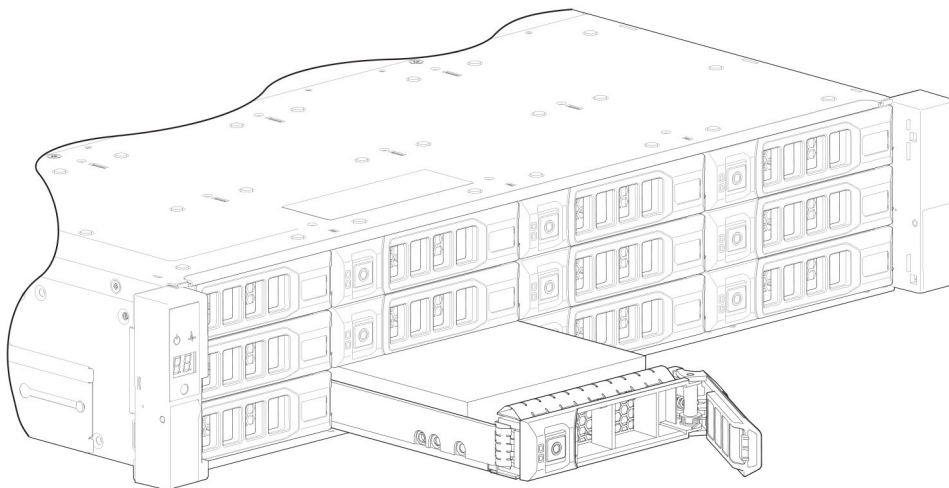
2. Gently move the drive carrier module approximately 25 mm (1 in.), and then wait 30 seconds for the drive to spin down.

Figure 39. Removing an LFF drive carrier module (2 of 2)

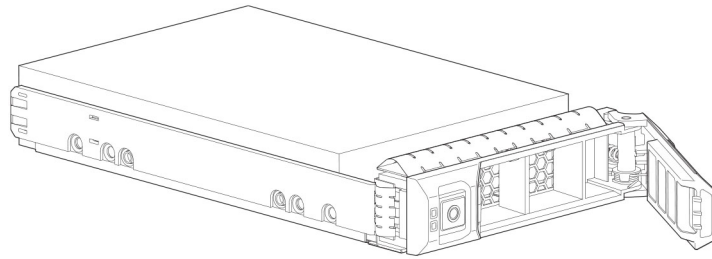
1. Press the latch on the drive module carrier to open the handle.

Figure 40. LFF drive carrier module in open position

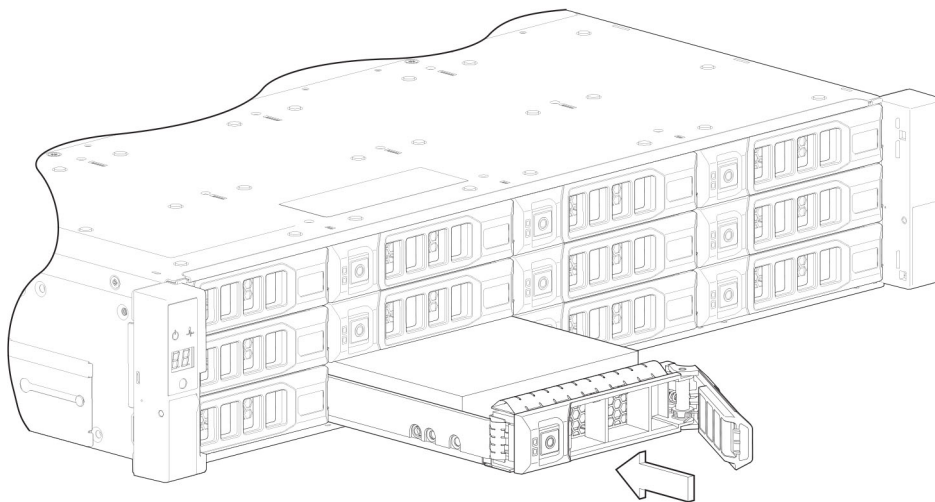
2. Insert the drive carrier module into the enclosure.
3. Gently slide the drive carrier module into the enclosure until it stops moving.

Figure 41. Installing an LFF drive carrier module (1 of 2)

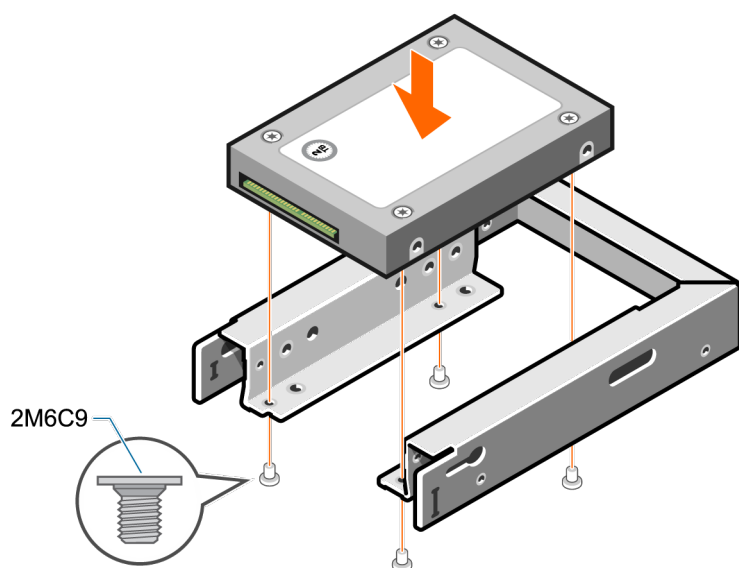
1. Install the 2.5" replacement disk drive into the 3.5" mounting bracket.

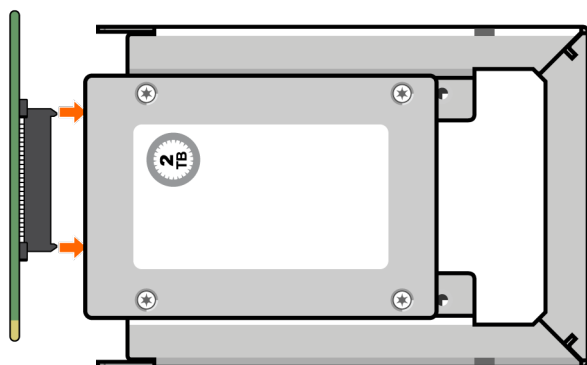
2. Insert the SAS connector into the SAS interface on the disk drive.

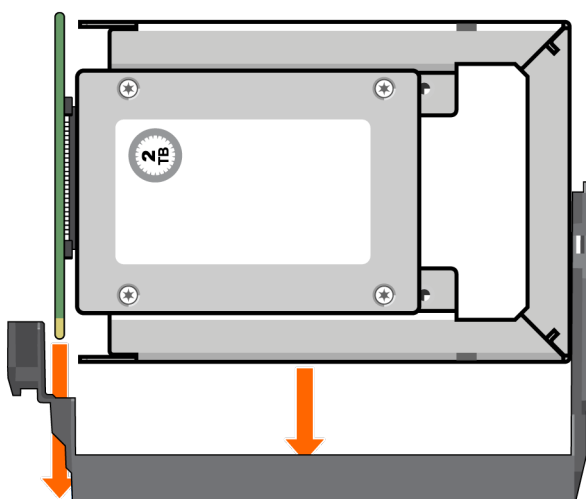
3. Insert the 3.5" mounting bracket with the 2.5" disk drive into the lower assembly.

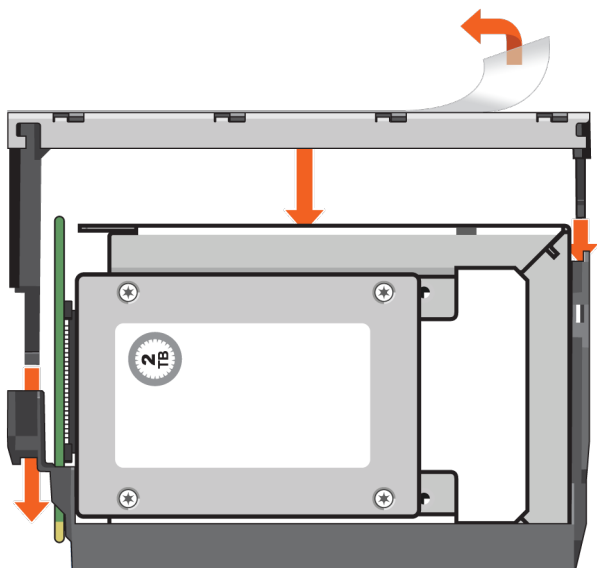
4. Remove the protective film from the upper assembly of the DDIC.
5. Slide the upper assembly of the DDIC onto the mounting bracket with the 2.5" disk drive

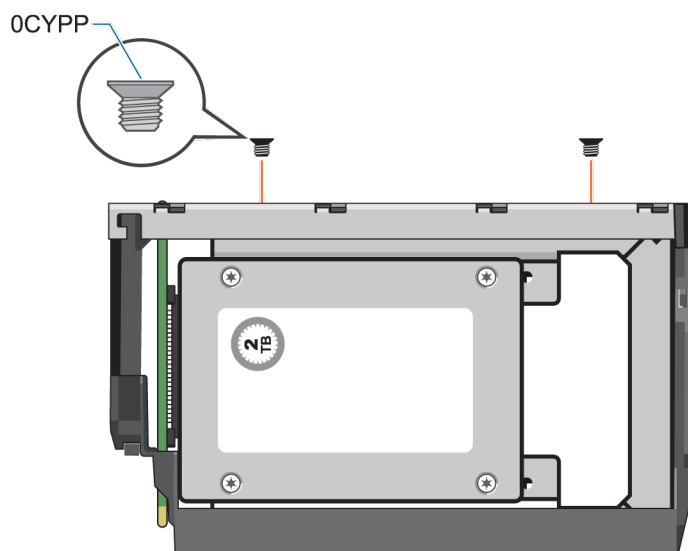
6. Secure the upper assembly to the mounting bracket using the supplied screws.

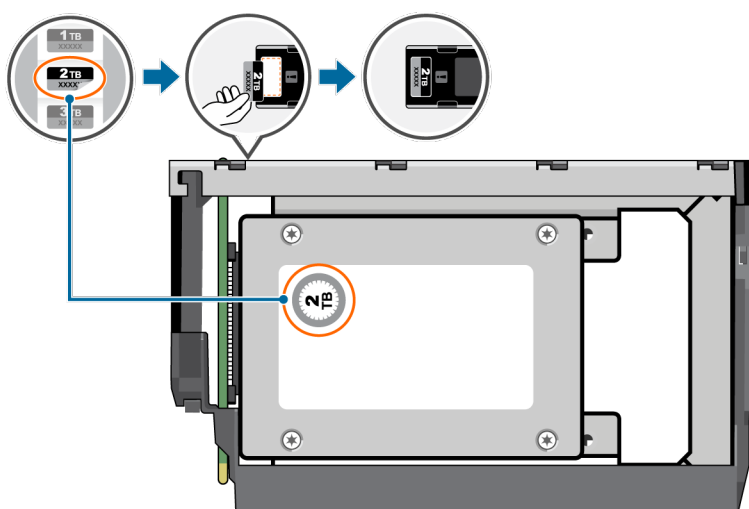
7. Attach the appropriate drive size label to the label location on top of the upper assembly.

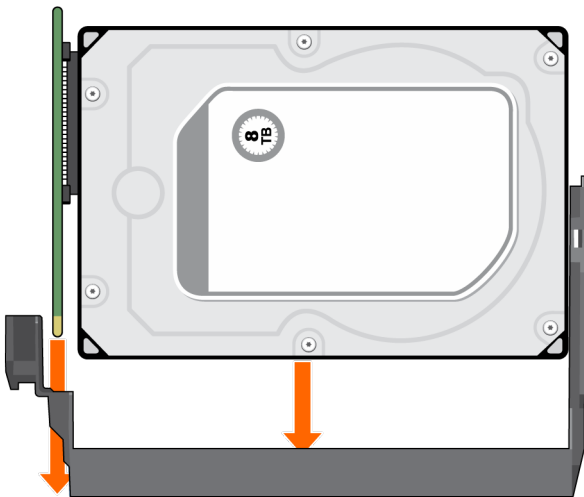
2. Slide the disk drive into the lower assembly of the DDIC.

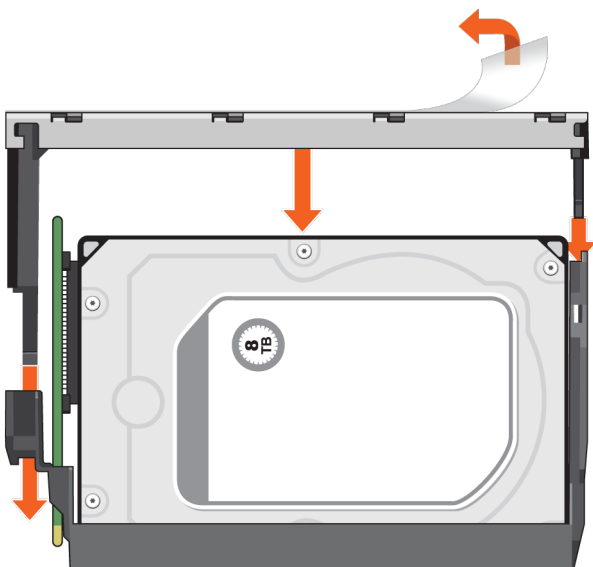
3. Remove the protective film from the upper assembly of the DDIC.
4. Slide the upper assembly of the DDIC onto the disk drive.

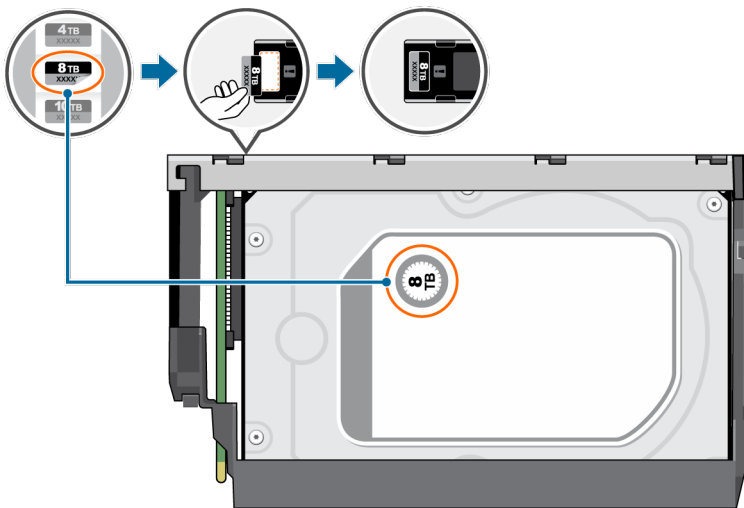
- Attach the appropriate drive size label to the label location on top of the upper assembly.

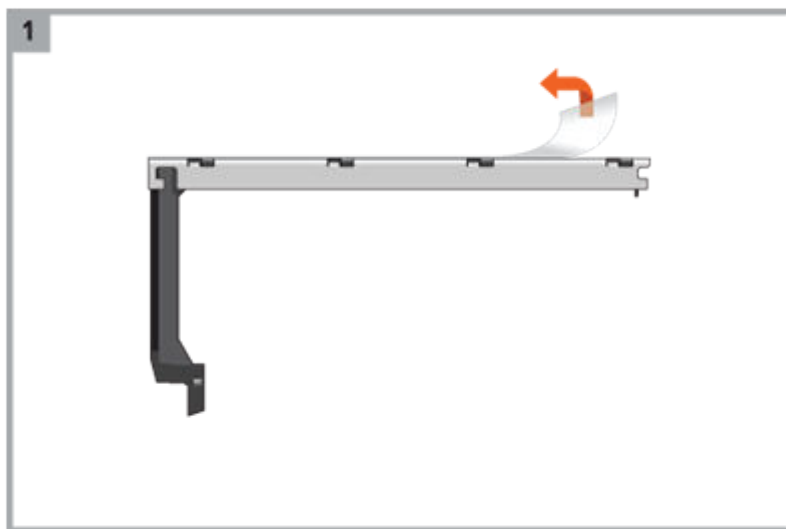
1. Remove the protective plastic from the new DDIC.

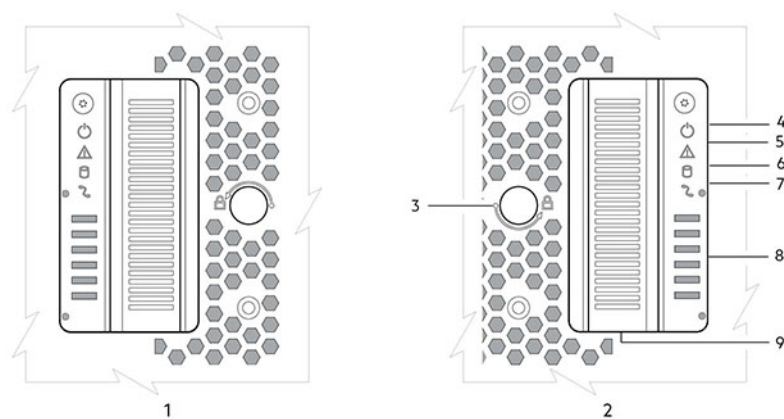
Figure 48. Drawer front panel details

1. Verify that the anti-tamper locks are not engaged. The red arrows on the locks point inwards if the locks are disengaged as shown in the following figure. If necessary, unlock them by rotating counter-clockwise using a Torx T20 bit.

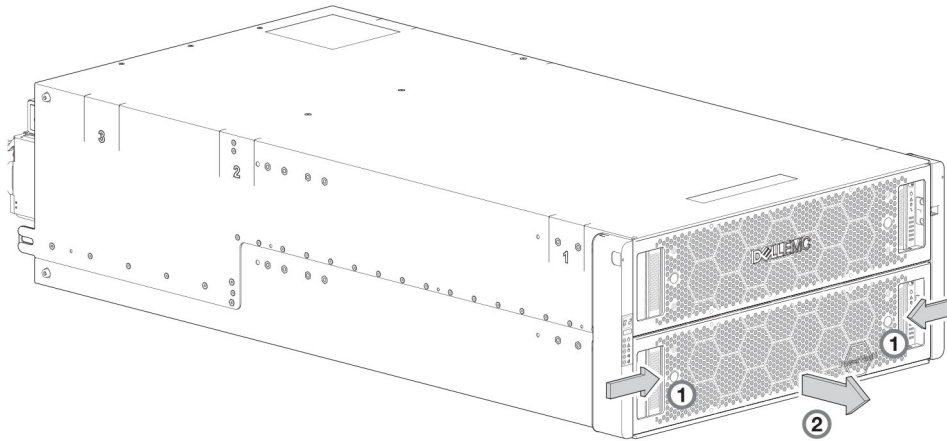
Figure 49. Opening a drawer (1 of 2)

2. Push the drawer latches inward and hold them as shown in the following figure.

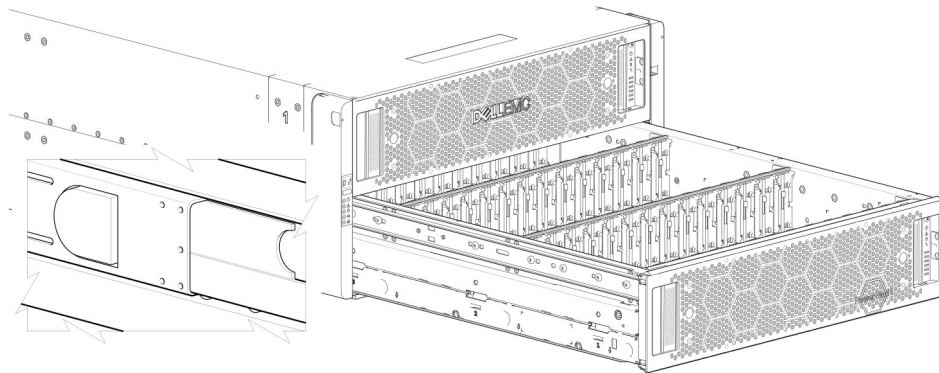
Figure 50. Opening a drawer (2 of 2)

3. Pull the drawer outward until it locks at the drawer stops as shown in the following figure. The drawer is shown empty, which is how the enclosure is delivered. A drawer slide rail latch detail is inset.

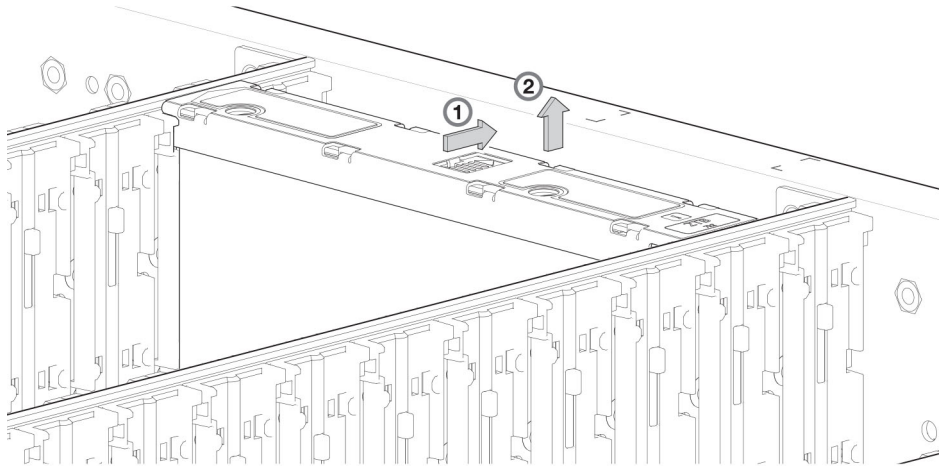
Figure 51. Removing a DDIC (1 of 2)

3. Unlock the DDIC from its seated position in the slot by pushing the latch button in the direction shown in the following figure:

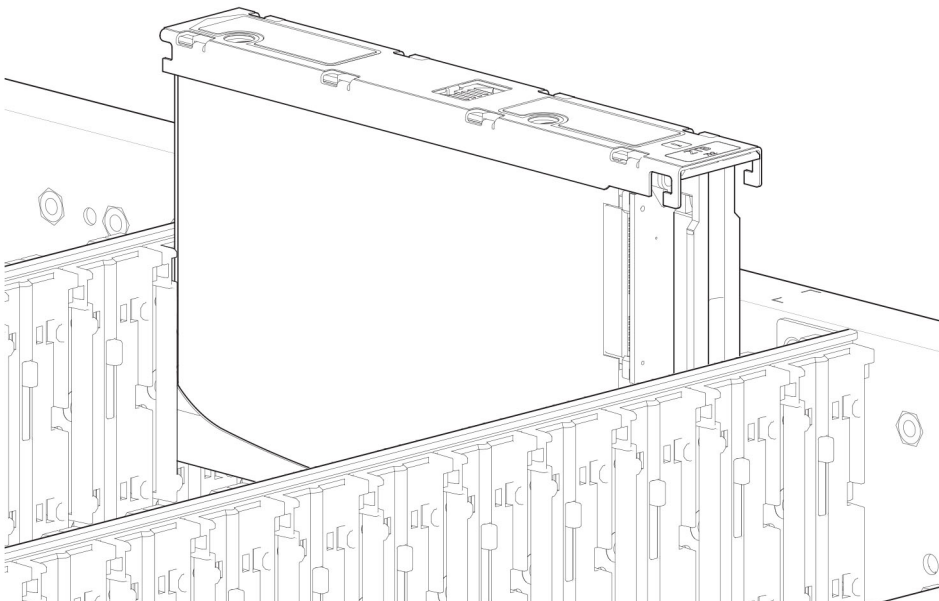
Figure 52. Removing a DDIC (2 of 2)

4. Pull the DDIC upwards and out of the drawer slot.

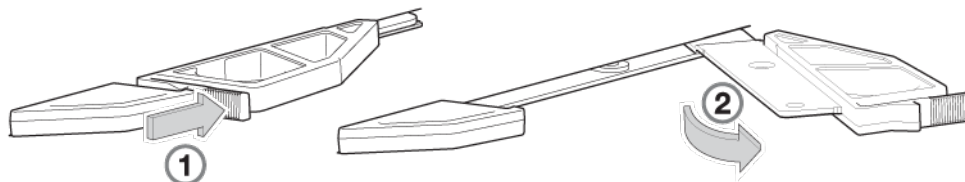
Figure 55. Removing a controller module from an enclosure

1. Shut down the storage system using PowerVault Manager or the CLI.
2. Disconnect any cables connected to the controller module.
Label each cable to facilitate re-connection to the replacement controller module.
3. Grasp the module latch between the thumb and forefinger, and squeeze the flange and handle together to release the latch handle, and swing the latch handle out to release the controller module from its seated position.

4. Swing the latch handle open, then grip the latch handle and ease the controller module forward from the slot.
5. Place both hands on the controller module body, and pull it straight out of the enclosure such that the controller module remains level during removal.

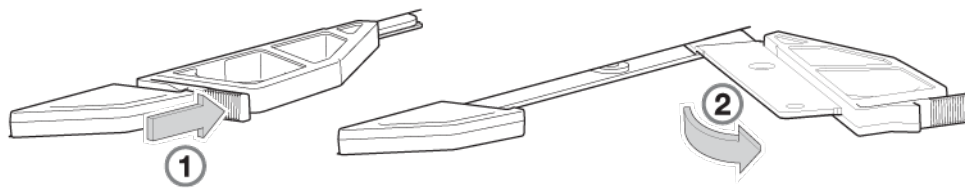
Figure 57. Open module latch

2. Disconnect any cables connected to the IOM.
Label each cable to facilitate re-connection to the replacement IOM.
 3. Grasp the module latch between the thumb and forefinger, and squeeze the flange and handle together to release the latch handle, and swing the latch handle out to release the IOM from its seated position.

4. Swing the latch handle open, then grip the latch handle and ease the IOM forward from the slot.
5. Place both hands on the IOM body, and pull it straight out of the enclosure such that the IOM remains level during removal.

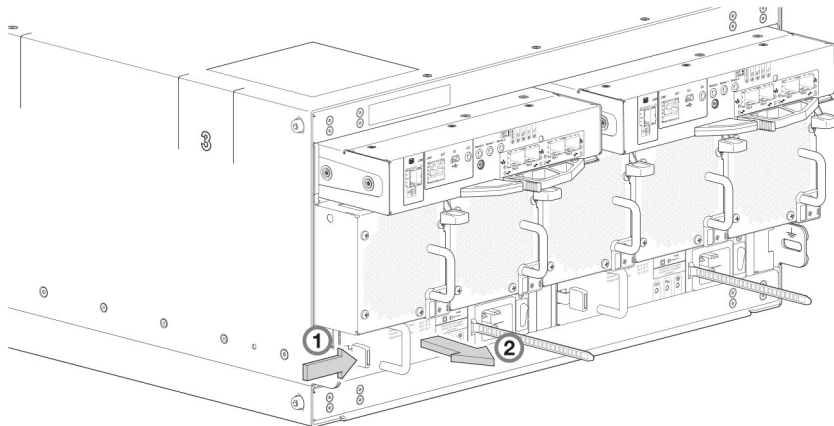
Figure 58. Removing a PSU (1 of 2)

1. Stop all I/O from hosts to the enclosure. See [Shutting down a controller module](#).
NOTE: This step is not required for hot-swapping. However, it is required when replacing both PSUs at once.
2. Use management software to shut down any other system components necessary.
NOTE: This step is not required for hot-swapping. However, it is required when replacing both PSUs at once.
3. Verify the Power OK LED is lit, then switch off the faulty PSU, and disconnect the power supply cable.
4. If replacing a single PSU via hot-swap, proceed to step 6.
5. If replacing both PSUs, verify that the enclosure was shut down using management interfaces, and that the enclosure is powered off.
6. Verify that the power cable is disconnected.
7. Push the release latch to the right and hold it in place (detail No.1).
8. With your other hand, grasp the handle and pull the PSU outward (detail No.2).

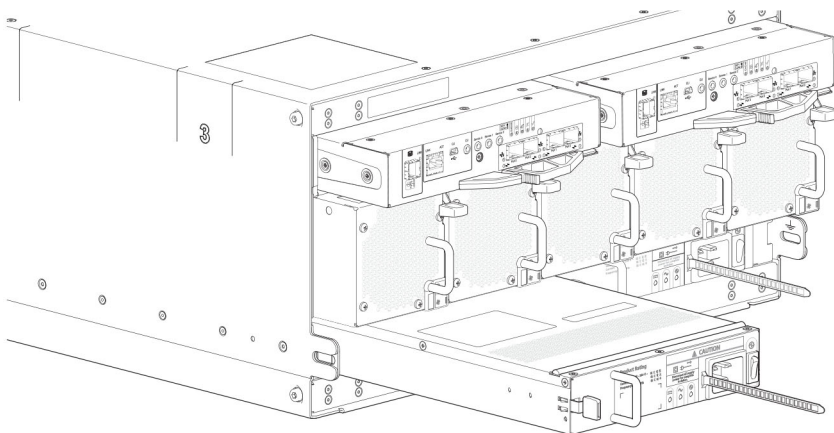
Figure 59. Removing a PSU (2 of 2)

9. While supporting the PSU with both hands, remove it from the enclosure.
10. If replacing both PSUs, repeat steps 5 through 9.

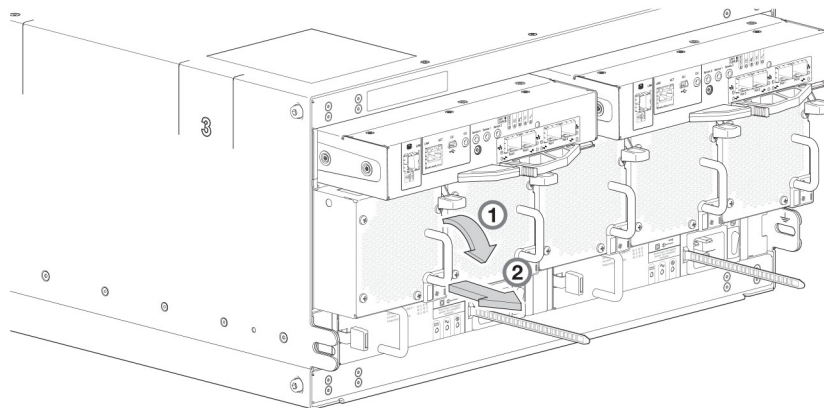
Figure 60. Removing an FCM (1 of 2)

1. Identify the fan cooling (FCM) module to be removed. If the FCM module has failed, the Fan Fault LED will illuminate amber. See [Fan cooling module \(FCM\)](#).
2. Push the release latch down and hold it in place (detail No.1).
3. With your other hand, grasp the handle and pull the FCM outward (detail No.2).

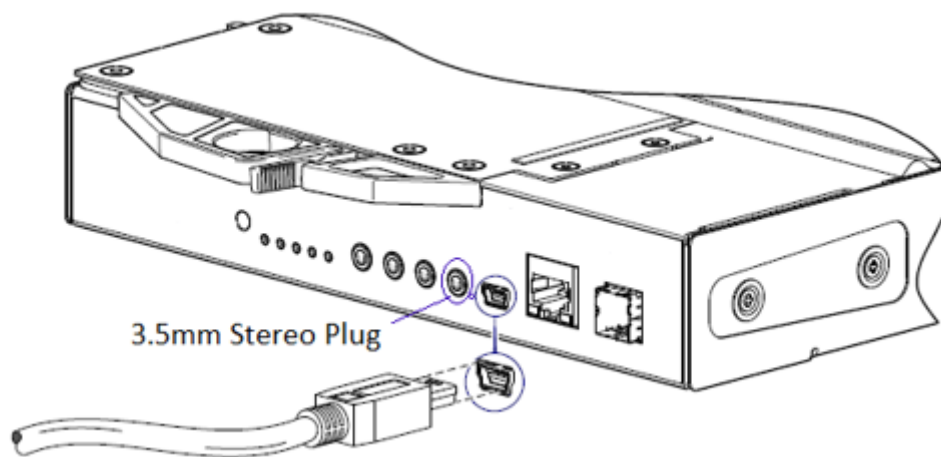
Figure 64. Connecting a USB cable to the USB CLI port

The mini-USB connector plugs into the USB CLI port as shown in the following figure:

1. Connect the 3.5mm/DB9 serial cable from a computer with a serial port to the 3.5mm stereo plug CLI port on controller A. Alternatively, connect a generic mini-USB cable (not included) from a computer to the USB CLI port on controller A.
