Dell EMC PowerVault ME4 Series Storage System

Owner's Manual

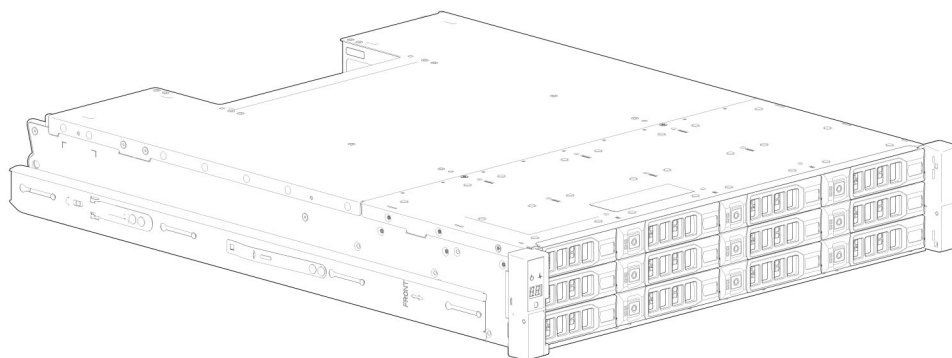
Figure 1. 2U12 enclosure system—front orientation

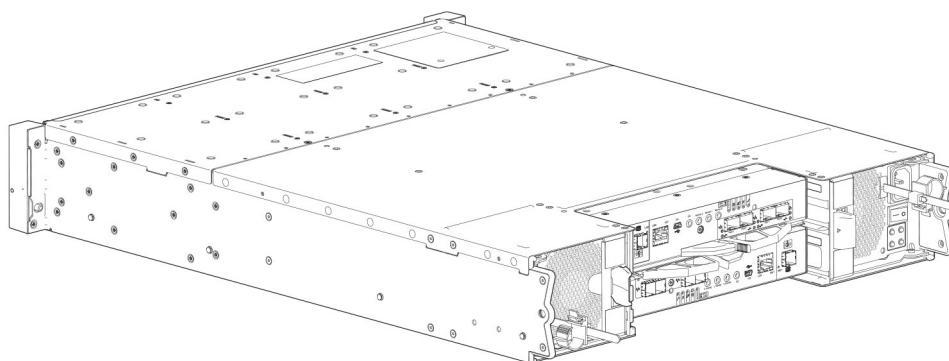
Figure 2. 2U12 enclosure system—rear orientation

The 2U12 controller enclosure in [2U12 enclosure system—rear orientation](#) on page 8 is equipped with 2 controllers (4-port FC/ISCSI model shown).

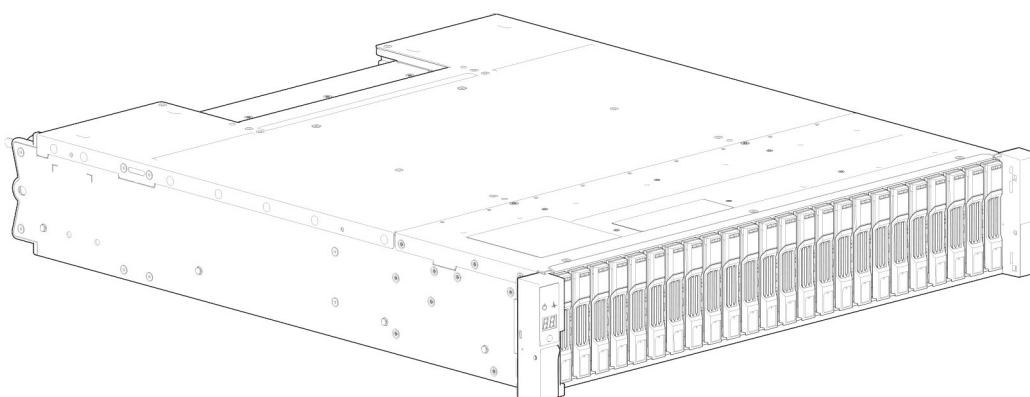
Figure 3. 2U24 enclosure system—front orientation

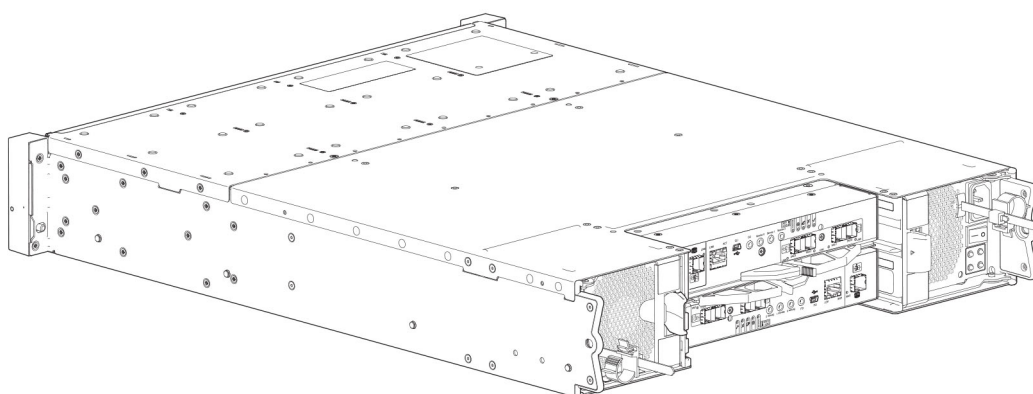
Figure 4. 2U24 enclosure system—rear orientation

The 2U24 controller enclosure is equipped with dual-controllers (4-port SAS model shown).

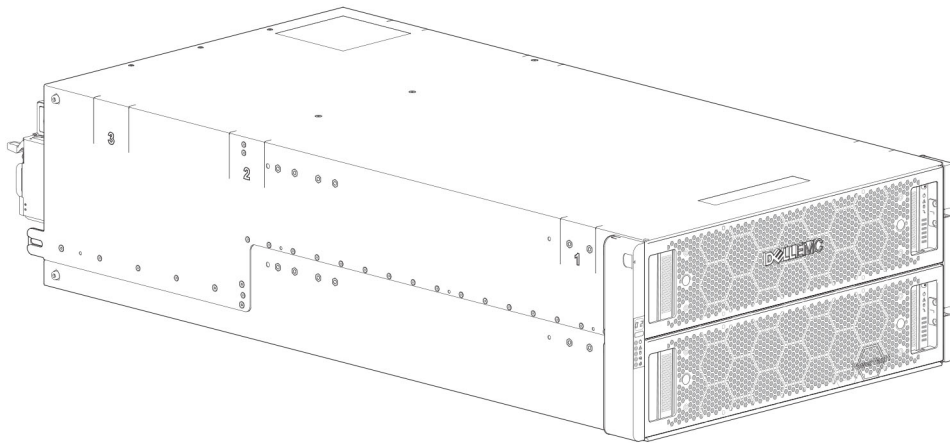
Figure 5. 5U84 enclosure system—front orientation

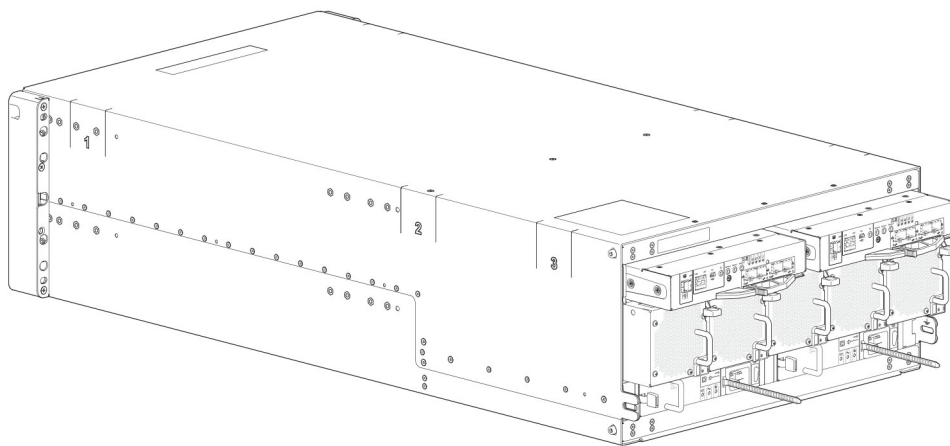
Figure 6. 5U84 enclosure system—rear orientation

The 5U84 controller enclosure is equipped with dual-controllers (4-port FC/iSCSI model shown).

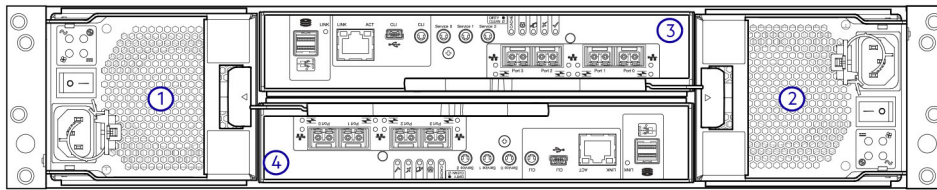
Figure 10. 2U controller enclosure—rear panel components (4-port FC/iSCSI)

| 1. Power cooling module slot 0 | 2. Power cooling module slot 1 |
| 3. Controller module slot A | 4. Controller module slot B |

Alphabetic designators on controller modules or IOMs and numeric designators on PCMs indicate slot sequencing for the modules used in 2U enclosures. Controller modules, IOMs, and PCMs are available as CRUs. The ME4 Series RBODs use 4-port controller modules. These RBODs support the ME412/ME424/ME484 EBODs for optionally adding storage.

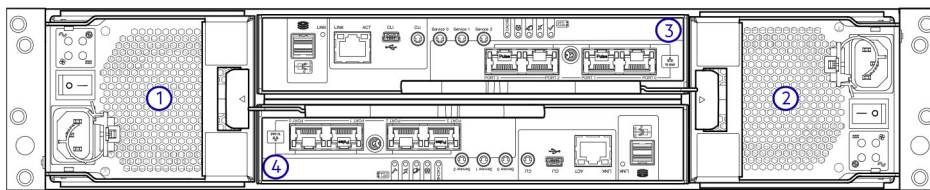
Figure 11. 2U controller enclosure—rear panel components (4-port iSCSI 10Gbase-T)

| 1. Power cooling module slot 0 | 2. Power cooling module slot 1 |
| 3. Controller module slot A | 4. Controller module slot B |

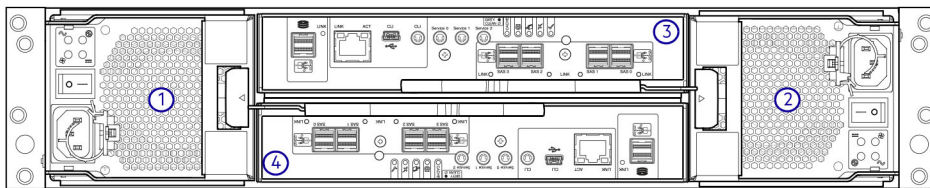
Figure 12. 2U controller enclosure—rear panel components (4-port SAS)

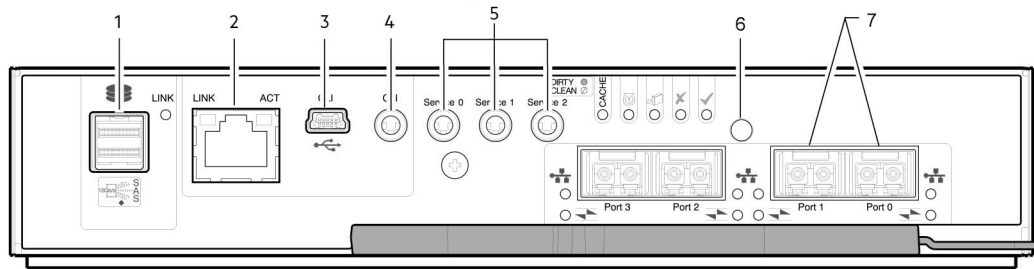
The Converged Network Controller (CNC) ports on the 4-port FC/iSCSI controller module can be configured with 16Gb/s FC SFPs or 10 GbE iSCSI SFPs.

Figure 14. 4-port FC/iSCSI controller module detail

| 7. CNC ports (ports 3, 2, 1, 0) | |

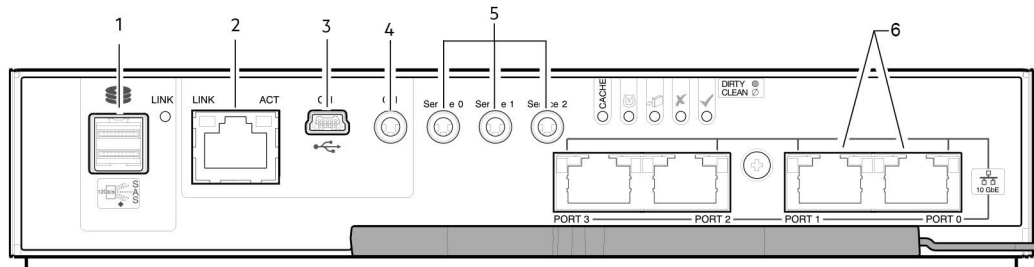
The following figure shows iSCSI 10Gbase-T host interface ports that ship configured with pre-installed external connectors.

Figure 15. 4-port iSCSI 10Gbase-T controller module detail

| 5. 3.5 mm serial ports (service only) | 6. 10Gbase-T ports (ports 3, 2, 1, 0) |

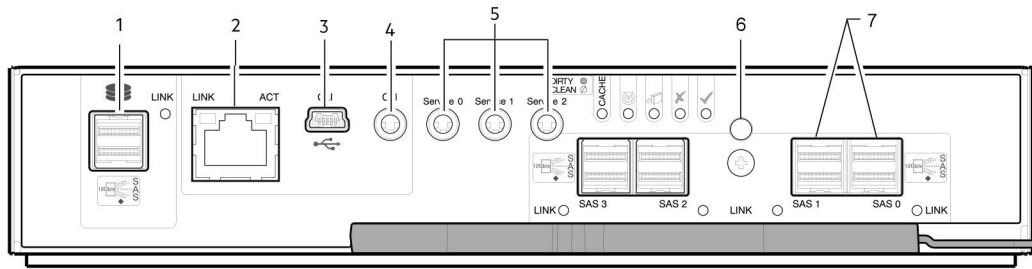
The following figure shows SAS host interface ports that ship configured with 12 Gb/s mini-SAS HD (SFF-8644) external connectors.

Figure 16. 4-port mini-SAS HD controller module detail

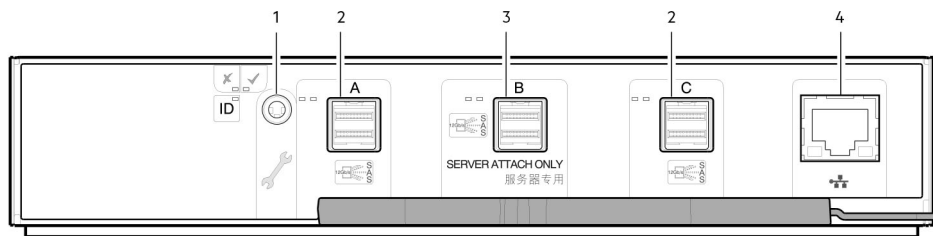
The following figure shows the IOM used in supported expansion enclosures for adding storage. Ports A/B/C ship configured with 12 Gb/s mini-SAS HD (SFF-8644) external connectors.

Figure 17. IOM detail – ME412/ME424/ME484

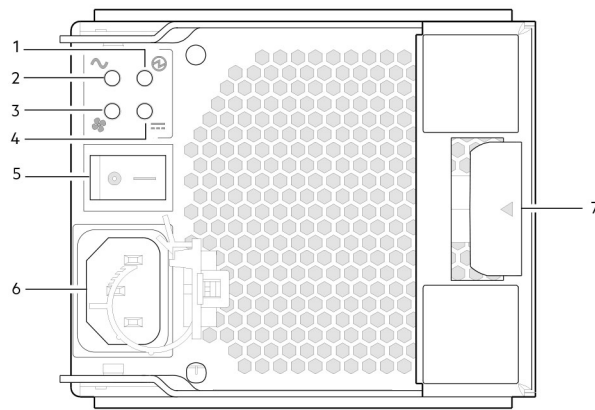
The following figure shows the power cooling module (PCM) used in controller enclosures and optional expansion enclosures. The PCM includes integrated cooling fans. The example shows a PCM oriented for use in the left PCM slot of the enclosure rear panel.

Figure 18. Power cooling module (PCM)

| 1. PCM OK LED (Green) | 2. AC Fail LED (Amber/blinking amber) |
| 3. Fan Fail LED (Amber/blinking amber) | 4. DC Fail LED (Amber/blinking amber) |

- If any of the PCM LEDs are illuminated amber, a module fault condition or failure has occurred.
- For a detailed description of PCM LED behavior, see [2U enclosure LEDs](#) on page 34.

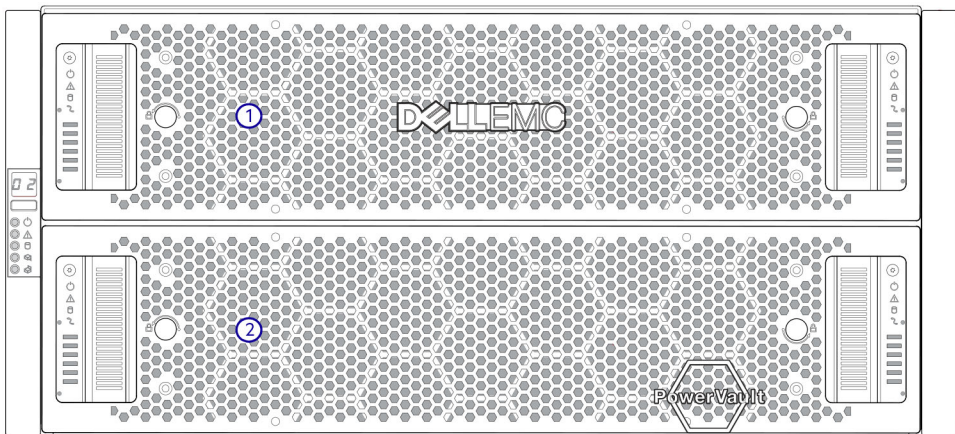
Figure 19. 5U84 enclosure—front panel components

- 1. 5U84 enclosure drawer (slot 0 = top drawer)
- 2. 5U84 enclosure drawer (slot 1 = bottom drawer)

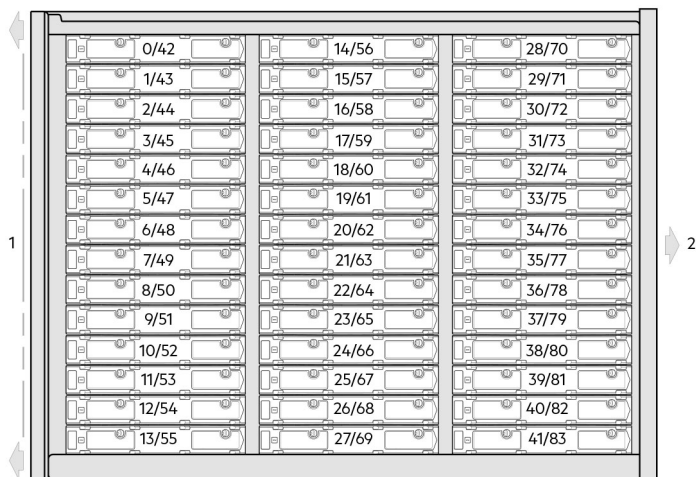
This figure shows a plan view of an enclosure drawer that is accessed from the enclosure front panel. The conceptual graphics are simplified for clarity.

Figure 20. 5U84 enclosure system - plan view of drawer accessed from front panel

- 1. Drawer front panel (shown as an edge in plan view)
- 2. Direction into the enclosure drawer slot (slot 0 or 1)

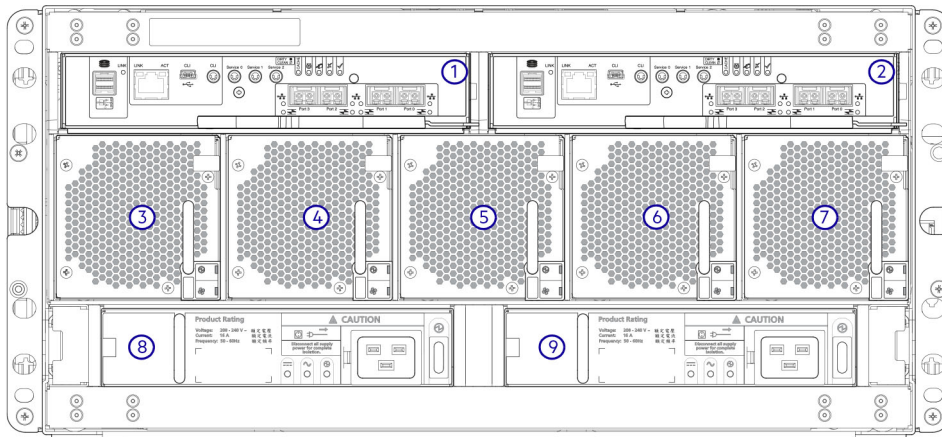
Figure 21. 5U84 controller enclosure—rear panel components (4-port FC/iSCSI)

| 7. FCM slot 4 | 8. PSU slot 0 |
| 9. PSU slot 1 | |

Alphabetic designators on controller modules and IOMs, and numeric designators on PSUs (Power Supply Units) and FCMs (Fan Control Modules) indicate slot sequencing for modules used in 5U84 enclosures. Controller modules, IOMs, PSUs, and FCMs are available as CRUs.

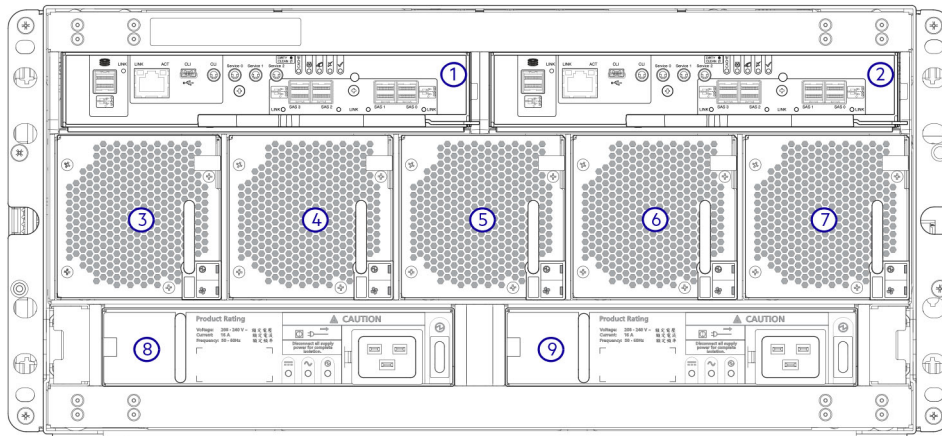
Figure 22. 5U84 controller enclosure—rear panel components (4-port SAS)

| 7. FCM slot 4 | 8. PSU slot 0 |
| 9. PSU slot 1 | |

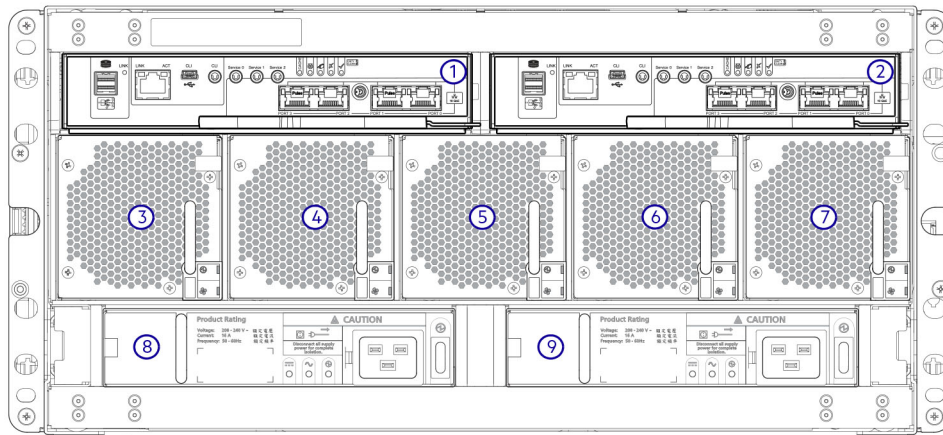
Figure 23. 5U84 controller enclosure—rear panel components (4-port iSCSI 10Gbase-T)

| 7. FCM slot 4 | 8. PSU slot 0 |
| 9. PSU slot 1 | |

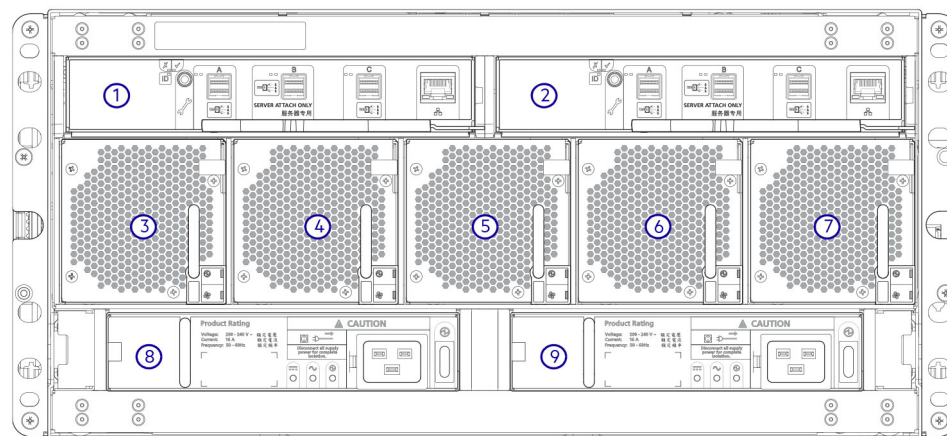
Figure 24. 5U84 expansion enclosure—rear panel components

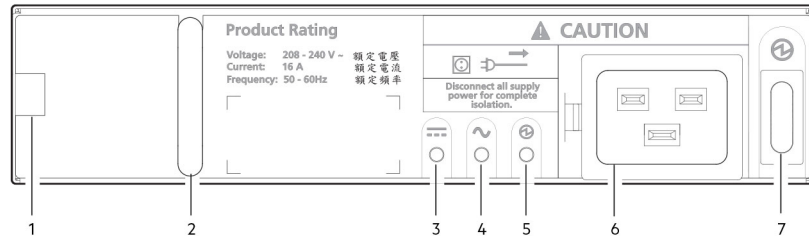
This figure shows the power supply unit that is used in 5U controller enclosures and optional 5U84 expansion enclosures.

Figure 25. Power supply unit (PSU)

| 3. PSU Fault LED (Amber/blinking amber) | 4. AC Fail LED (Amber/blinking amber) |

- If any of the PSU LEDs are illuminated amber, a module fault condition or failure has occurred.
- For a detailed description of PSU LEDs, see [FCM LED states](#) on page 37.

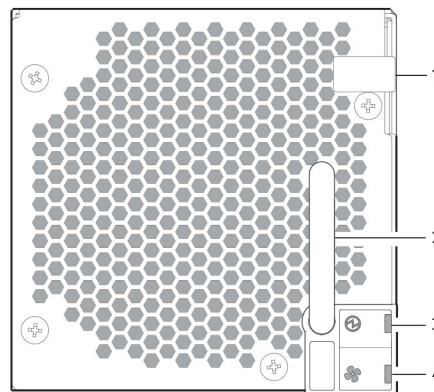
The following figure shows the fan cooling module (FCM) used in 5U controller enclosures and optional 5U expansion enclosures.

Figure 26. Fan cooling module (FCM)

- If any of the FCM LEDs are illuminated amber, a module fault condition or failure has occurred..
- For a detailed description of FCM LEDs, see [5U84 enclosure FCM LEDs](#) on page 37.

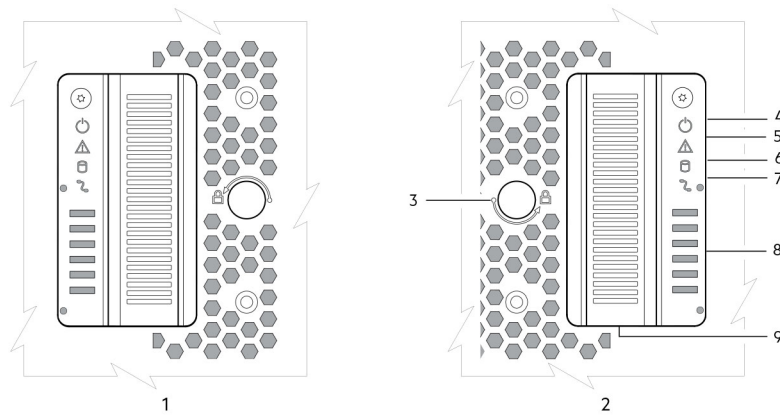
Each drawer can be locked shut by turning both anti-tamper locks clockwise using a screwdriver with a Torx T20 bit (included in your shipment). The anti-tamper locks are symmetrically placed on the left and right sides of the drawer bezel. Drawer status and activity LEDs can be monitored by two drawer LEDs panels located next to the two drawer-pull pockets located on the left and right side of each drawer.

Figure 27. Drawer bezel details

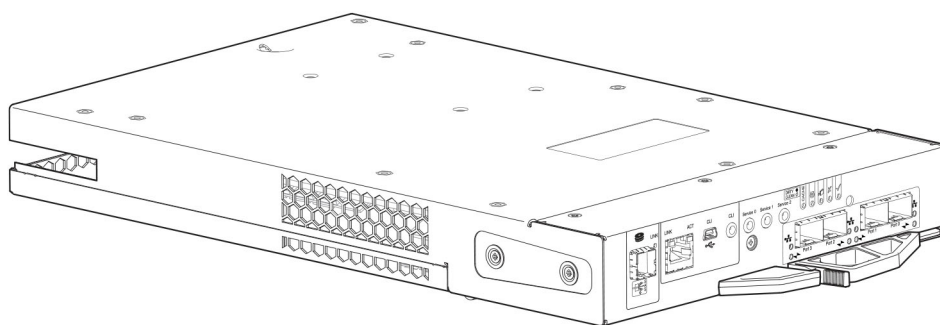
The following figure shows a 4-port FC/iSCSI controller module aligned for use in the top slot located on the 2U enclosure rear panel. The controller module is also properly aligned for use in either slot located on the 5U84 enclosure rear panel.

Figure 30. Controller module – rear orientation

Each controller module maintains VPD (Vital Product Data) in EEPROM devices. In a dual-controller module system, controller modules are interconnected by SBB-defined I2C buses on the midplane. In this way, the SBB module can discover the type and capabilities of the partner SBB module, and vice versa, within the enclosure.

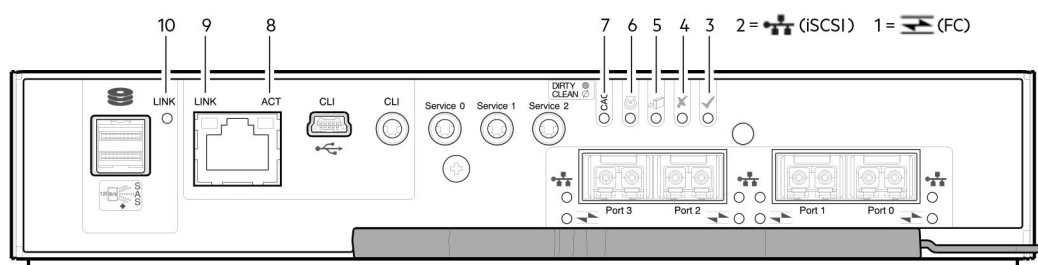
Figure 31. ME4 Series Storage System FC/iSCSI controller modules (FC and 10GbE SFPs) LEDs

Table 6. ME4 Series controller modules (FC and iSCSI SFPs) LEDs

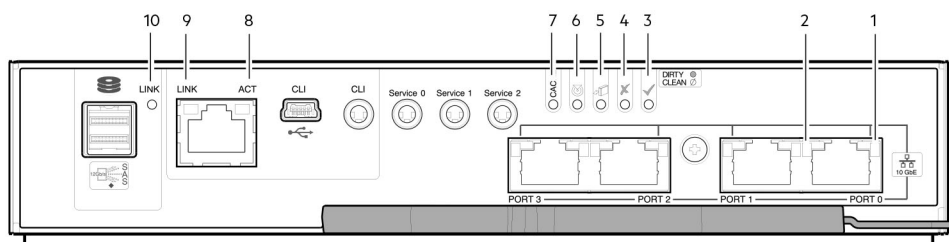
Figure 32. ME4 Series 10Gbase-T controller module LEDs

Table 7. ME4 Series 10Gbase-T controller module LEDs

6	Identify	White—The controller module is being identified.
7	Cache status ³	<ul style="list-style-type: none"> Green—Cache is dirty (contains unwritten data) and operation is normal. The unwritten information can be log or debug data that remains in the cache, so a green cache status LED does not, by itself, indicate that any user data is at risk or that any action is necessary. Off—In a working controller, cache is clean (contains no unwritten data). This is an occasional condition that occurs while the system is booting. Blinking green—A CompactFlash flush or cache self-refresh is in progress, indicating cache activity.
8	Network Port Activity Status ⁴	<ul style="list-style-type: none"> Off—The Ethernet link is not established, or the link is down. Green—The Ethernet link is up (applies to all negotiated link speeds).
9	Network Port Link Speed ⁴	<ul style="list-style-type: none"> Off—Link is up at 10/100base-T negotiated speeds. Amber—Link is up and negotiated at 1000base-T.

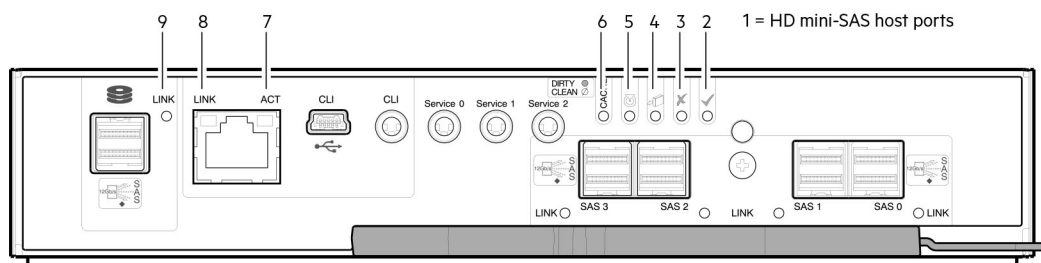
Figure 33. ME4 Series SAS controller module LEDs

Table 8. ME4 Series SAS controller module LEDs

6	Cache status ³	<ul style="list-style-type: none"> Green—Cache is dirty (contains unwritten data) and operation is normal. The unwritten information can be log or debug data that remains in the cache, so a green cache status LED does not, by itself, indicate that any user data is at risk or that any action is necessary. Off—In a working controller, cache is clean (contains no unwritten data). This is an occasional condition that occurs while the system is booting. Blinking green—A CompactFlash flush or cache self-refresh is in progress, indicating cache activity.
7	Network Port Activity Status ⁴	<ul style="list-style-type: none"> Off—The Ethernet link is not established, or the link is down. Green—The Ethernet link is up (applies to all negotiated link speeds).
8	Network Port Link Speed ⁴	<ul style="list-style-type: none"> Off—Link is up at 10/100base-T negotiated speeds. Amber — Link is up and negotiated at 1000base-T.

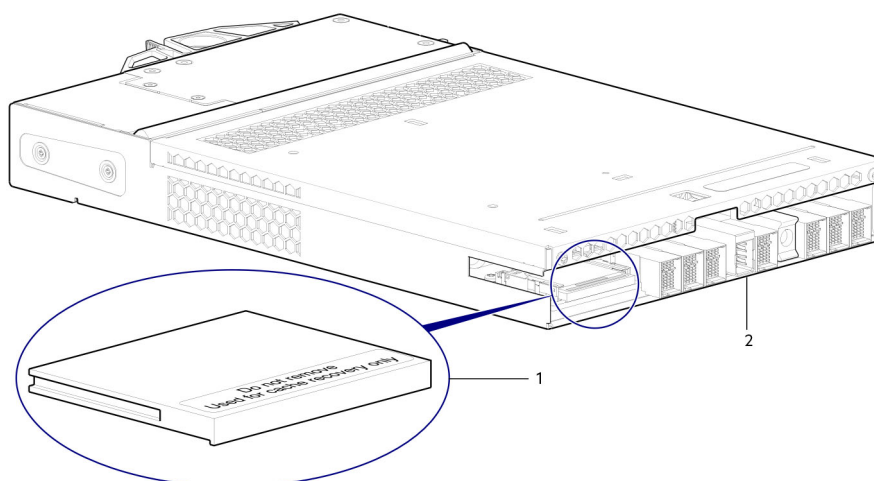
During a power loss or controller failure, data stored in cache is saved off to non-volatile memory (CompactFlash). The data is restored to cache, and then written to disk after the issue is corrected. To protect against writing incomplete data to disk, the image stored on the CompactFlash is verified before committing to disk. The CompactFlash memory card is located at the midplane-facing end of the controller module. Do not remove the card; it is used for cache recovery only.

**Figure 34. CompactFlash memory card**

1. CompactFlash memory card
2. Controller module viewed from back

In single-controller module configurations, if the controller module has failed or does not start, and the Cache Status LED is on or blinking, the CompactFlash needs to be transported to a replacement controller to recover data not flushed to the disk.

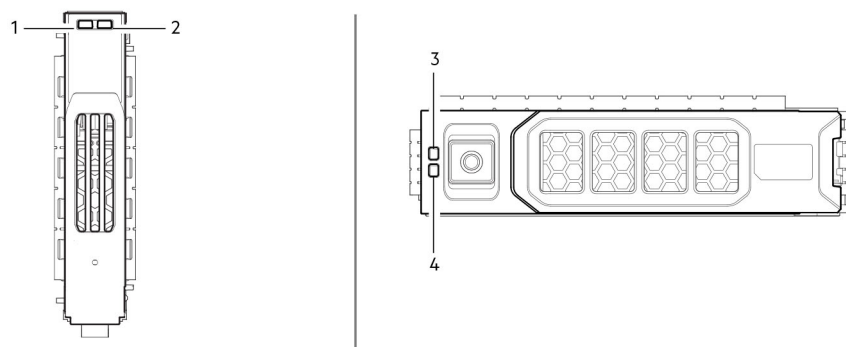
The drive module LEDs are identified in the figure, and the LED behavior is described in the table following the figure.

- In normal operation, the green LED are on, and flicker as the drive operates.
- In normal operation the amber LED will be:
 - Off if there is no drive present.
 - Off as the drive operates.
 - On if there is a drive fault.

Figure 35. LEDs: Drive carrier LEDs (SFF and LFF modules) used in 2U enclosures

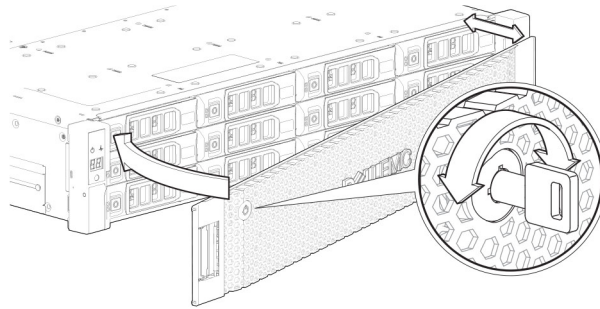
The following figure shows a partial view of a 2U12 enclosure:

Figure 37. Attaching or removing the 2U enclosure front bezel

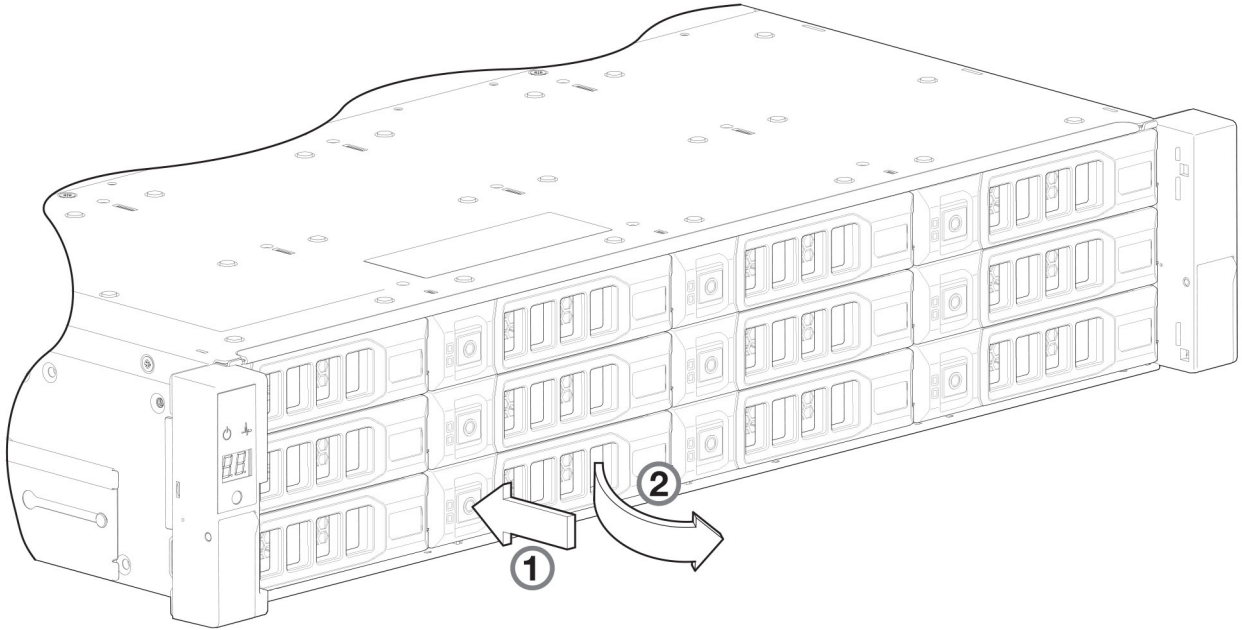
1. Press the latch on the drive module carrier to open the handle.

Figure 38. Removing an LFF drive carrier module (1 of 2)

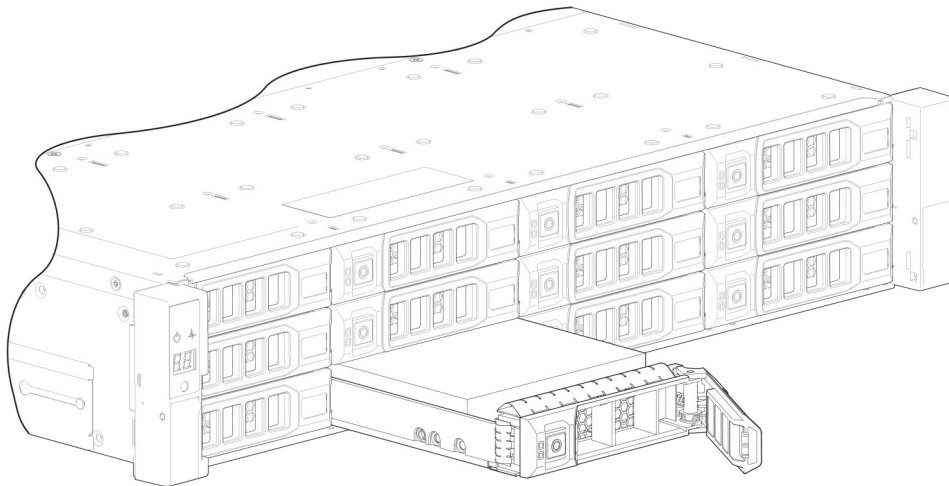
2. Gently move the drive carrier module approximately 25 mm (1 in.), and then wait 30 seconds for the drive to spin down.

Figure 39. Removing an LFF drive carrier module (2 of 2)

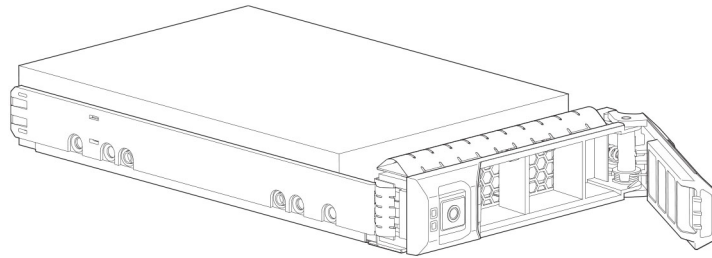
1. Press the latch on the drive module carrier to open the handle.

Figure 40. LFF drive carrier module in open position

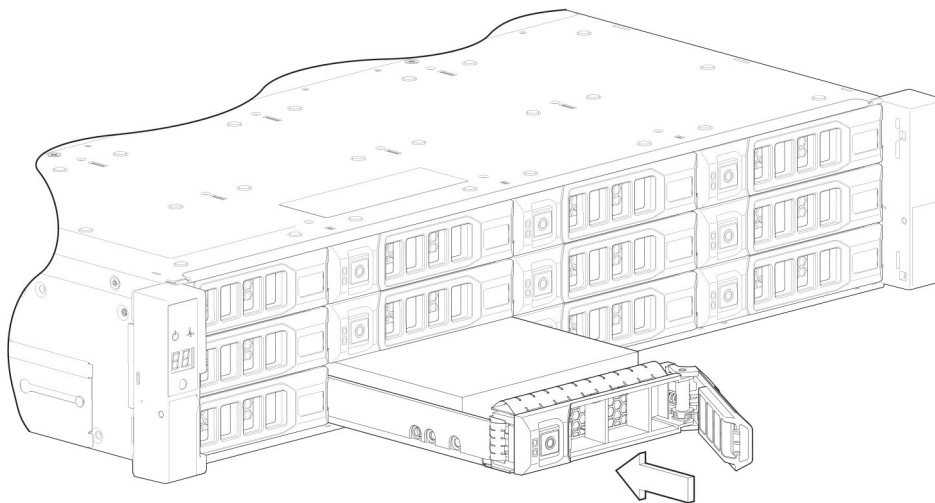
2. Insert the drive carrier module into the enclosure.
3. Gently slide the drive carrier module into the enclosure until it stops moving.

Figure 41. Installing an LFF drive carrier module (1 of 2)

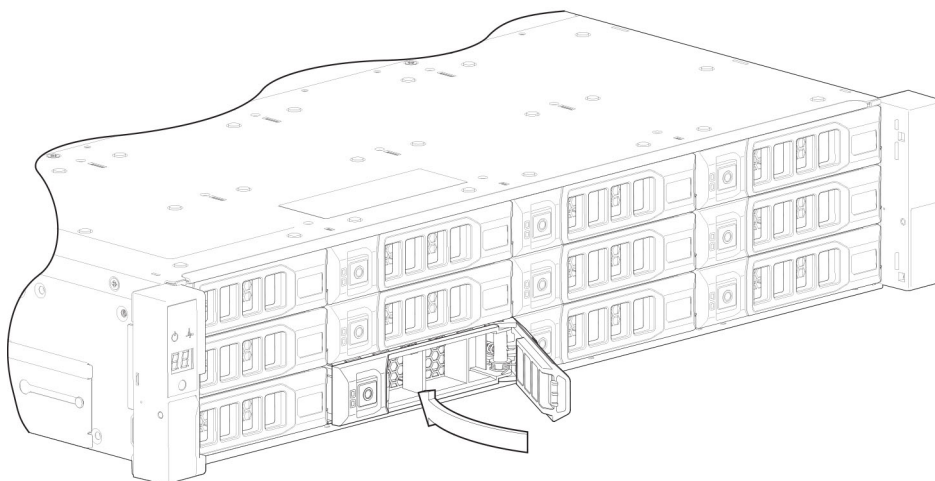
4. Push the drive carrier module further into the enclosure until the latch handle starts to engage.
5. Continue to push firmly until the latch handle fully engages. You should hear a click as the latch handle engages and holds the handle closed.

Figure 42. Installing an LFF drive carrier module (2 of 2)

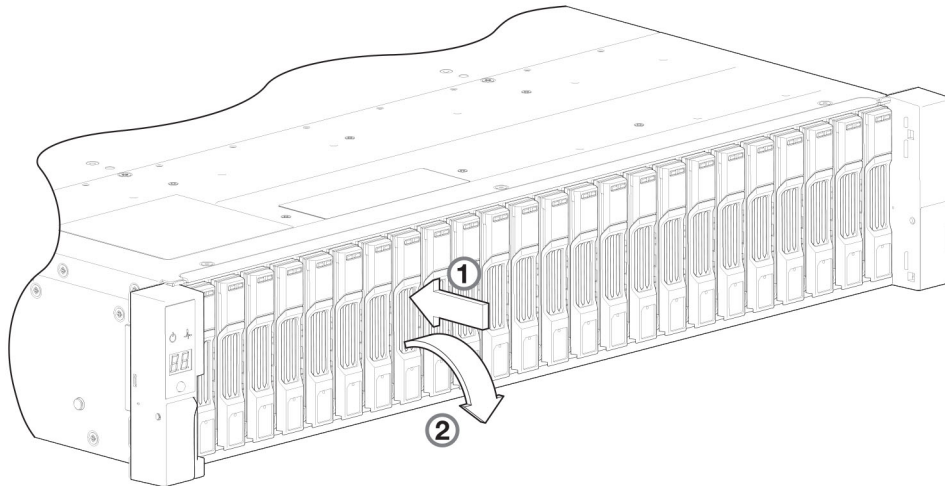
1. Press the latch on the drive module carrier to open the handle.

Figure 43. Removing an SFF drive module carrier (1 of 2)

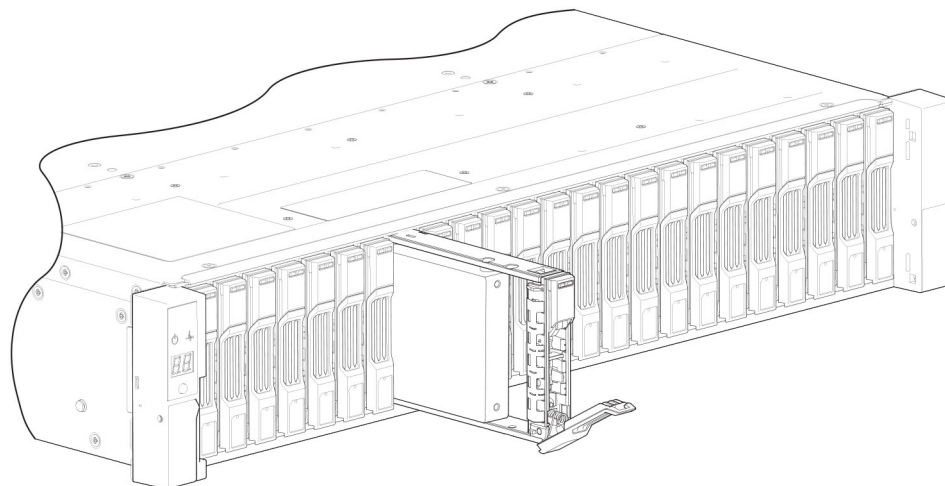
2. Gently move the drive carrier module approximately 25 mm (1 in.), and then wait 30 seconds for the drive to spin down.

Figure 44. Removing an SFF drive module carrier (2 of 2)

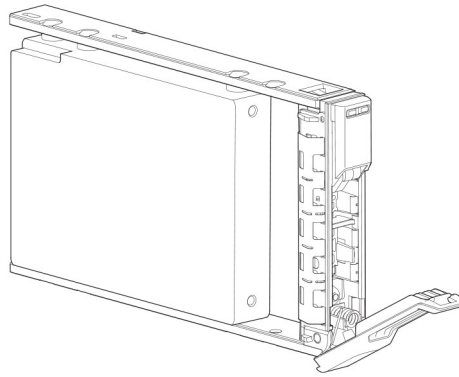
1. Press the latch on the drive module carrier to open the handle.

Figure 45. SFF drive carrier module in open position

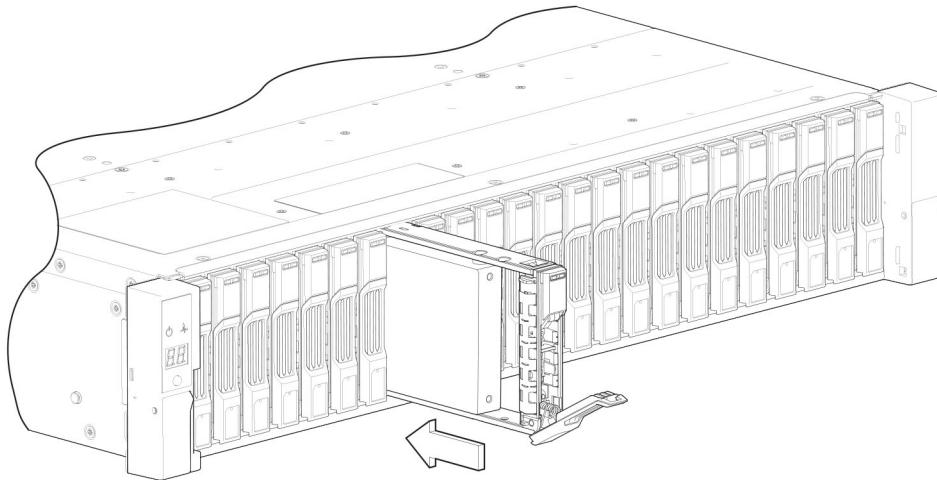
Figure 46. Installing an SFF drive carrier module (1 of 2)

2. Insert the drive carrier module into the enclosure.
3. Gently slide the drive carrier module into the enclosure until it stops moving.

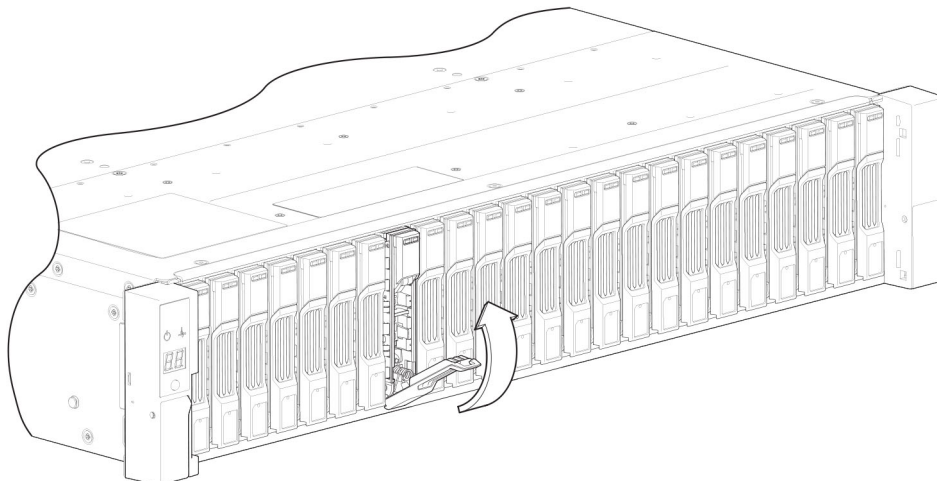
Figure 47. Installing an SFF drive carrier module (2 of 2)

4. Push the drive carrier module further into the enclosure until the latch handle starts to engage.
5. Continue to push firmly until the latch handle fully engages. You should hear a click as the latch handle engages and holds the handle closed.

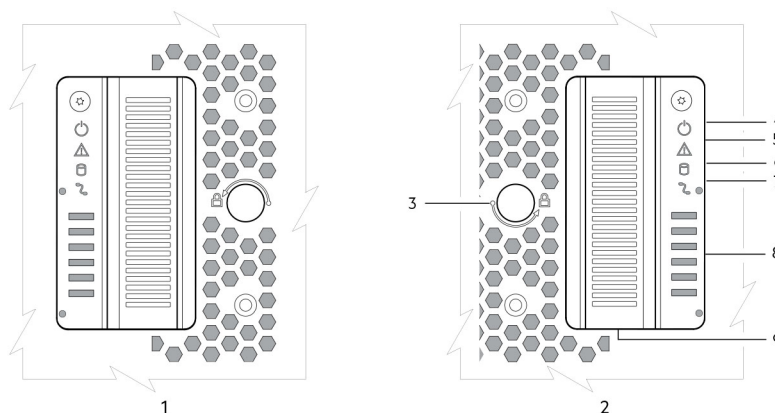
Figure 48. Drawer front panel details

1. Verify that the anti-tamper locks are not engaged. The red arrows on the locks point inwards if the locks are disengaged as shown in the following figure. If necessary, unlock them by rotating counter-clockwise using a Torx T20 bit.

1. Left side
2. Right side
3. Anti-tamper lock
4. Sideplane OK/Power Good

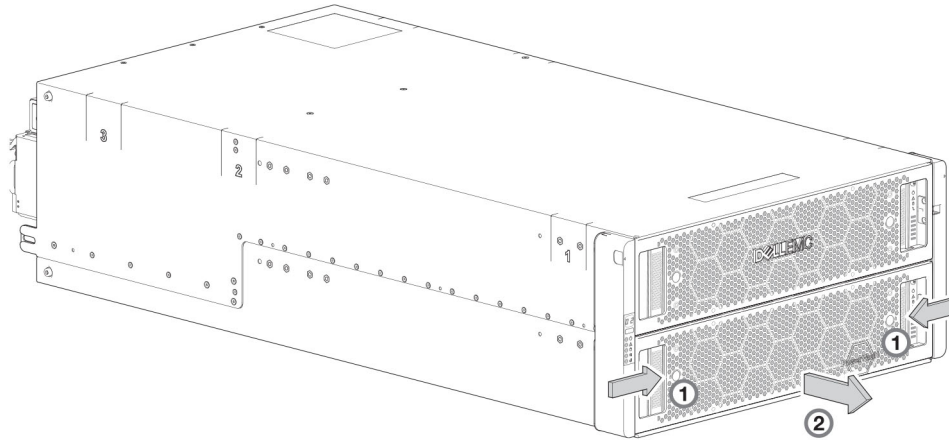
Figure 49. Opening a drawer (1 of 2)

- 5. Drawer Fault
 - 6. Logical Fault
 - 7. Cable Fault
 - 8. Drawer Activity
 - 9. Drawer pull handle
2. Push the drawer latches inward and hold them as shown in the following figure.

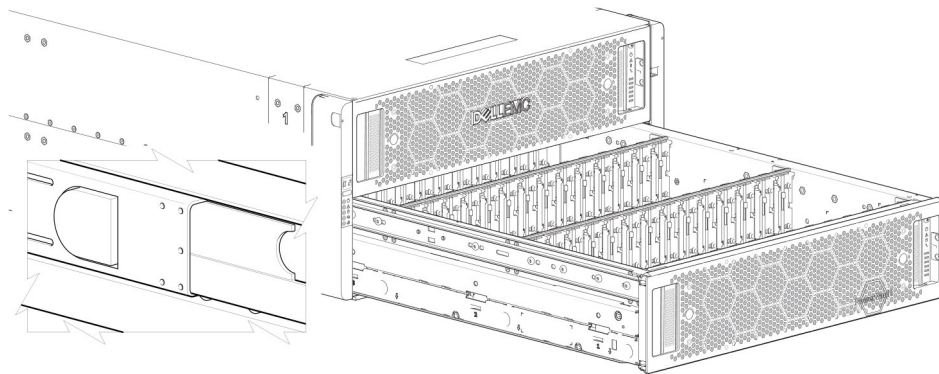
Figure 50. Opening a drawer (2 of 2)

3. Pull the drawer outward until it locks at the drawer stops as shown in the following figure. The drawer is shown empty, which is how the enclosure is delivered. A drawer slide rail latch detail is inset.

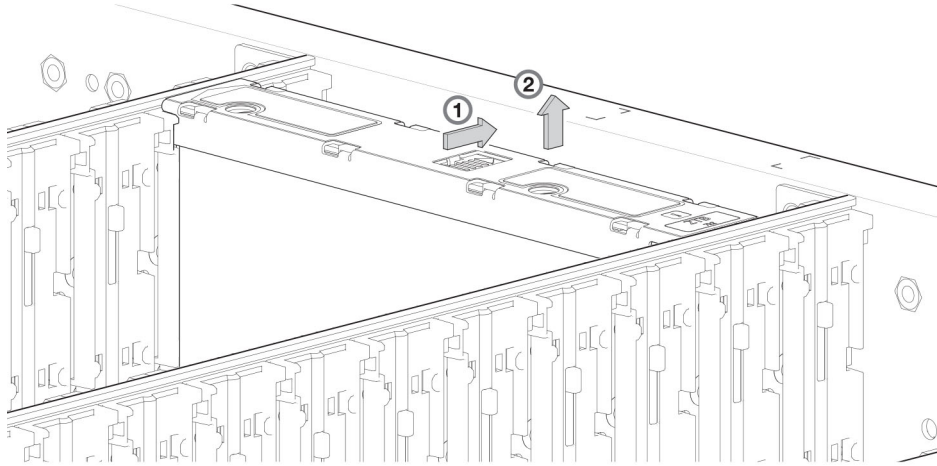
Figure 51. Removing a DDIC (1 of 2)

- If the slot number is known, see [5U84 enclosure system - plan view of drawer accessed from front panel](#) on page 16, which provides a view of a drawer that is dual-indexed with top drawer (left integer) and bottom drawer (right integer) slot numbering.
 - If the disk drive has failed, a fault LED is lit on the front panel of the affected drawer.
 - If the disk drive has failed, the Drive Fault LED on the DDIC is lit amber.
2. Open the drawer that contains the DDIC to remove.
 3. Unlock the DDIC from its seated position in the slot by pushing the latch button in the direction shown in the following figure:

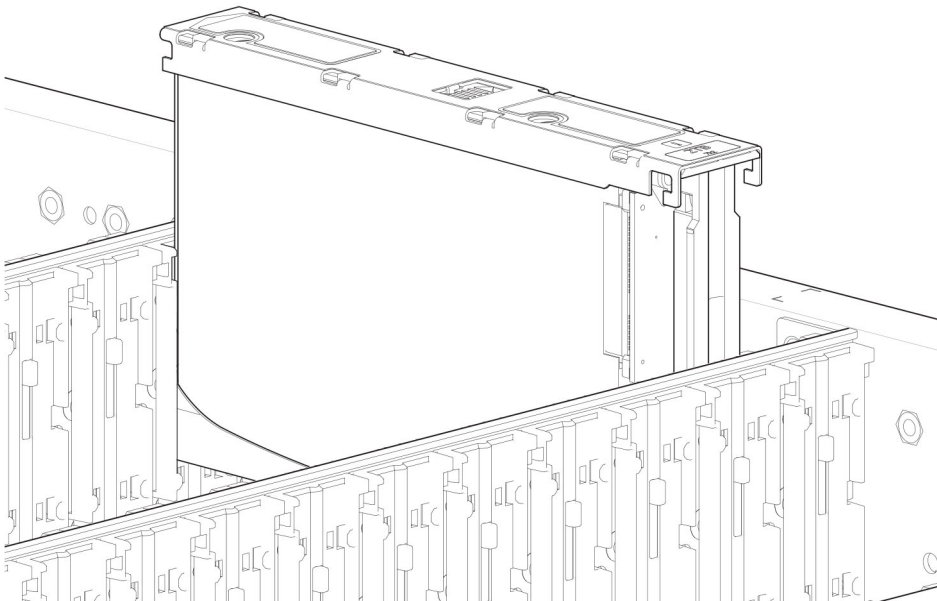
Figure 52. Removing a DDIC (2 of 2)

4. Pull the DDIC upwards and out of the drawer slot.

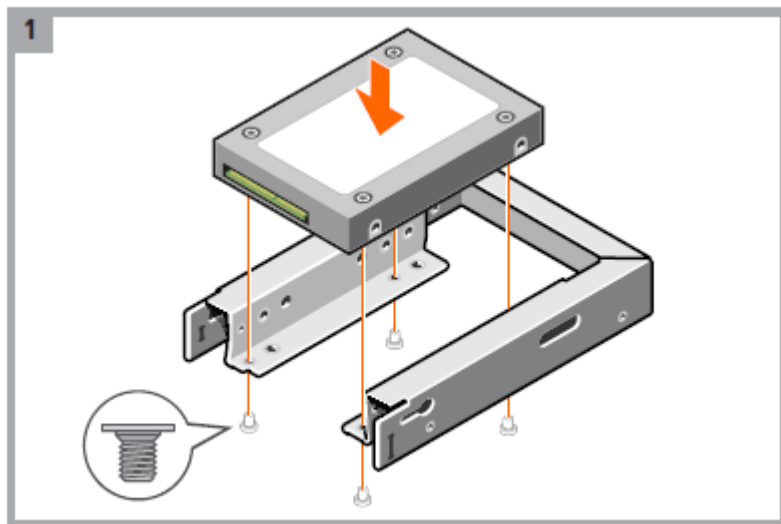
1. Install the 2.5" replacement disk drive into the 3.5" adapter.

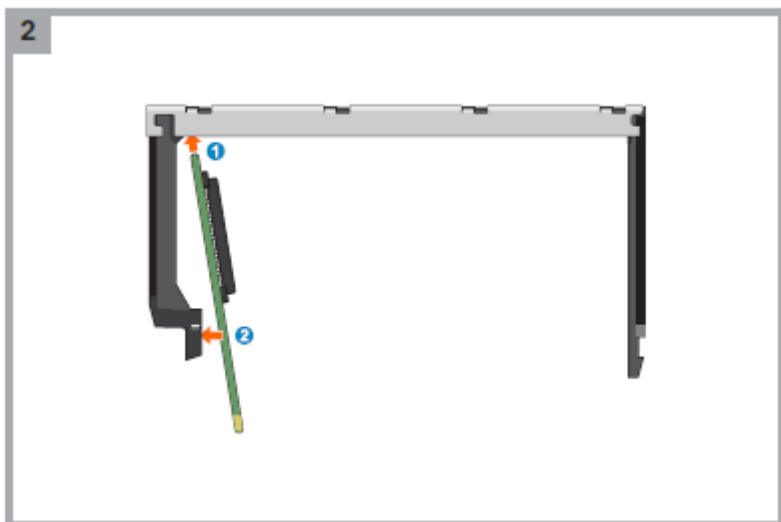
2. Insert the SAS connector into the new DDIC.

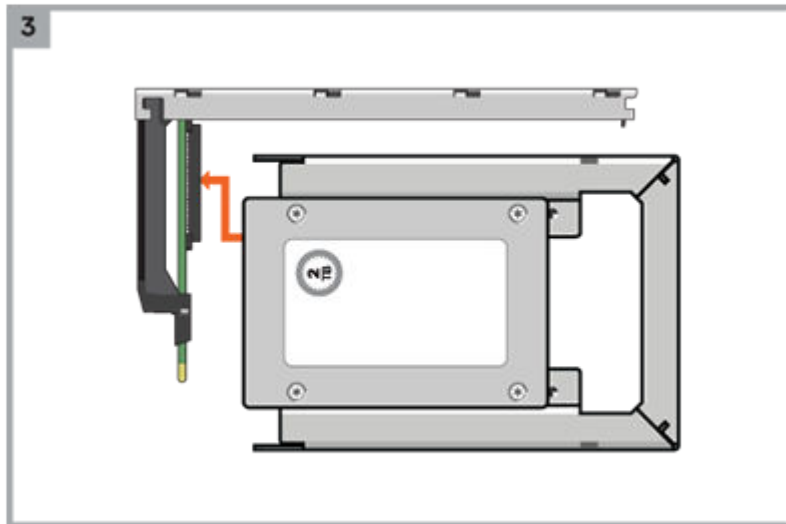
3. Insert the 3.5" adapter with the 2.5" disk drive into the new DDIC and connect the disk drive to the SAS connector.

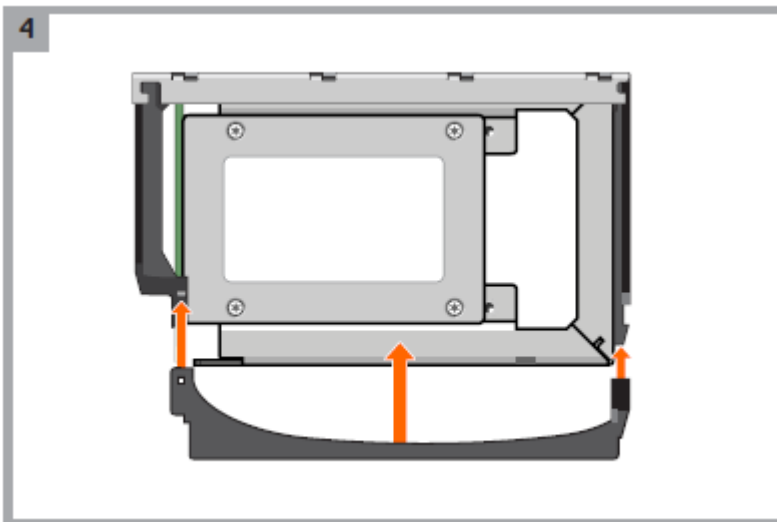
4. Attach the bottom bracket to the new DDIC.

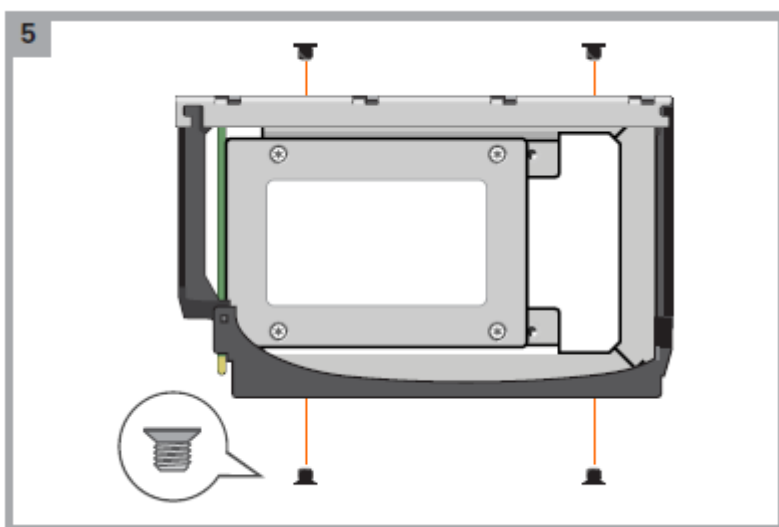
5. Secure the disk drive in the new DDIC using the four screws shipped with the new DDIC.

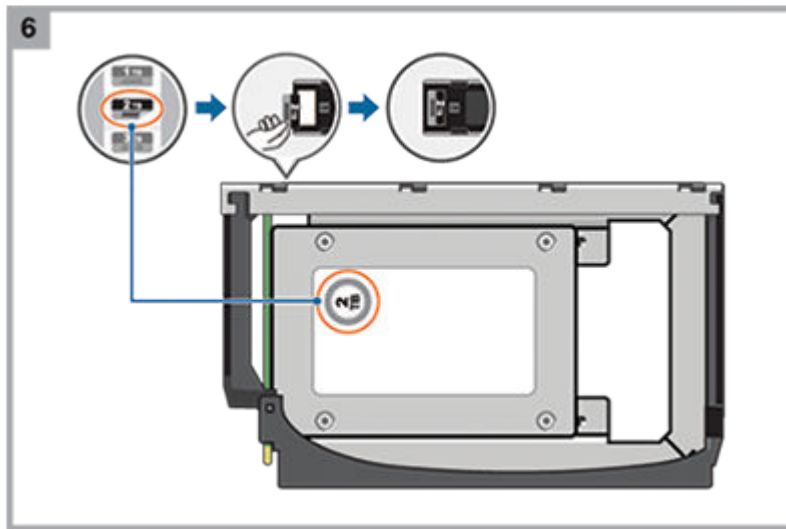
6. Attach the appropriate disk drive size label to the new DDIC.

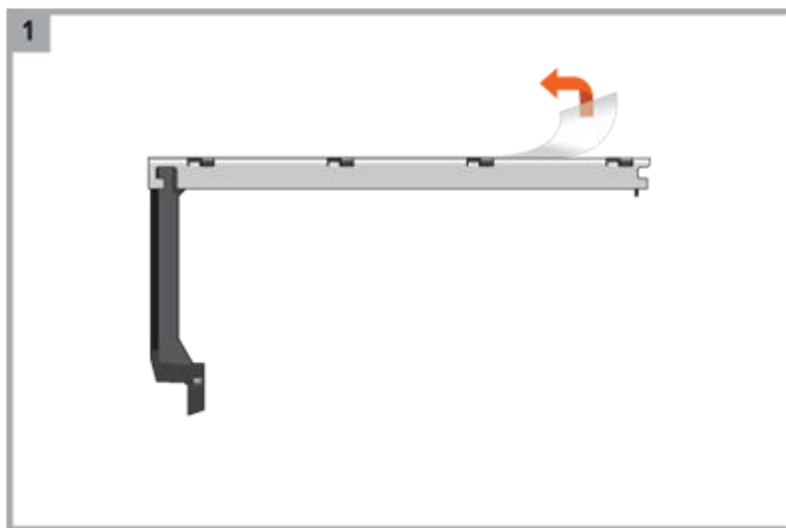
1. Remove the protective plastic from the new DDIC.

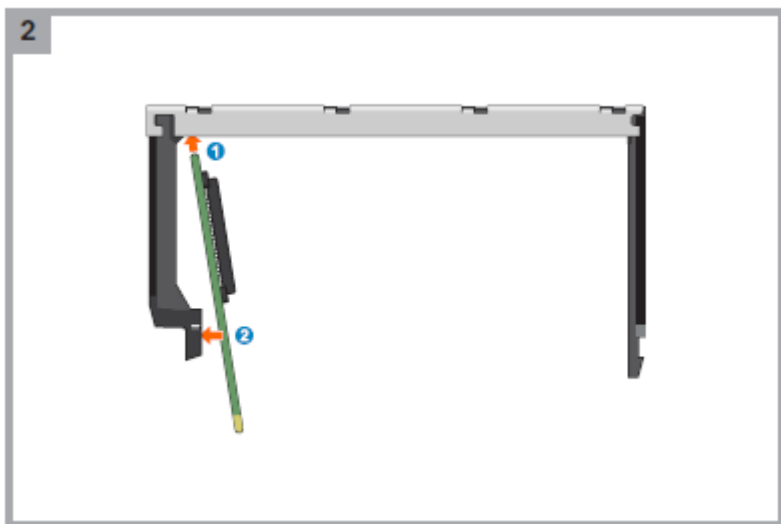
2. Insert the SAS connector into the new DDIC.
