Dell EMC PowerVault ME4 Series Storage System

Owner's Manual

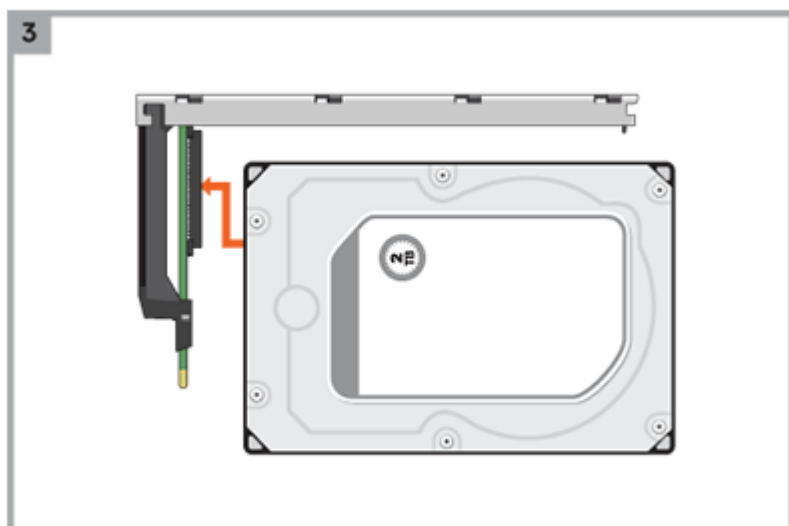
3. Insert the disk drive into the new DDIC and connect the disk drive to the SAS connector. .

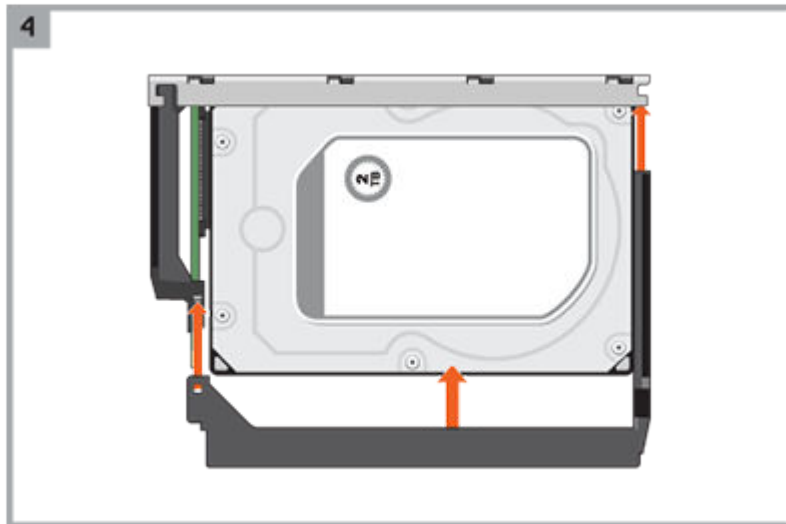
4. Attach the bottom bracket to the new DDIC.

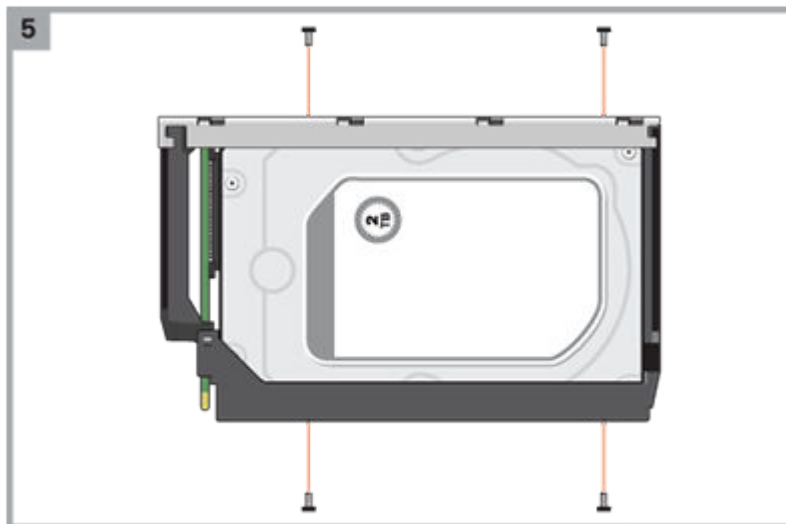
5. Secure the disk drive in the new DDIC using the four screws shipped with the new DDIC.

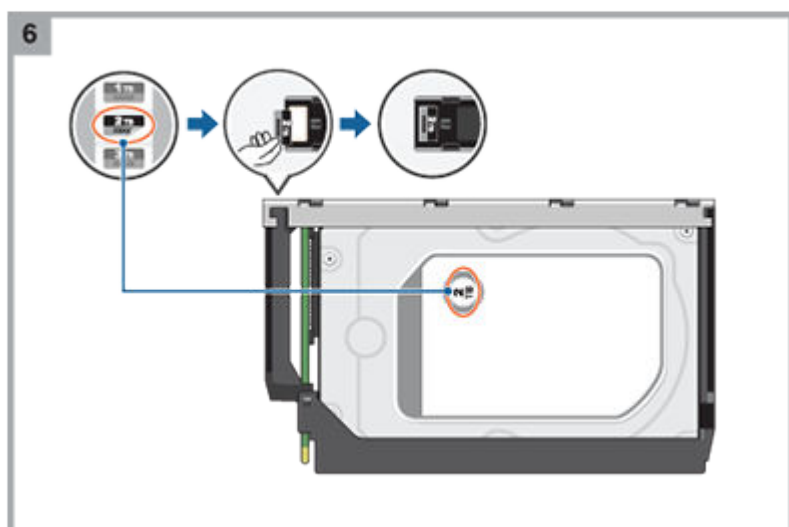
6. Attach the appropriate disk drive size label to the new DDIC.

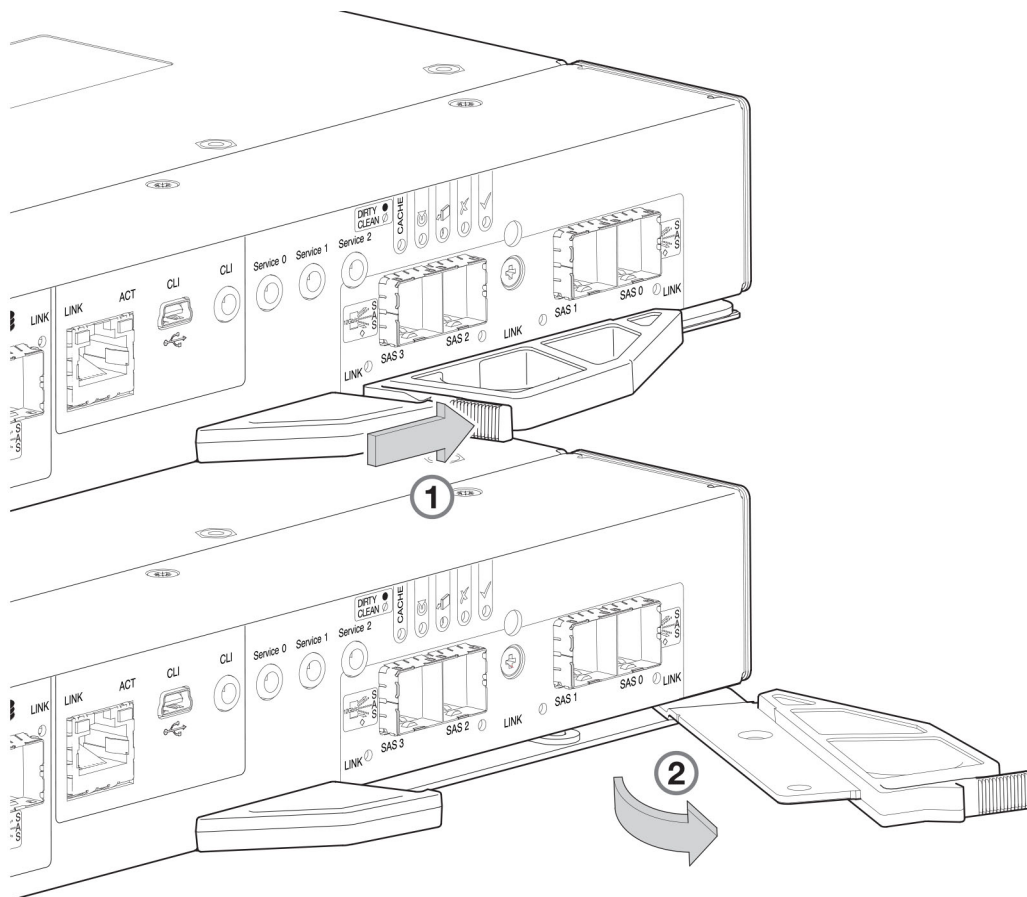
Figure 54. Removing a controller module from an enclosure

5. Grasp the module latch between the thumb and forefinger, and squeeze the flange and handle together to release the latch handle, and swing the latch handle out to release the controller module from its seated position.

NOTE: Removing a controller module shows a 4-port SAS controller module. However, all of the controller modules use the same latching mechanism.

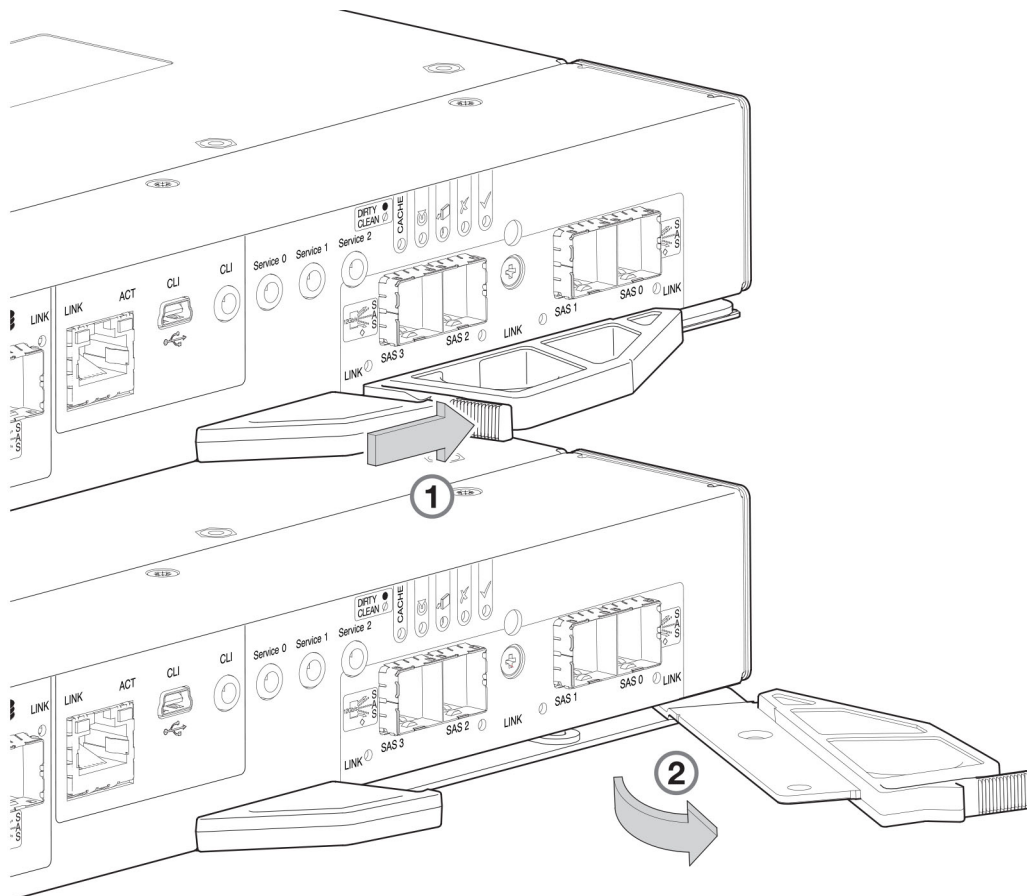
Figure 55. Removing a controller module from an enclosure

1. Shut down the storage system using PowerVault Manager or the CLI.
2. Disconnect any cables connected to the controller module.
Label each cable to facilitate re-connection to the replacement controller module.
3. Grasp the module latch between the thumb and forefinger, and squeeze the flange and handle together to release the latch handle, and swing the latch handle out to release the controller module from its seated position.

NOTE: The previous figures show a 4-port SAS controller module. However, all of the controller modules use the same latching mechanism.

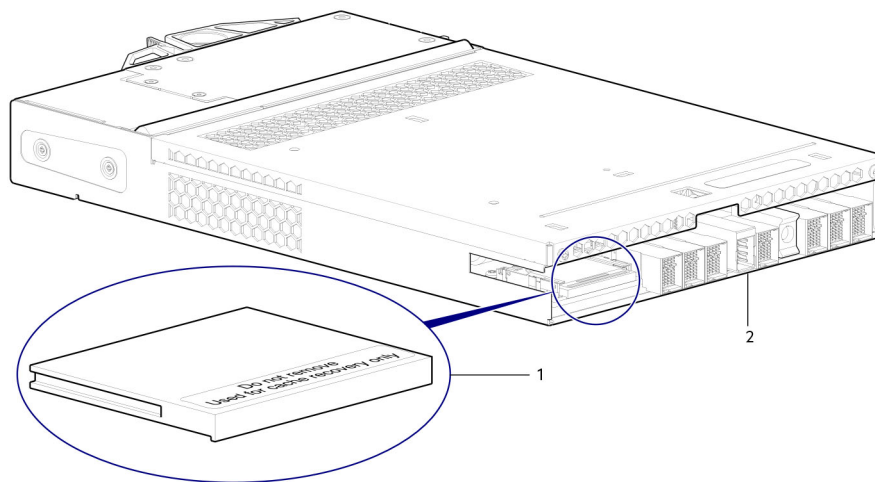
Figure 56. CompactFlash memory card location

1. Remove the failed controller module from the controller enclosure.
2. Locate the CompactFlash memory card at the midplane-facing end of the failed controller module.

- a. CompactFlash memory card
- b. Controller module viewed from back

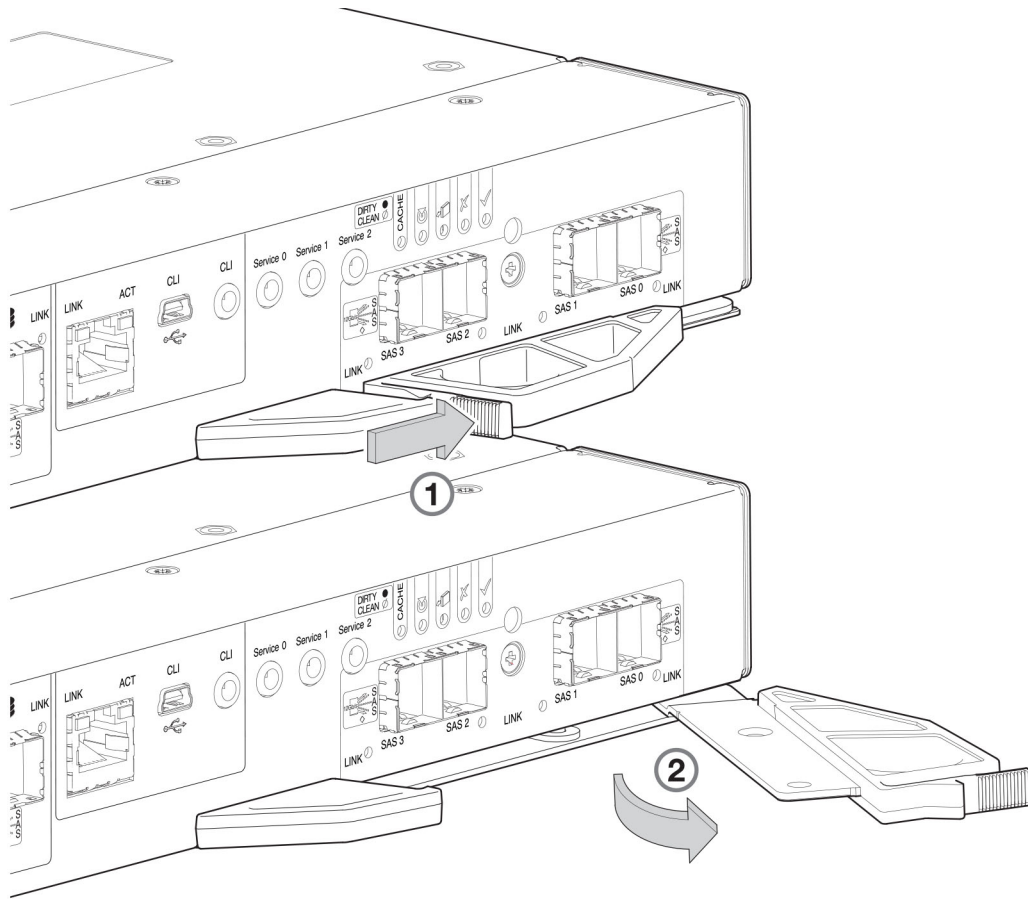
Figure 57. Removing an IOM from an enclosure

2. Disconnect any cables connected to the IOM.
Label each cable to facilitate re-connection to the replacement IOM.
 3. Grasp the module latch between the thumb and forefinger, and squeeze the flange and handle together to release the latch handle, and swing the latch handle out to release the IOM from its seated position.

4. **NOTE:** Removing an IOM from an enclosure on page 67 shows a 4-port SAS controller module instead of an IOM. However, an IOM uses the same latching mechanism as the controller module.
5. Swing the latch handle open, then grip the latch handle and ease the IOM forward from the slot.
6. Place both hands on the IOM body, and pull it straight out of the enclosure such that the IOM remains level during removal.

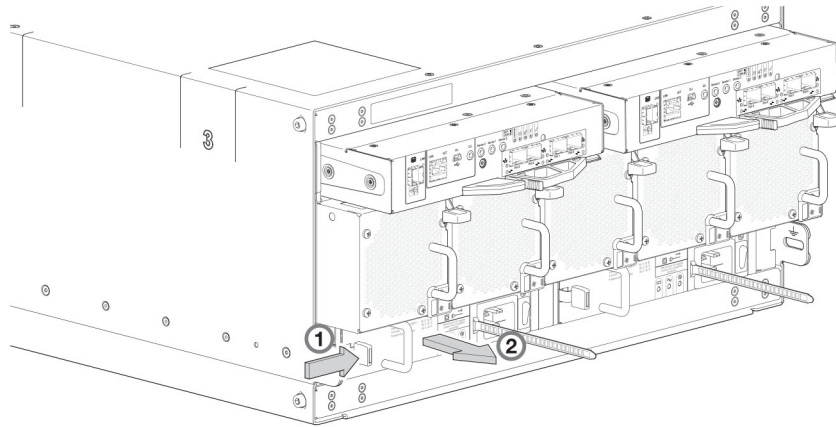
Figure 58. Removing a PSU (1 of 2)

7. Push the release latch to the right and hold it in place (detail No.1).
8. With your other hand, grasp the handle and pull the PSU outward (detail No.2).

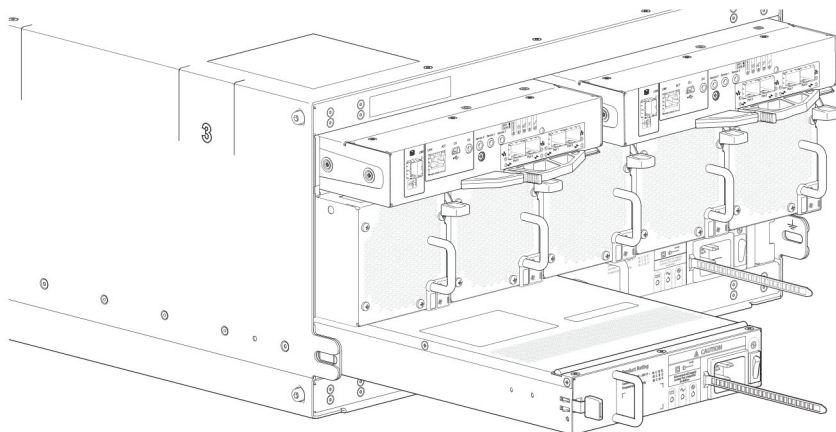
Figure 59. Removing a PSU (2 of 2)

9. While supporting the PSU with both hands, remove it from the enclosure.
10. If replacing both PSUs, repeat steps 5 through 9.
NOTE: The PSU slot must not be empty for more than 2 minutes while the enclosure is powered.

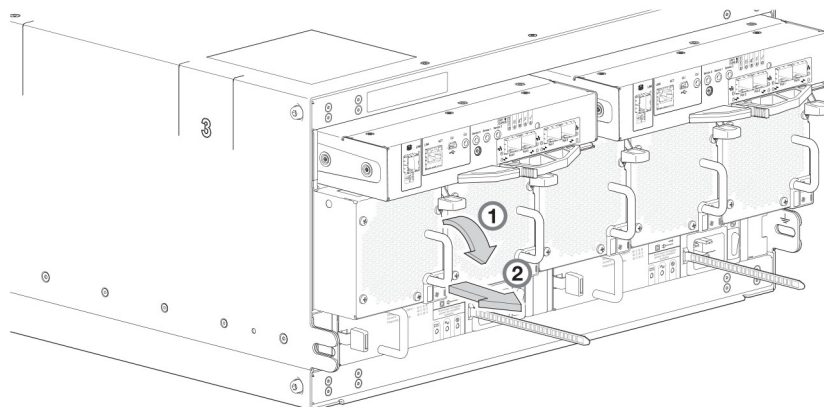
Figure 60. Removing an FCM (1 of 2)

1. Identify the fan cooling (FCM) module to be removed. If the FCM module has failed, the Fan Fault LED will illuminate amber. See [Fan cooling module \(FCM\)](#) on page 19.
2. Push the release latch down and hold it in place (detail No.1).
3. With your other hand, grasp the handle and pull the FCM outward (detail No.2).

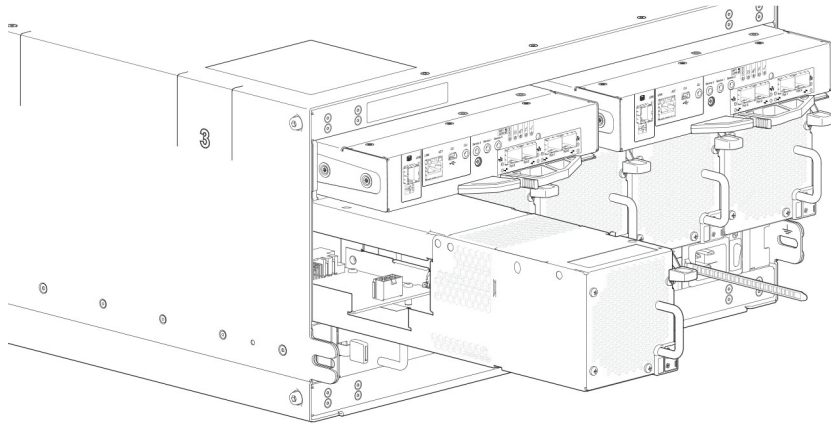
Figure 61. Removing an FCM (2 of 2)

4. While supporting the FCM with both hands, remove it from the enclosure.

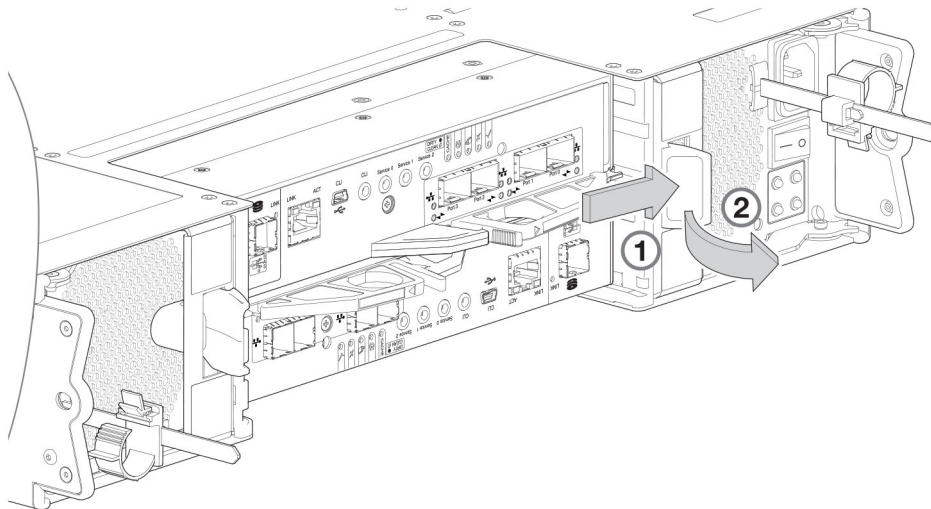
Figure 62. Removing a PCM (1 of 2)

3. Switch off the faulty PCM, and disconnect the power supply cable.
4. If replacing a single PCM using hot-swap, proceed to step 6.
5. If replacing both PCMs, verify that the enclosure was shut down using management interfaces, and that the enclosure is powered off.
6. Verify that the power cable is disconnected.
7. Grasp the latch and the side of the PCM handle between thumb and forefinger, squeeze together and open the handle to cam the PCM out of the enclosure as shown in the following figure.

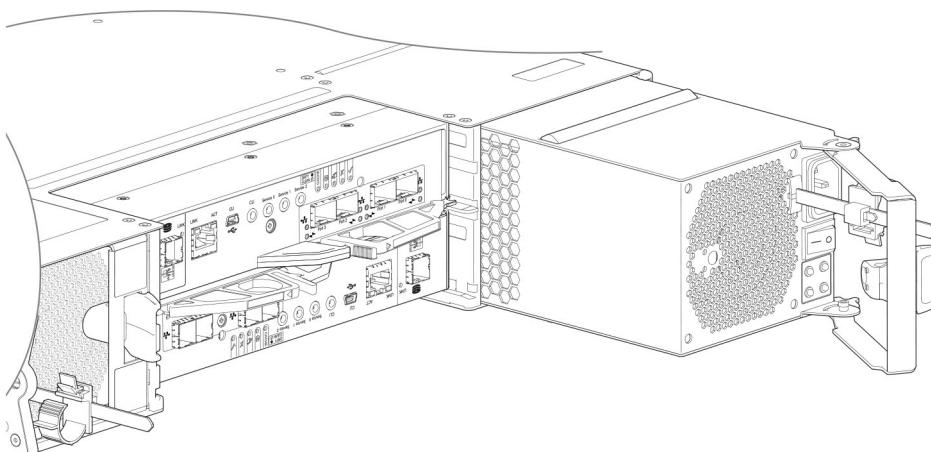
Figure 63. Removing a PCM (2 of 2)

8. Grip the handle and withdraw the PCM, taking care to support the base of the module with both hands as you remove it from the enclosure as shown in the following figure.

i NOTE: The remove PCM illustrations show a chassis configured as a 4-port FC/iSCSI controller enclosure. The procedure applies to all 2U controller enclosures and expansion enclosures.

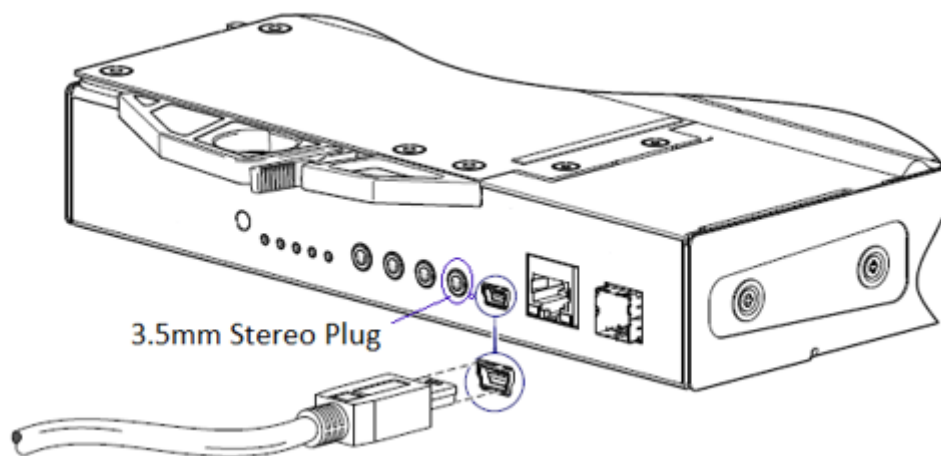
Figure 64. Connecting a USB cable to the USB CLI port

1. Connect the 3.5mm/DB9 serial cable from a computer with a serial port to the 3.5mm stereo plug CLI port on controller A. Alternatively, connect a generic mini-USB cable (not included) from a computer to the USB CLI port on controller A . The mini-USB connector plugs into the USB CLI port as shown in the following figure:
