# Dell EMC PowerVault ME4 Series Storage System

Owner's Manual

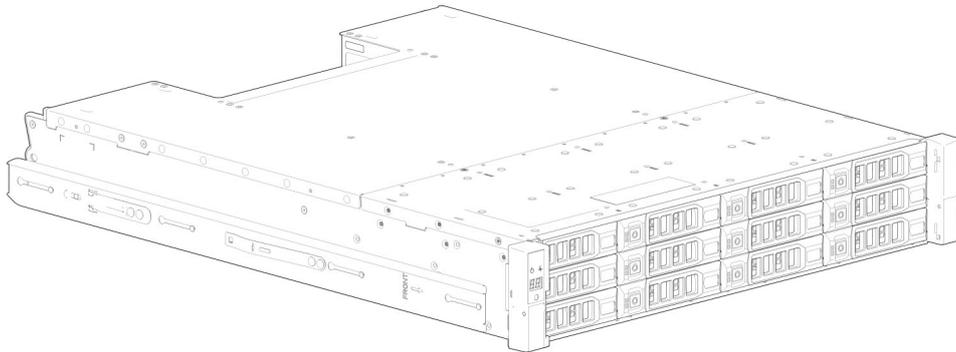
Figure 1. 2U12 enclosure system—front orientation

- 2U (rack space) controller enclosure (2U12)— see [Figure 1. 2U12 enclosure system—front orientation](#) on page 7 and [Figure 2. 2U12 enclosure system—rear orientation](#) on page 7: holds up to 12 low profile (1-inch high) 3.5" form factor disk drives in a horizontal orientation.

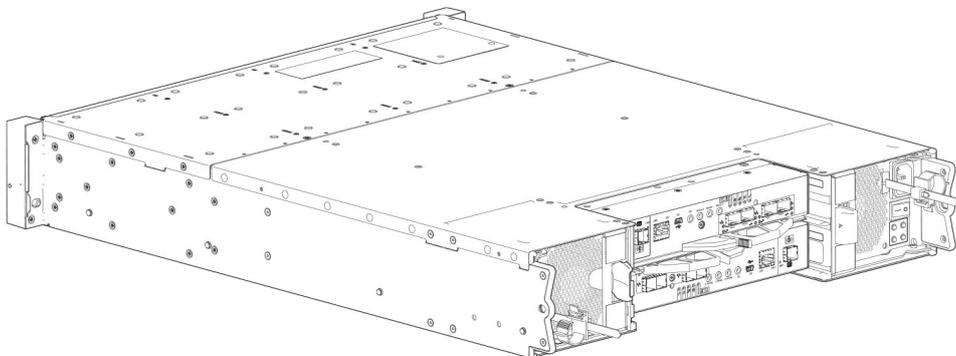
Figure 2. 2U12 enclosure system—rear orientation

The 2U12 controller enclosure in [2U12 enclosure system—rear orientation](#) is equipped with 2 controllers (4-port FC/ISCSI model shown).

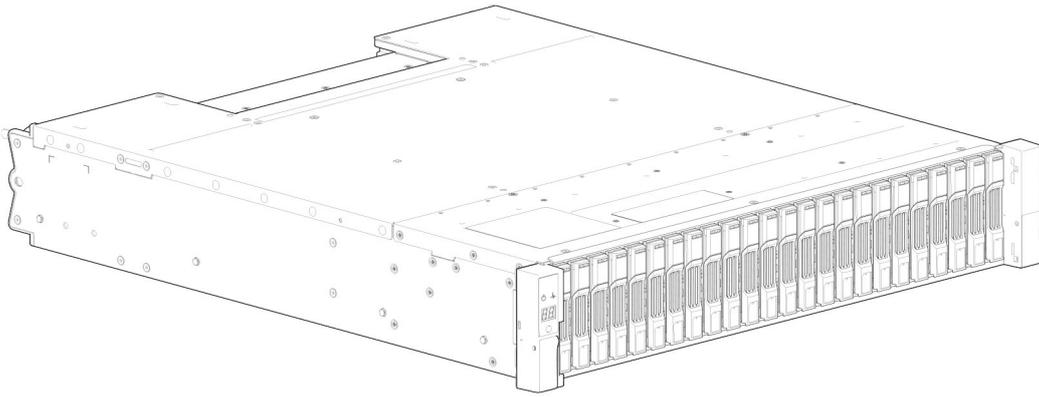
**Figure 3. 2U24 enclosure system—front orientation**

- 2U (rack space) controller enclosure (2U24)— see [Figure 3. 2U24 enclosure system—front orientation](#) on page 8 and [Figure 4. 2U24 enclosure system—rear orientation](#) on page 8: holds up to 24 low profile (5/8 inch high) 2.5" form factor disk drives in a vertical orientation.

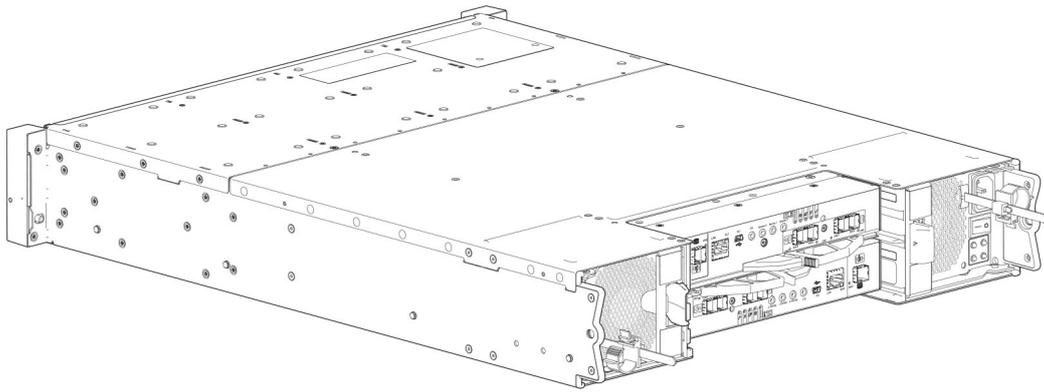
**Figure 4. 2U24 enclosure system—rear orientation**

The 2U24 controller enclosure is equipped with dual-controllers (4-port SAS model shown).

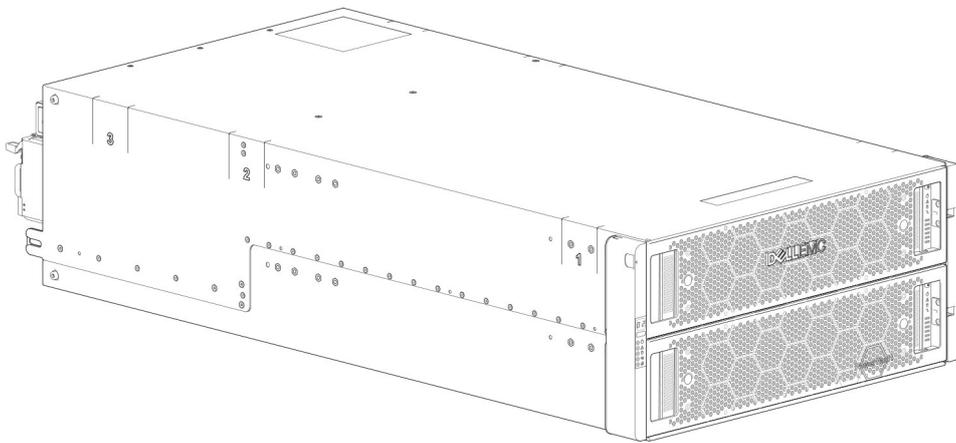
**Figure 5. 5U84 enclosure system—front orientation**

- 5U (rack space) controller enclosure (5U84)— see [Figure 5. 5U84 enclosure system—front orientation](#) on page 8 and [Figure 6. 5U84 enclosure system—rear orientation](#) on page 9: holds up to 84 low profile (1-inch high) 3.5" form factor disk drives in a vertical orientation within the disk drawer. Two vertically-stacked drawers each hold 42 disks. If used, 2.5" disks require 3.5" adapters.

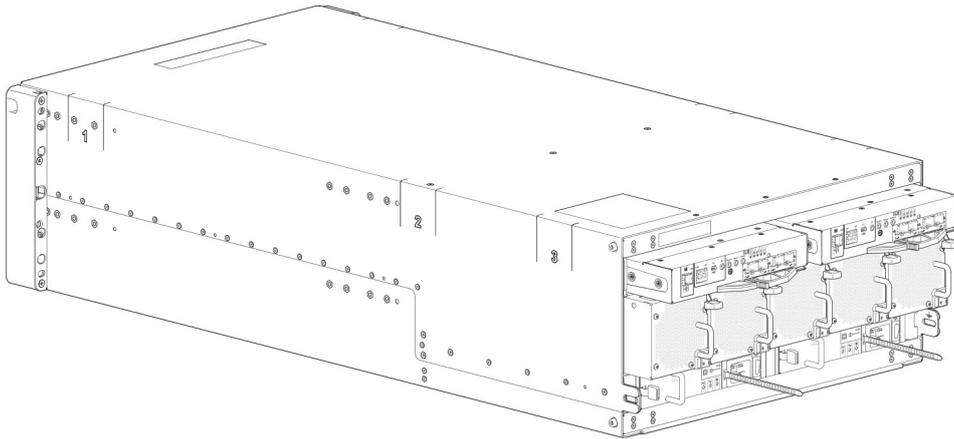
**Figure 6. 5U84 enclosure system—rear orientation**

The 5U84 controller enclosure is equipped with dual-controllers (4-port FC/iSCSI model shown).

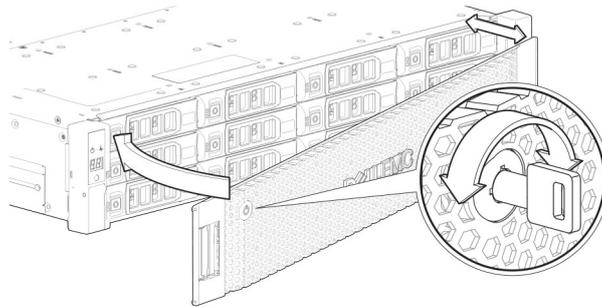
**Figure 7. Attaching or removing the 2U enclosure front bezel**

The following figure shows a partial view of a 2U12 enclosure:

- For information about enclosure front panel LEDs, see [2U enclosure Ops panel](#) on page 19.
- For information about disk LEDs for LFF and SFF disk modules, see [Verify front panel LEDs](#).
- For information about the optional 2U enclosure front bezel, see [Figure 7. Attaching or removing the 2U enclosure front bezel](#) on page 9.

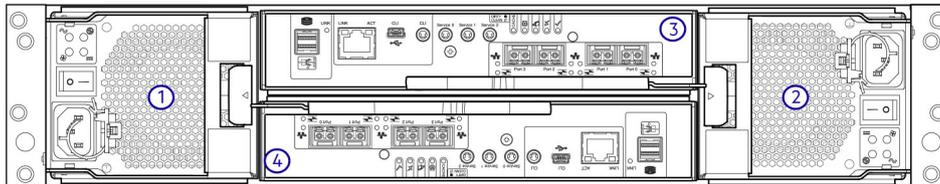
Figure 10. 2U controller enclosure—rear panel components (4-port FC/iSCSI)

Alphabetic designators on controller modules or IOMs and numeric designators on PCMs indicate slot sequencing for the modules used in 2U enclosures. Controller modules, IOMs, and PCMs are available as CRUs. The ME4 Series RBODs use 4-port controller modules. These RBODs support the ME412/ME424/ME484 EBODs for optionally adding storage.

| 1. Power cooling module slot 0 | 2. Power cooling module slot 1 |
| 3. Controller module slot A | 4. Controller module slot B |

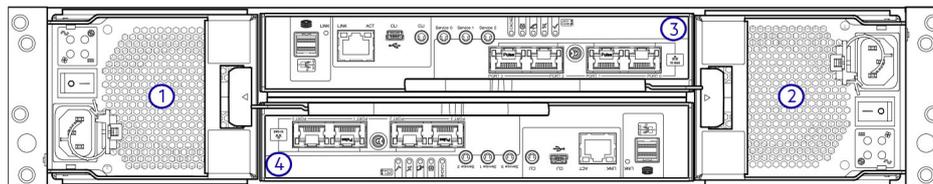
Figure 11. 2U controller enclosure—rear panel components (4-port iSCSI 10Gbase-T)

| 1. Power cooling module slot 0 | 2. Power cooling module slot 1 |
| 3. Controller module slot A | 4. Controller module slot B |

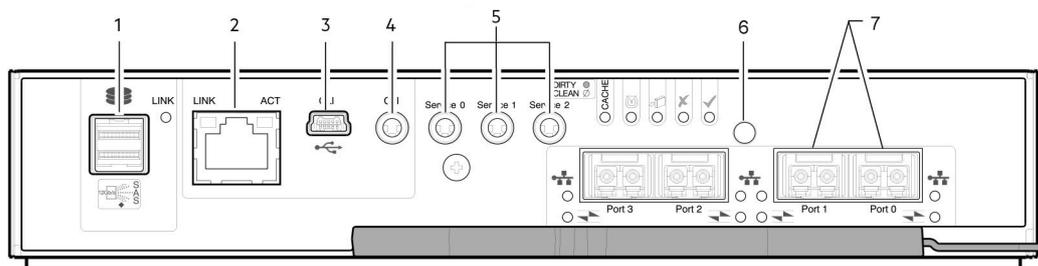
**Figure 14. 4-port FC/iSCSI controller module detail**

The Converged Network Controller (CNC) ports on the 4-port FC/iSCSI controller module can be configured with 16Gb/s FC SFPs or 10 GbE iSCSI SFPs.

| 7. CNC ports (ports 3, 2, 1, 0) | |

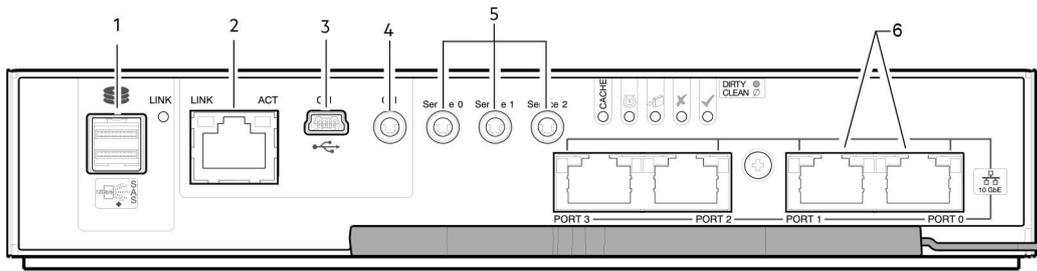
**Figure 15. 4-port iSCSI 10Gbase-T controller module detail**

The following figure shows iSCSI 10Gbase-T host interface ports that ship configured with pre-installed external connectors.

| 5. 3.5 mm serial ports (service only) | 6. 10Gbase-T ports (ports 3, 2, 1, 0) |

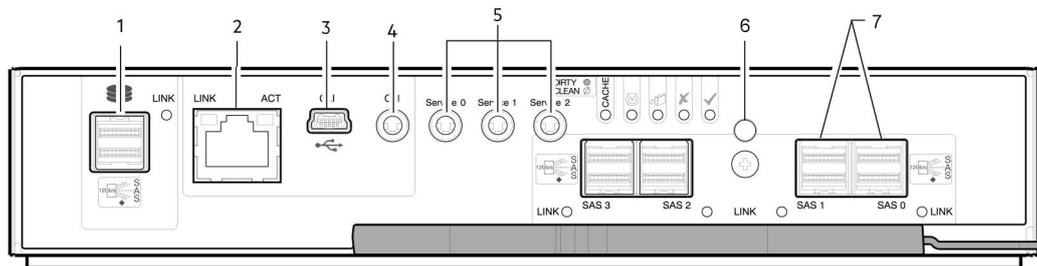
**Figure 16. 4-port mini-SAS HD controller module detail**

The following figure shows SAS host interface ports that ship configured with 12 Gb/s mini-SAS HD (SFF-8644) external connectors.

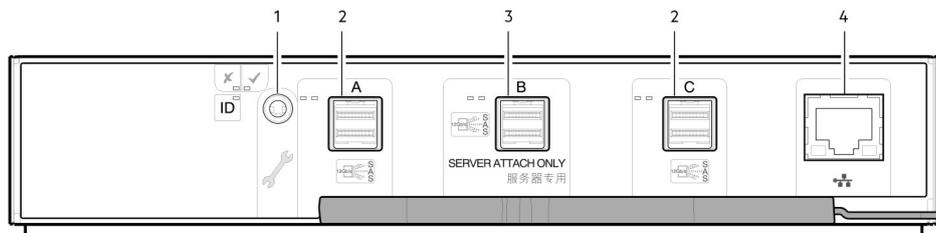
The following figure shows the IOM used in supported expansion enclosures for adding storage. Ports A/B/C ship configured with 12 Gb/s mini-SAS HD (SFF-8644) external connectors.

- When the IOM shown in **Figure 17. IOM detail – ME412/ME424/ME484** on page 13 is used with ME4 Series controller modules for adding storage, the middle HD mini-SAS expansion labeled port B is disabled by the firmware.
- The Ethernet port on the IOM is not used in controller/expansion enclosure configurations, and is disabled.

Expansion enclosure IOM status is monitored by the LEDs located on the face plate. See [Figure 17. IOM detail – ME412/ME424/ME484](#) on page 13. LED behaviors for expansion enclosure IOMs are described in the following table. For actions pertaining to [Cache status LED details](#) on page 25 or [Table 14. Expansion enclosure IOM LED states](#) on page 33, see [Fault isolation methodology](#) on page 28.

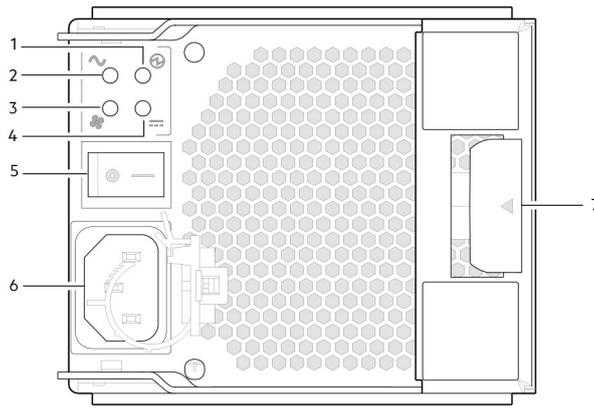
**Figure 18. Power cooling module (PCM)**

The following figure shows the power cooling module (PCM) used in controller enclosures and optional expansion enclosures. The PCM includes integrated cooling fans. The example shows a PCM oriented for use in the left PCM slot of the enclosure rear panel.

| 1. PCM OK LED (Green) | 2. AC Fail LED (Amber/blinking amber) |
| 3. Fan Fail LED (Amber/blinking amber) | 4. DC Fail LED (Amber/blinking amber) |

- If any of the PCM LEDs are illuminated amber, a module fault condition or failure has occurred.
- For a detailed description of PCM LED behavior, see [2U enclosure LEDs](#) on page 31.

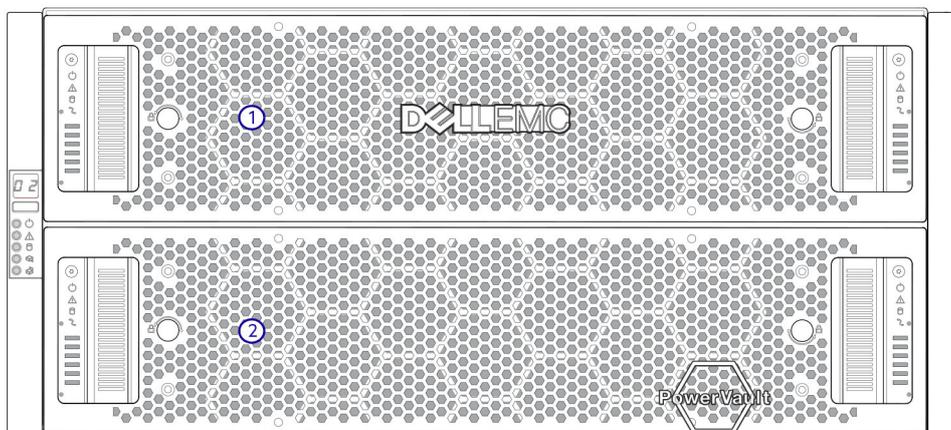
**Figure 19. 5U84 enclosure—front panel components**

1. 5U84 enclosure drawer (slot 0 = top drawer)

Figure 19. 5U84 enclosure—front panel components on page 14 and Figure 20. 5U84 enclosure system - plan view of drawer accessed from front panel on page 15 show component locations—together with CRU slot indexing—relative to the 5U84 enclosure front panel with drawers, and the rear panel.

The recommended order for partially populating disk drives in the 5U84 enclosure optimizes the airflow through the chassis. [Figure 19. 5U84 enclosure—front panel components](#) on page 14 shows the location and indexing of drawers accessed from the enclosure front panel.

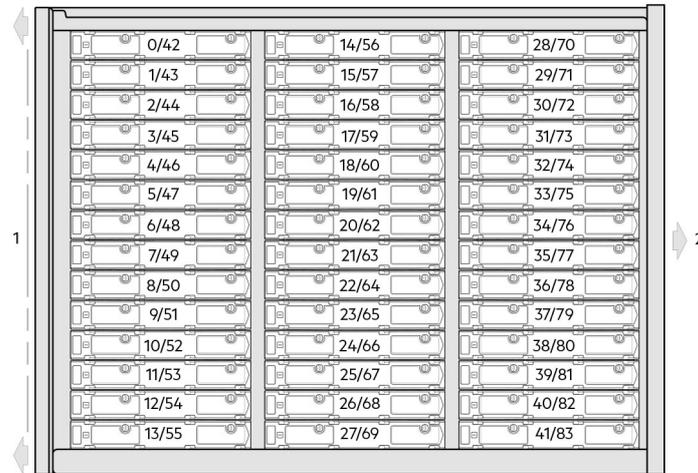
**Figure 20. 5U84 enclosure system - plan view of drawer accessed from front panel**

This figure shows a plan view of an enclosure drawer that is accessed from the enclosure front panel. The conceptual graphics are simplified for clarity.

1. Drawer front panel (shown as an edge in plan view)
2. Direction into the enclosure drawer slot (slot 0 or 1)

- 5U84 chassis configured with up to 84 LFF disks in DDICs. See [Figure 20. 5U84 enclosure system - plan view of drawer accessed from front panel](#) on page 15.
- 5U84 chassis configured with SFF disks in 2.5" to 3.5" hybrid driver carrier adapter.
- 5U84 empty chassis with midplane, module runner system, and drawers.

At the front of the enclosure, two drawers can be opened and closed. Each drawer provides access to 42 slots for Disk Drive in Carrier (DDIC) modules. DDICs are top mounted into the drawers as shown in [Figure 20. 5U84 enclosure system - plan view of drawer accessed from front panel](#) on page 15. The front of the enclosure also provides enclosure status LEDs and drawer status/activity LEDs.

1. Determine which drawer contains the disk drive to remove.
  - If the slot number is known, see [Figure 20. 5U84 enclosure system - plan view of drawer accessed from front panel](#) on page 15, which provides a view of a drawer that is dual-indexed with *top drawer* (left integer) and *bottom drawer* (right integer) slot numbering.
  - If the disk drive has failed, a fault LED is lit on the front panel of the affected drawer.
  - If the disk drive has failed, the Drive Fault LED on the DDIC is lit amber.
2. Open the drawer that contains the DDIC to remove.
3. Unlock the DDIC from its seated position in the slot by pushing the latch button in the direction shown in the following figure:

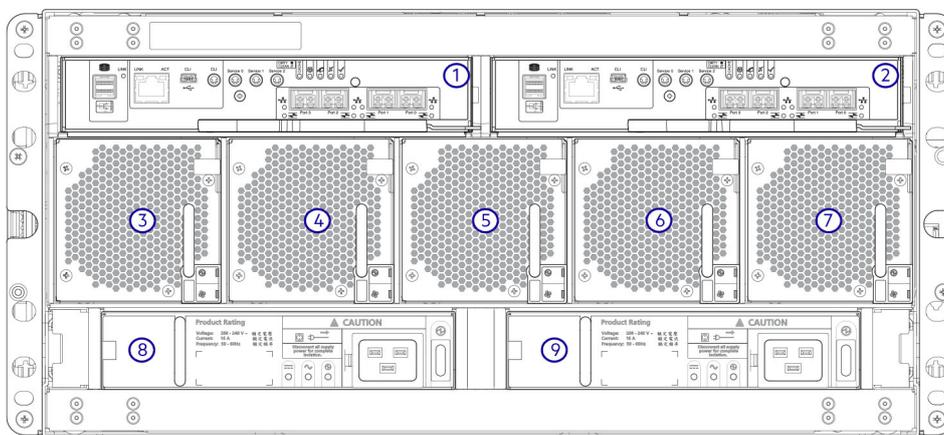
**Figure 21. 5U84 controller enclosure—rear panel components (4-port FC/iSCSI)**

Alphabetic designators on controller modules and IOMs, and numeric designators on PSUs (Power Supply Units) and FCMs (Fan Control Modules) indicate slot sequencing for modules used in 5U84 enclosures. Controller modules, IOMs, PSUs, and FCMs are available as CRUs.

| 7. FCM slot 4 | 8. PSU slot 0 |
| 9. PSU slot 1 | |

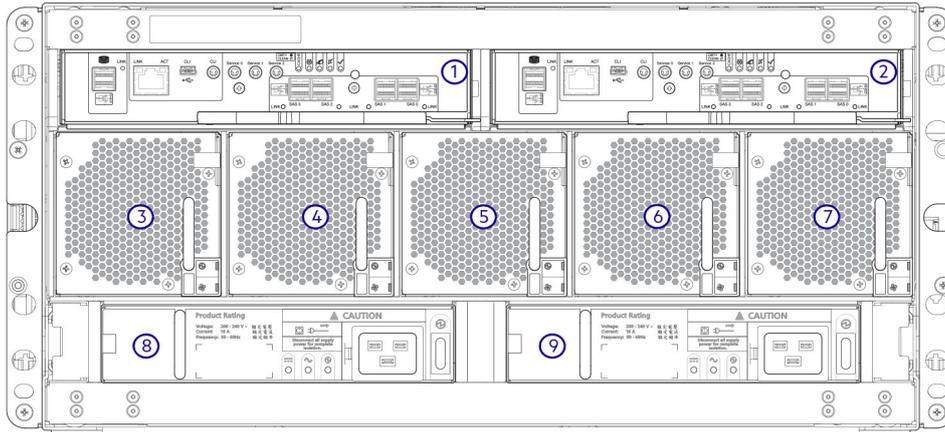
**Figure 22. 5U84 controller enclosure—rear panel components (4-port SAS)**

| 7. FCM slot 4 | 8. PSU slot 0 |
| 9. PSU slot 1 | |

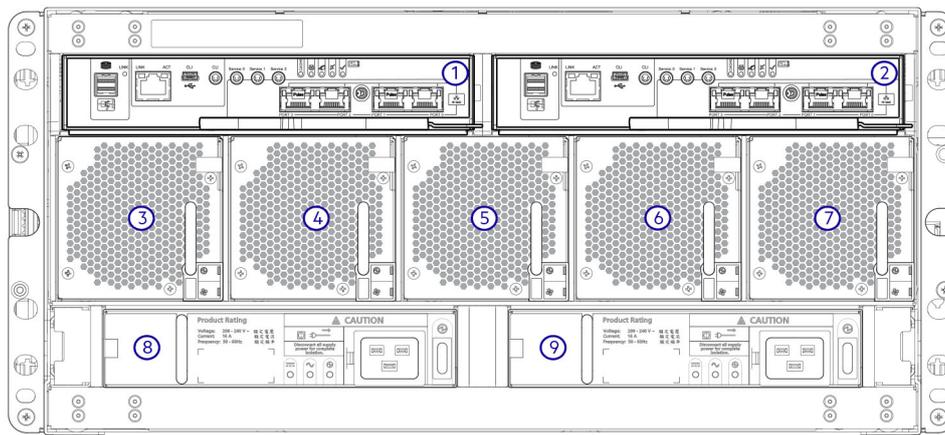
**Figure 23. 5U84 controller enclosure—rear panel components (4-port iSCSI 10Gbase-T)**

| 7. FCM slot 4 | 8. PSU slot 0 |
| 9. PSU slot 1 | |

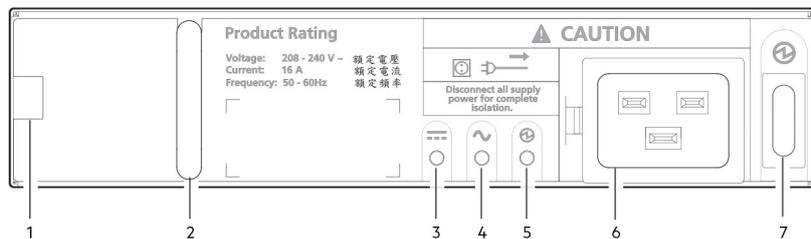
**Figure 25. Power supply unit (PSU)**

This figure shows the power supply unit that is used in 5U controller enclosures and optional 5U84 expansion enclosures.

| 3. PSU Fault LED (Amber/blinking amber) | 4. AC Fail LED (Amber/blinking amber) |

- If any of the PSU LEDs are illuminated amber, a module fault condition or failure has occurred.
- For a detailed description of PSU LEDs, see [Table 16. FCM LED descriptions](#) on page 34.

3. Slide the PSU into the slot until the latch clicks home.
4. Connect the AC power cord.
5. Move the PSU power switch to the On position.
6. Wait for the Power OK LED on the newly inserted PSU to illuminate green. See [Figure 25. Power supply unit \(PSU\)](#) on page 17.

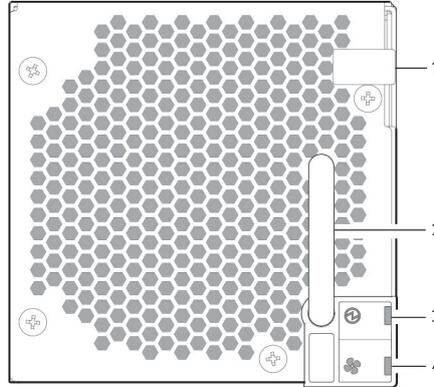
**Figure 26. Fan cooling module (FCM)**

The following figure shows the fan cooling module (FCM) used in 5U controller enclosures and optional 5U expansion enclosures.

- If any of the FCM LEDs are illuminated amber, a module fault condition or failure has occurred..
- For a detailed description of FCM LEDs, see [Fan cooling module LEDs](#) on page 34.

1. Identify the fan cooling (FCM) module to be removed. If the FCM module has failed, the Fan Fault LED will illuminate amber. See [Figure 26. Fan cooling module \(FCM\)](#) on page 18.
2. Push the release latch down and hold it in place (detail No.1).
3. With your other hand, grasp the handle and pull the FCM outward (detail No.2).

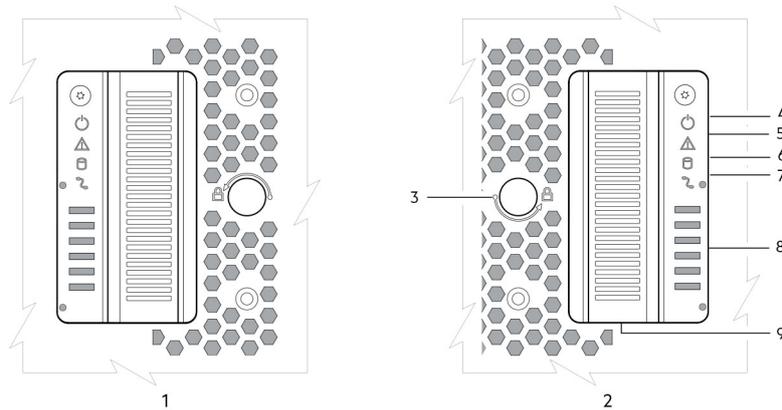
**Figure 27. Drawer bezel details**

Each drawer can be locked shut by turning both anti-tamper locks clockwise using a screwdriver with a Torx T20 bit (included in your shipment). The anti-tamper locks are symmetrically placed on the left and right sides of the drawer bezel. Drawer status and activity LEDs can be monitored by two drawer LEDs panels located next to the two drawer-pull pockets located on the left and right side of each drawer.

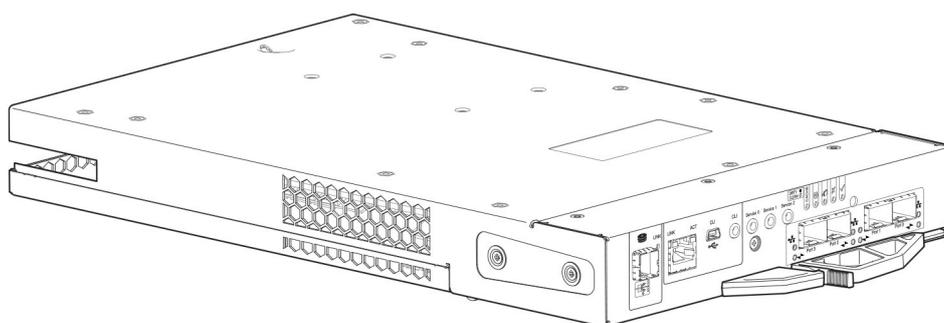
**Figure 30. Controller module – rear orientation**

The following figure shows a 4-port FC/iSCSI controller module aligned for use in the top slot located on the 2U enclosure rear panel. The controller module is also properly aligned for use in either slot located on the 5U84 enclosure rear panel.

Each controller module maintains VPD (Vital Product Data) in EEPROM devices. In a dual-controller module system, controller modules are interconnected by SBB-defined I2C buses on the midplane. In this way, the SBB module can discover the type and capabilities of the partner SBB module, and vice versa, within the enclosure.

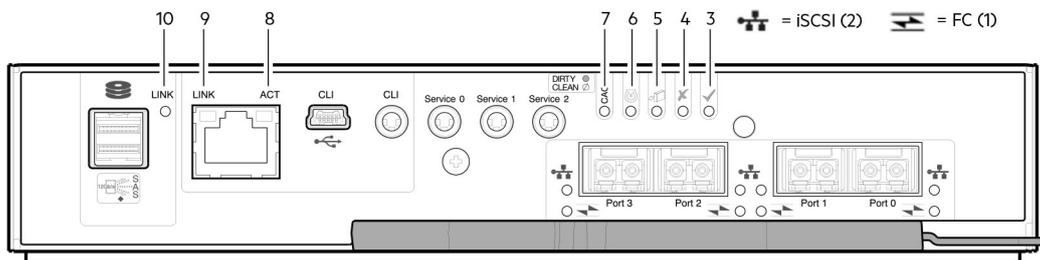
Figure 31. LEDs: ME4 Series Storage System FC/iSCSI controller modules (FC and 10GbE SFPs)

LED	Description	Definition
		cache, so a green cache status LED does not, by itself, indicate that any user data is at risk or that any action is necessary. Off—In a working controller, cache is clean (contains no unwritten data). This is an occasional condition that occurs while the system is booting. Blinking green—A CompactFlash flush or cache self-refresh is in progress, indicating cache activity.
8	Network Port Link Active Status <sup>5</sup>	Off—The Ethernet link is not established, or the link is down. Green—The Ethernet link is up (applies to all negotiated link speeds).
9	Network Port Link Speed <sup>5</sup>	Off—Link is up at 10/100 base-T negotiated speeds. Amber—Link is up and negotiated at 1000 base-T.
10	Expansion Port Status	Off—The port is empty or the link is down. Green—The port is connected and the link is up.

- In each diagram, the controller module is oriented for insertion into the top slot (A) of 2U enclosures. When oriented for use in the bottom slot (B) of 2U enclosures, the controller module labels appear upside down.
- In each diagram, the controller module is oriented for insertion into either slot of 5U84 enclosures.
- Alternatively, you can configure the 2U controller enclosure with a single controller module. Install the controller module in slot A, and install a blank plate in slot B.

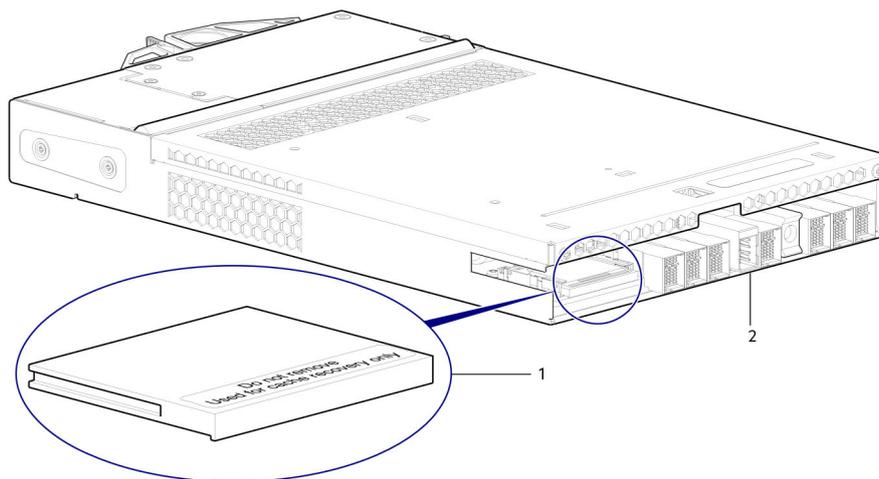
**Figure 34. CompactFlash memory card**

During a power loss or controller failure, data stored in cache is saved off to non-volatile memory (CompactFlash). The data is restored to cache, and then written to disk after the issue is corrected. To protect against writing incomplete data to disk, the image stored on the CompactFlash is verified before committing to disk. The CompactFlash memory card is located at the midplane-facing end of the controller module. Do not remove the card; it is used for cache recovery only.

1. CompactFlash memory card
2. Controller module viewed from back

In single-controller module configurations, if the controller module has failed or does not start, and the Cache Status LED is on or blinking, the CompactFlash needs to be transported to a replacement controller to recover data not flushed to the disk.

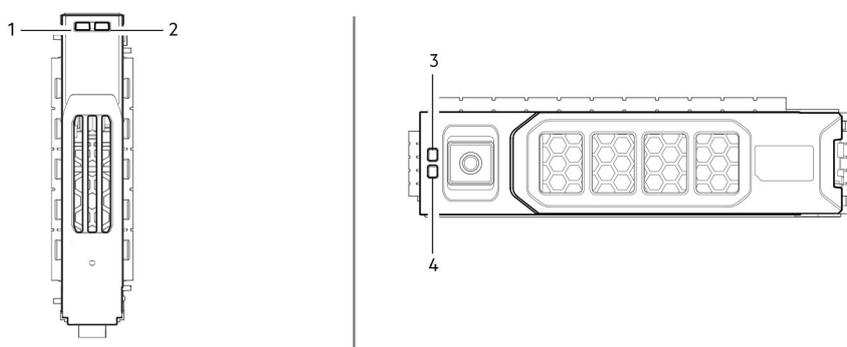
**Figure 35. LEDs: Drive carrier LEDs (SFF and LFF modules) used in 2U enclosures**

The drive module LEDs are identified in the figure, and the LED behavior is described in the table following the figure.

- In normal operation, the green LED are on, and flicker as the drive operates.
- In normal operation the amber LED will be:
  - Off if there is no drive present.
  - Off as the drive operates.
  - On if there is a drive fault.

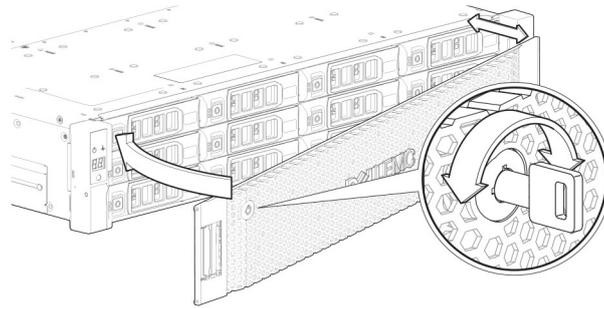
**Figure 37. Attaching or removing the 2U enclosure front bezel**

The following figure shows a partial view of a 2U12 enclosure:

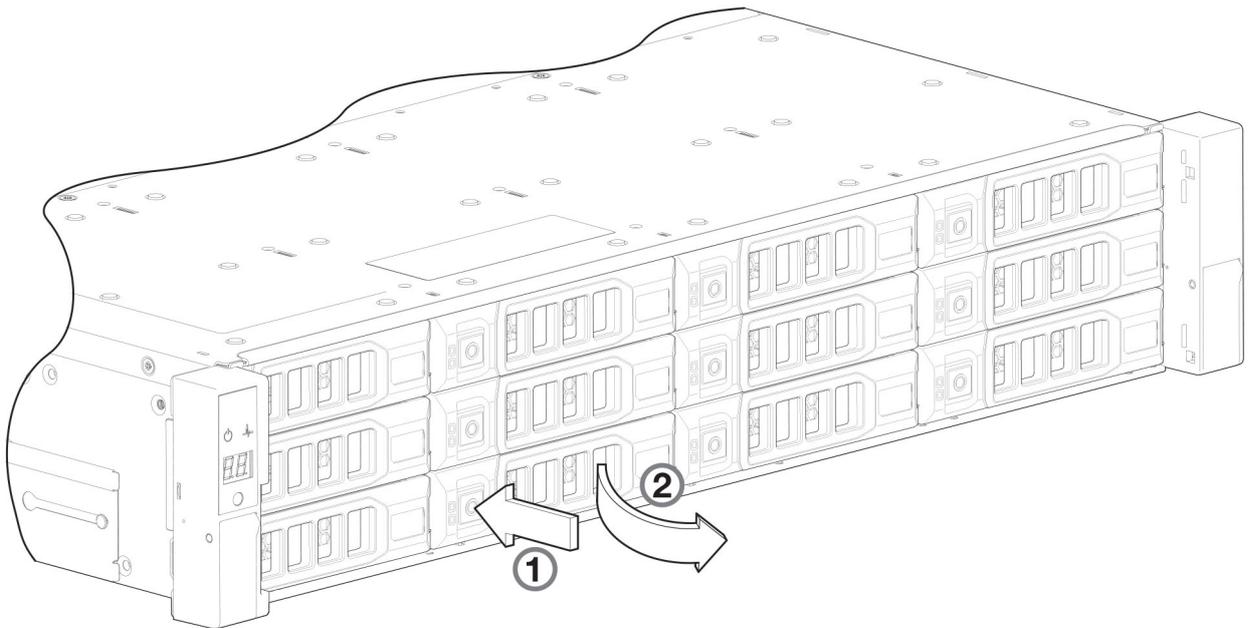
**Figure 38. Removing an LFF drive carrier module (1 of 2)**

1. Press the latch on the drive module carrier to open the handle.

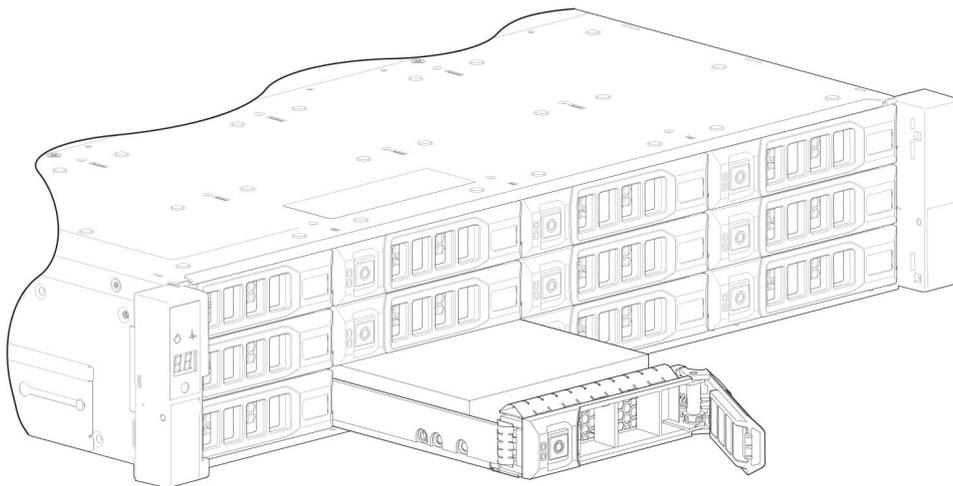
**Figure 39. Removing an LFF drive carrier module (2 of 2)**

2. Gently move the drive carrier module approximately 25 mm (1 in.), and then wait 30 seconds for the drive to spin down.

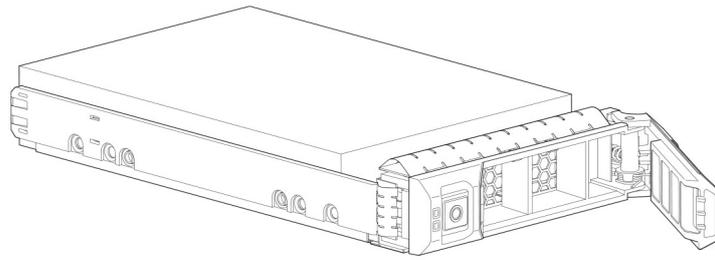
**Figure 40. LFF drive carrier module in open position**

1. Press the latch on the drive module carrier to open the handle.

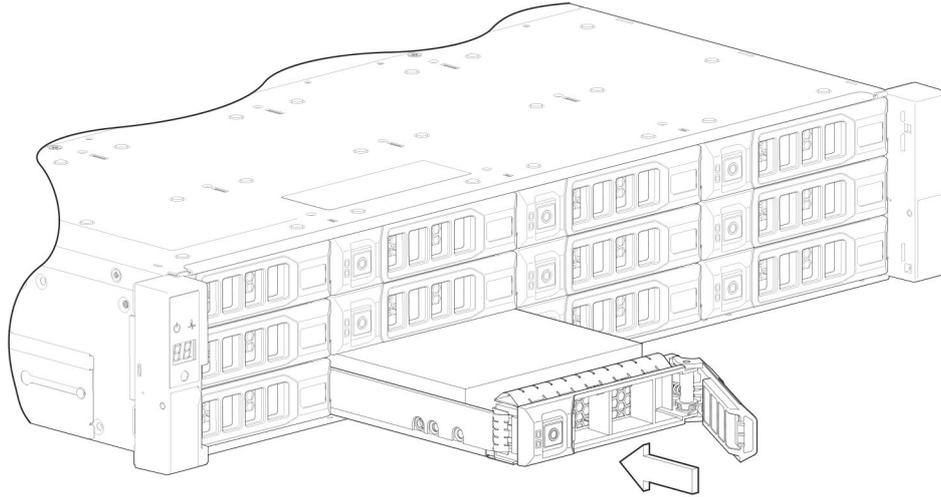
**Figure 41. Installing an LFF drive carrier module (1 of 2)**

2. Insert the drive carrier module into the enclosure.
3. Gently slide the drive carrier module into the enclosure until it stops moving.

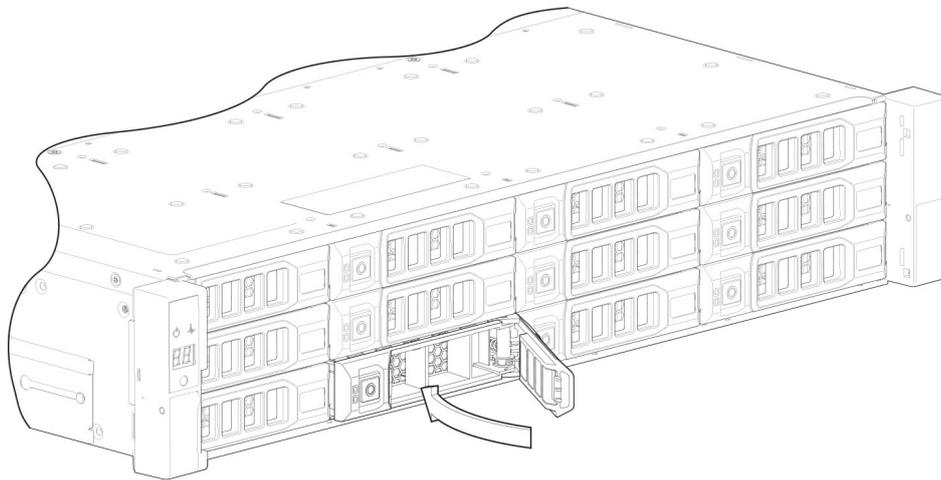
**Figure 42. Installing an LFF drive carrier module (2 of 2)**

4. Push the drive carrier module further into the enclosure until the latch handle starts to engage.
5. Continue to push firmly until the latch handle fully engages. You should hear a click as the latch handle engages and holds the handle closed.

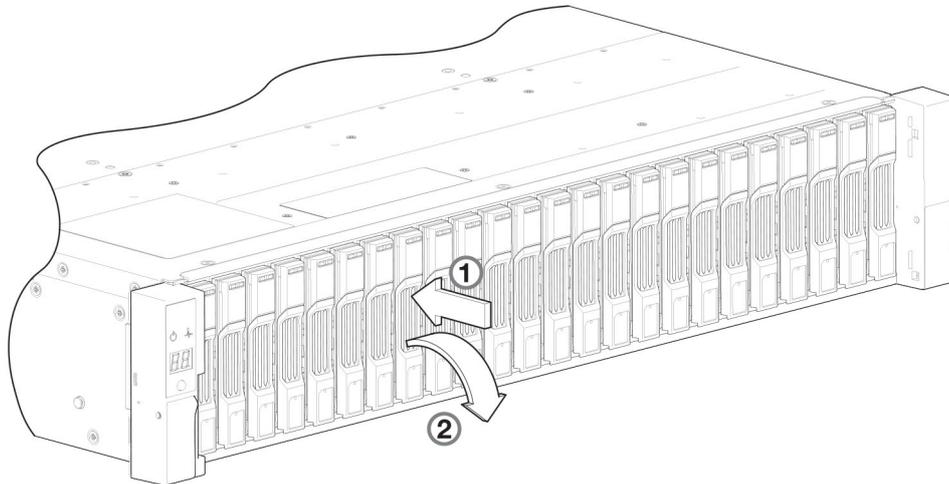
**Figure 43. Removing an SFF drive module carrier (1 of 2)**

1. Press the latch on the drive module carrier to open the handle.

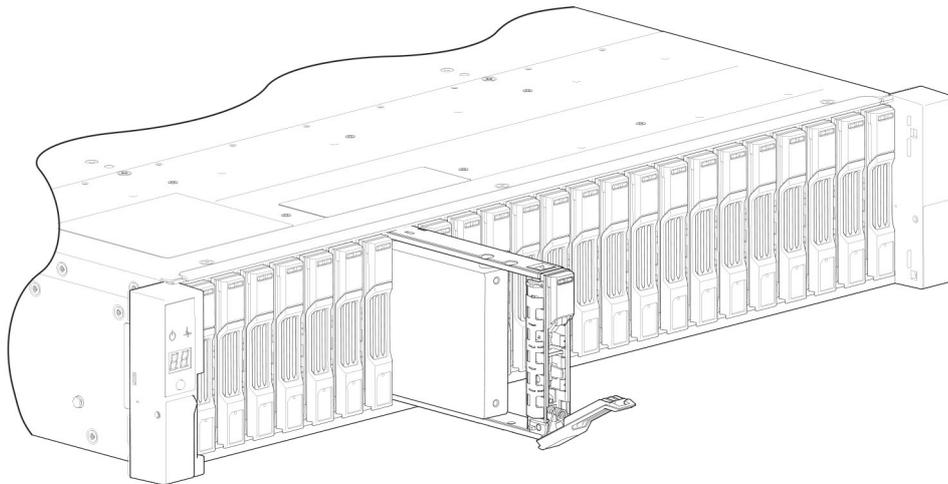
**Figure 44. Removing an SFF drive module carrier (2 of 2)**

2. Gently move the drive carrier module approximately 25 mm (1 in.), and then wait 30 seconds for the drive to spin down.

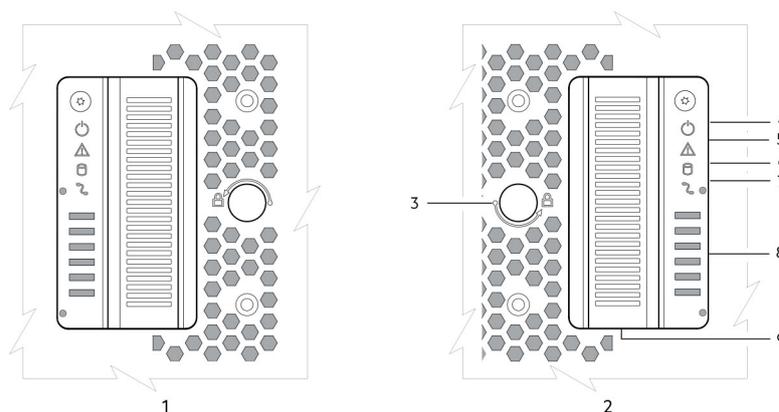
Figure 48. Drawer front panel details

1. Verify that the anti-tamper locks are not engaged. The red arrows on the locks point inwards if the locks are disengaged as shown in the following figure. If necessary, unlock them by rotating counter-clockwise using a Torx T20 bit.

1. Left side
2. Right side
3. Anti-tamper lock
4. Sideplane OK/Power Good
5. Drawer Fault
6. Logical Fault
7. Cable Fault
8. Drawer Activity
9. Drawer pull handle

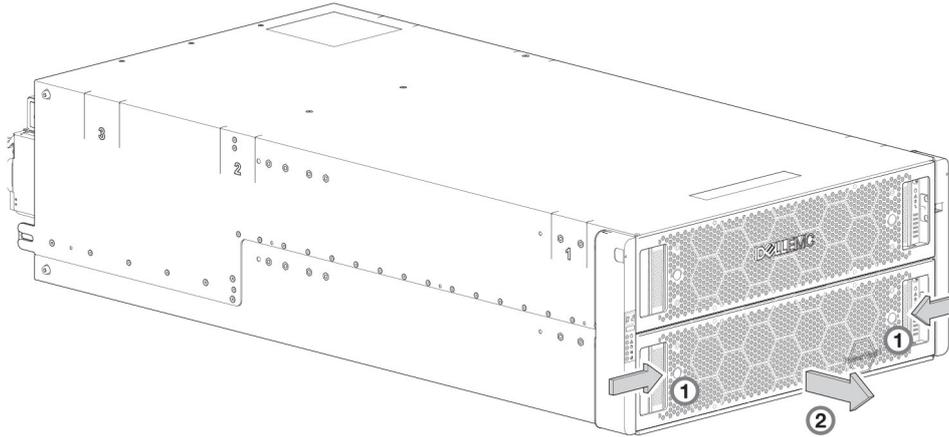
**Figure 49. Opening a drawer (1 of 2)**

2. Push the drawer latches inward and hold them as shown in the following figure.

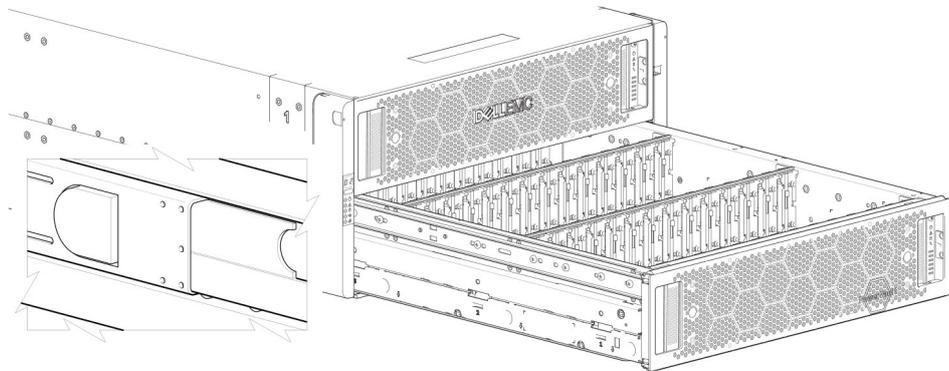
**Figure 50. Opening a drawer (2 of 2)**

3. Pull the drawer outward until it locks at the drawer stops as shown in the following figure. The drawer is shown empty, which is how the enclosure is delivered. A drawer slide rail latch detail is inset.

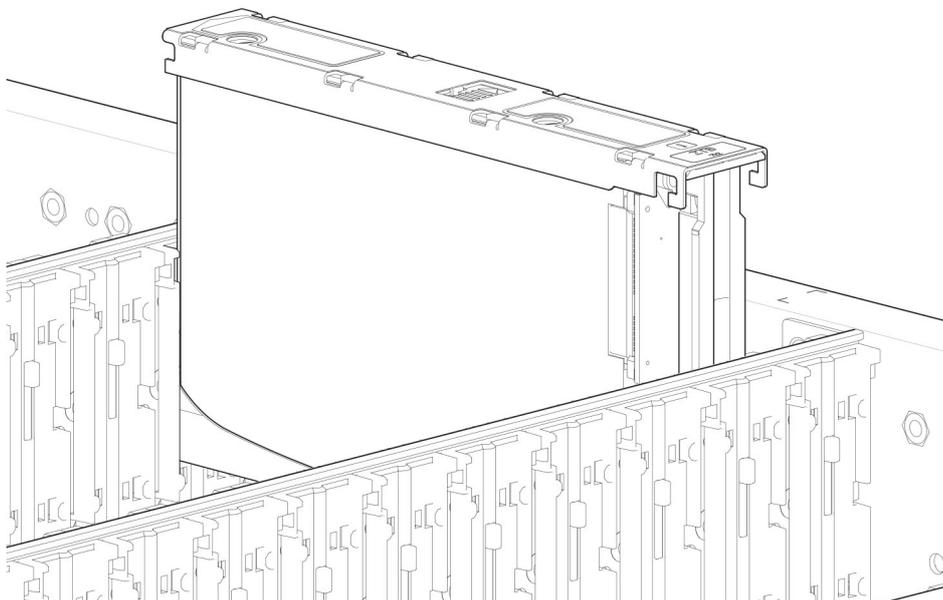
**Figure 52. Removing a DDIC (2 of 2)**

4. Pull the DDIC upwards and out of the drawer slot.

1. Align the DDIC with the target drive slot as shown in [Figure 52. Removing a DDIC \(2 of 2\)](#) on page 50 and insert it into the drive slot.
2. Lower the DDIC into the drive slot.
  - a. Push the DDIC downwards and hold it down.
  - b. Move the slide latch in the direction shown in the following figure:

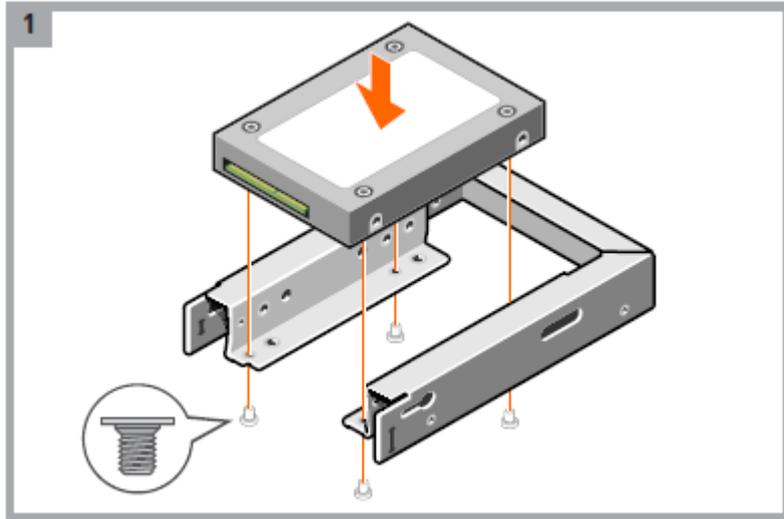
1. Install the 2.5" replacement disk drive into the 3.5" adapter.

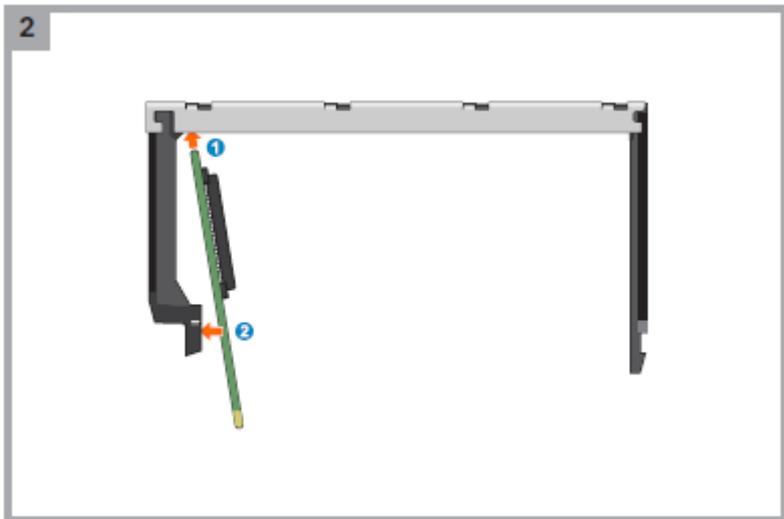
2. Insert the SAS connector into the new DDIC.

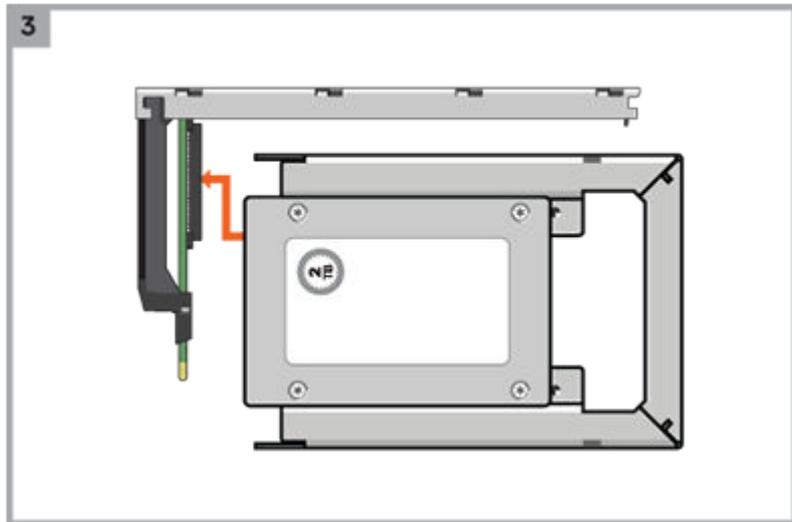
3. Insert the 3.5" adapter with the 2.5" disk drive into the new DDIC and connect the disk drive to the SAS connector.

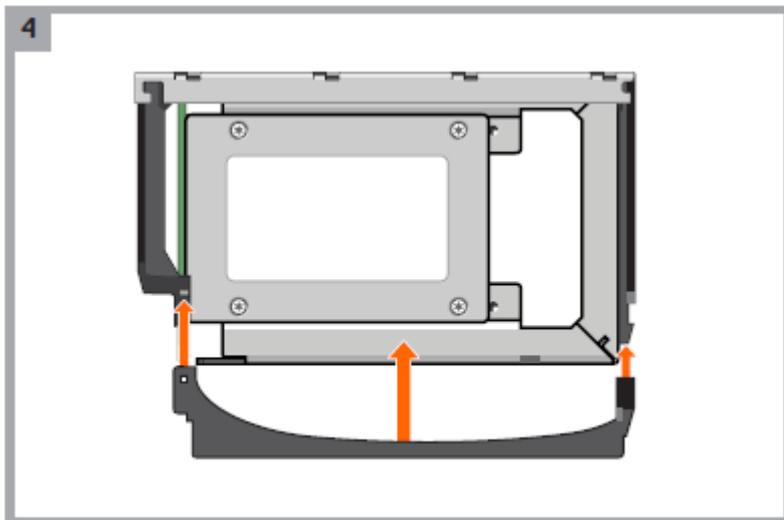
4. Attach the bottom bracket to the new DDIC.

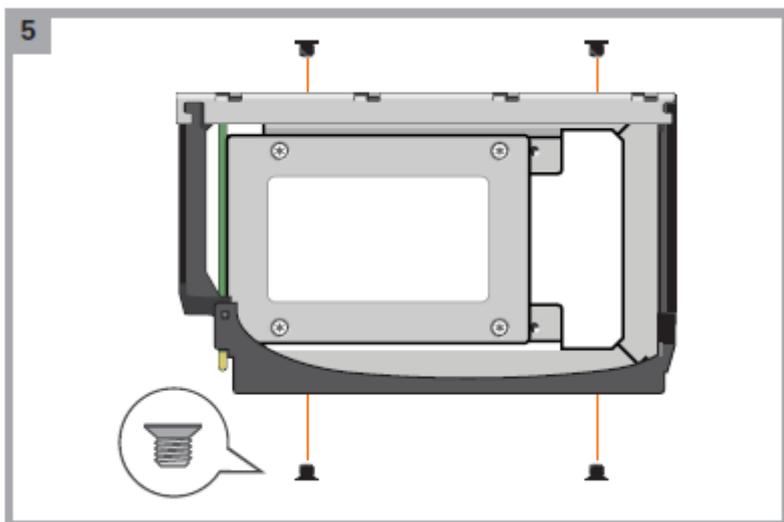
5. Secure the disk drive in the new DDIC using the four screws shipped with the new DDIC.

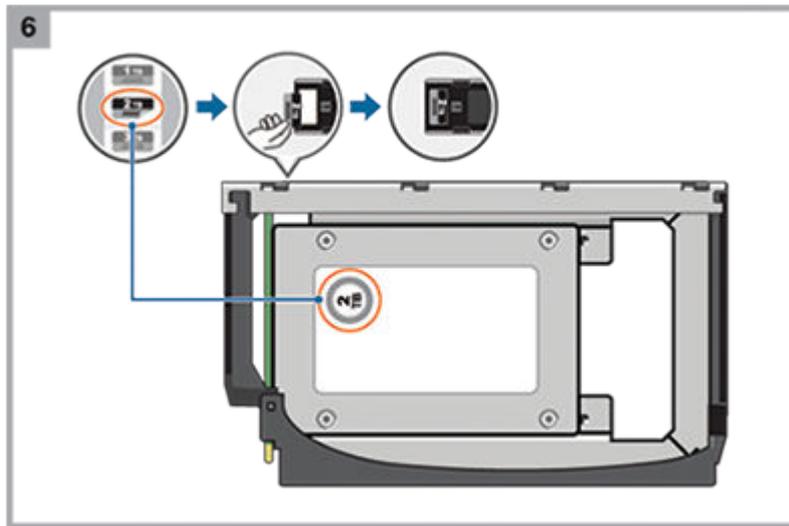
6. Attach the appropriate disk drive size label to the top of the new DDIC.

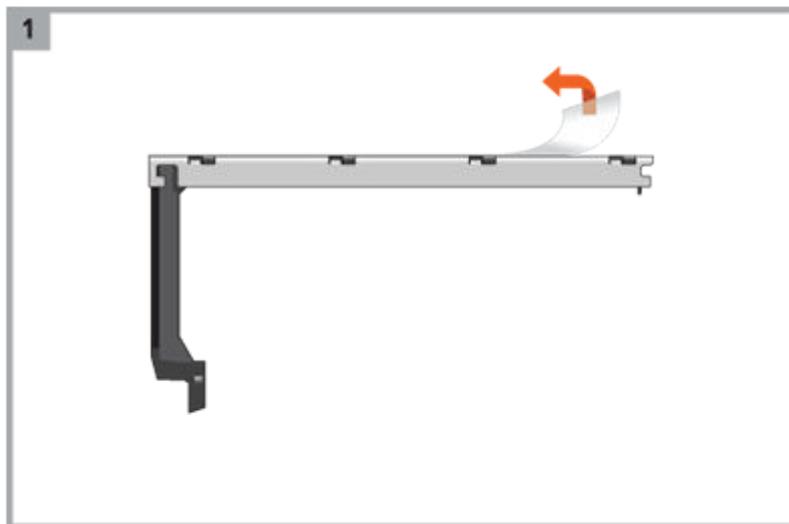
1. Remove the protective plastic from the new DDIC.

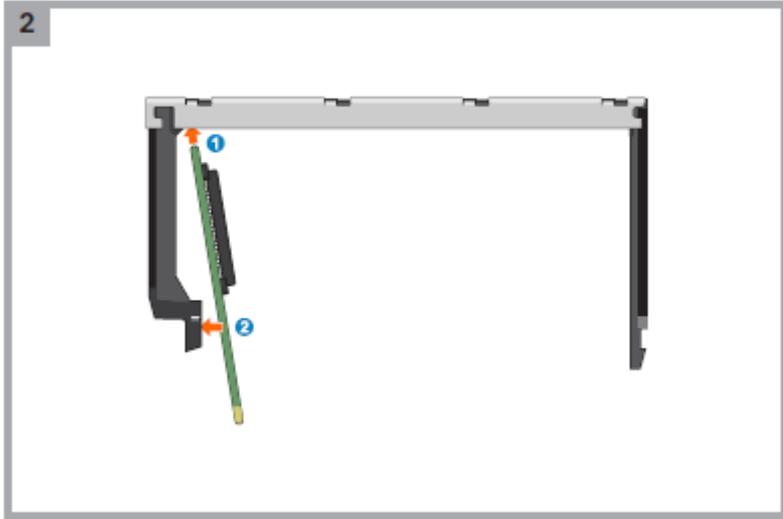
2. Insert the SAS connector into the new DDIC.

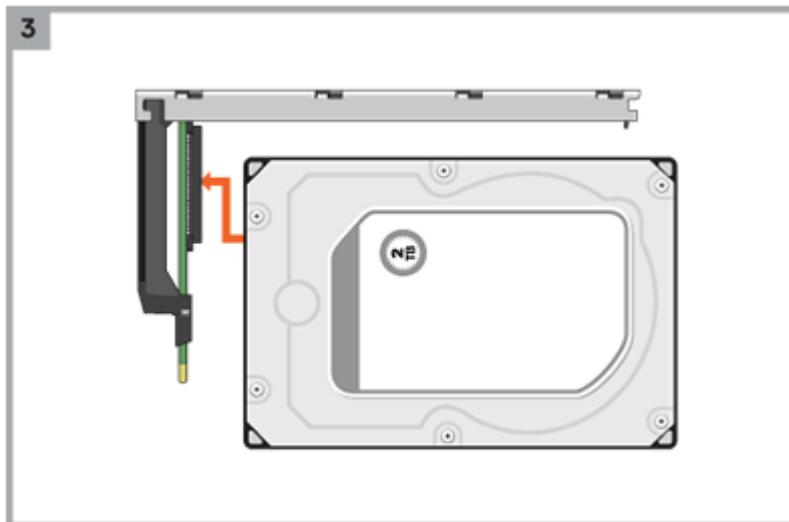
3. Insert the disk drive into the new DDIC and connect the disk drive to the SAS connector. .

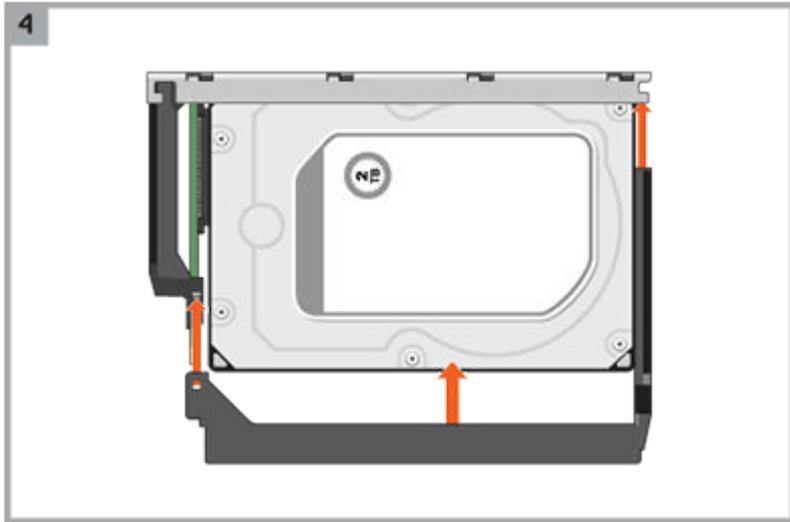
4. Attach the bottom bracket to the new DDIC.

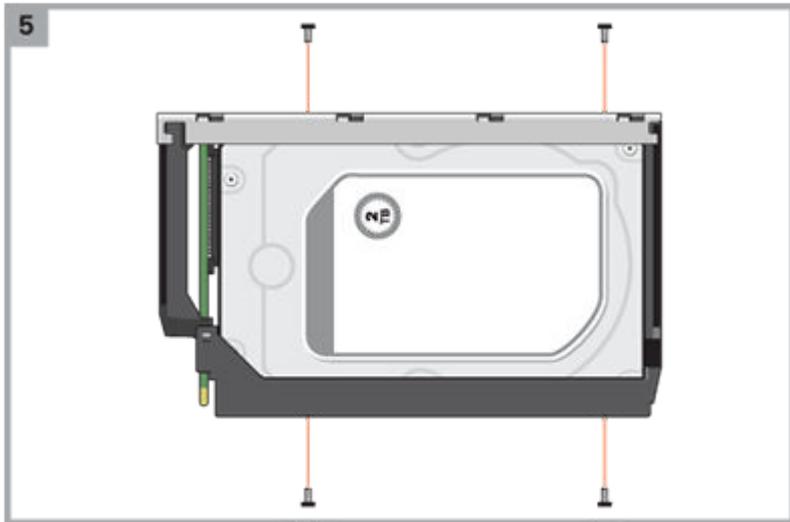
5. Secure the disk drive in the new DDIC using the four screws shipped with the new DDIC.

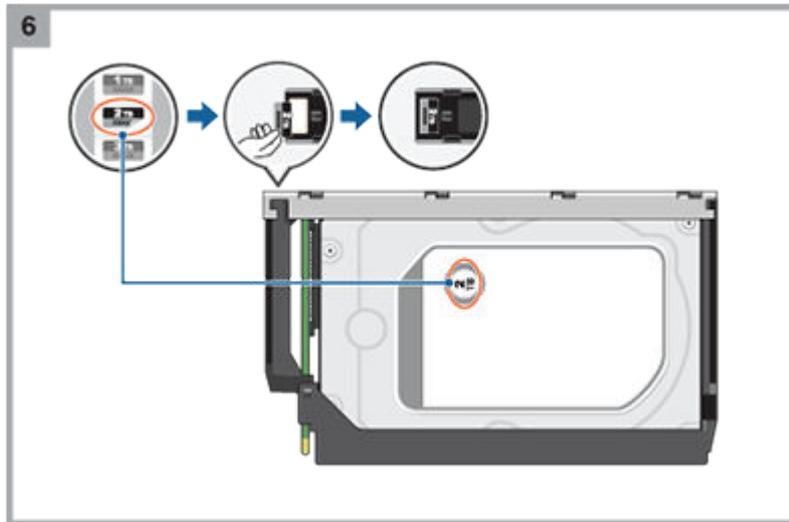
6. Attach the appropriate disk drive size label to the top of the new DDIC.
