# Dell EMC PowerVault ME4 Series Storage System

Owner's Manual

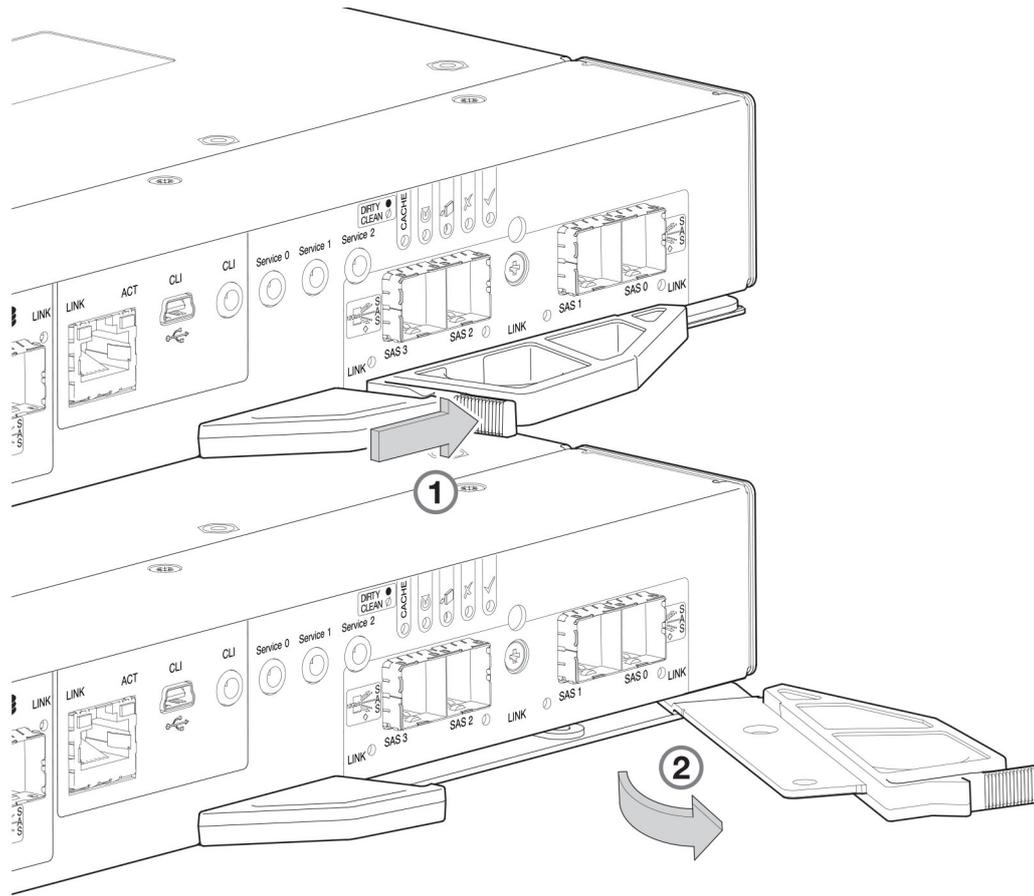
**Figure 54. Removing a controller module from an enclosure**

1. Verify that you have successfully shut down the controller module using the PowerVault Manager or the CLI.
2. Locate the enclosure with a UID LED that is illuminated.
3. Within the enclosure, locate the controller module with an **OK to Remove** LED that is blue.
4. Disconnect any cables connected to the controller module.  
Label each cable to facilitate re-connection to the replacement controller module.
5. Grasp the module latch between the thumb and forefinger, and squeeze the flange and handle together to release the latch handle, and swing the latch handle out to release the controller module from its seated position.

**NOTE:** Removing a controller module shows a 4-port SAS controller module. However, all of the controller modules use the same latching mechanism.

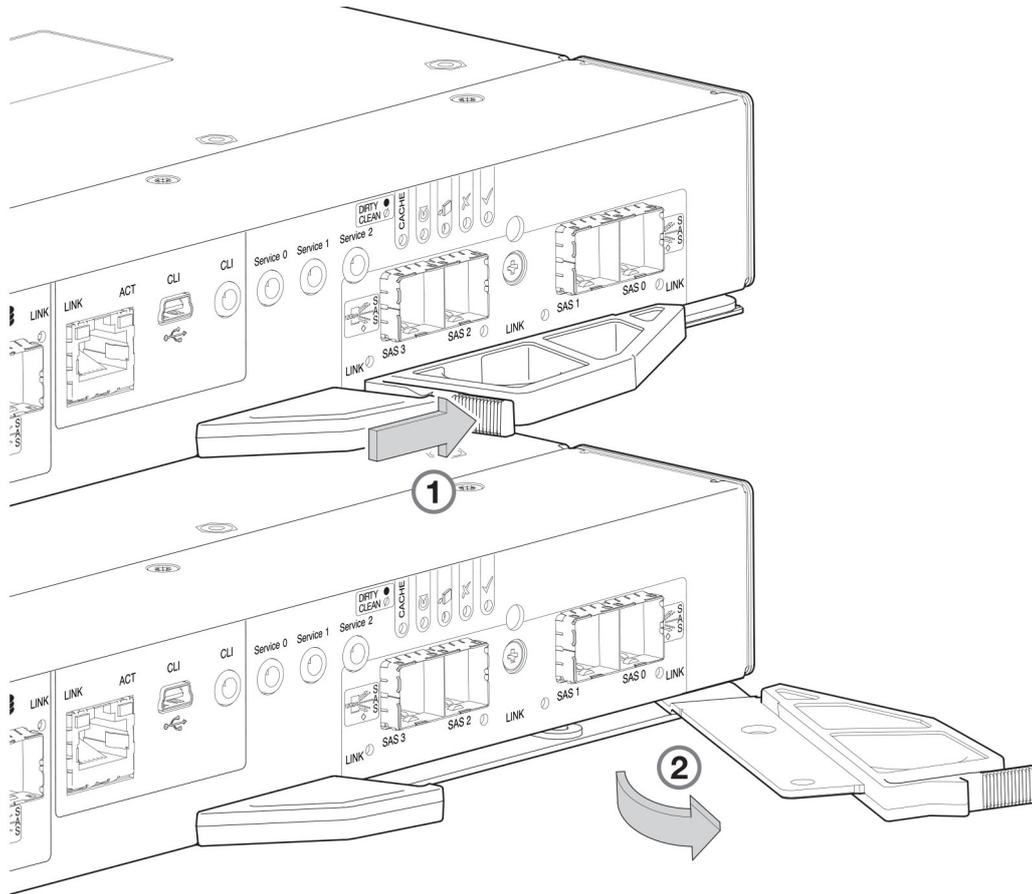
**Figure 55. Removing a controller module from an enclosure**

1. Shut down the storage system using PowerVault Manager or the CLI.
2. Disconnect any cables connected to the controller module.  
Label each cable to facilitate re-connection to the replacement controller module.
3. Grasp the module latch between the thumb and forefinger, and squeeze the flange and handle together to release the latch handle, and swing the latch handle out to release the controller module from its seated position.

**NOTE:** The previous figures show a 4-port SAS controller module. However, all of the controller modules use the same latching mechanism.

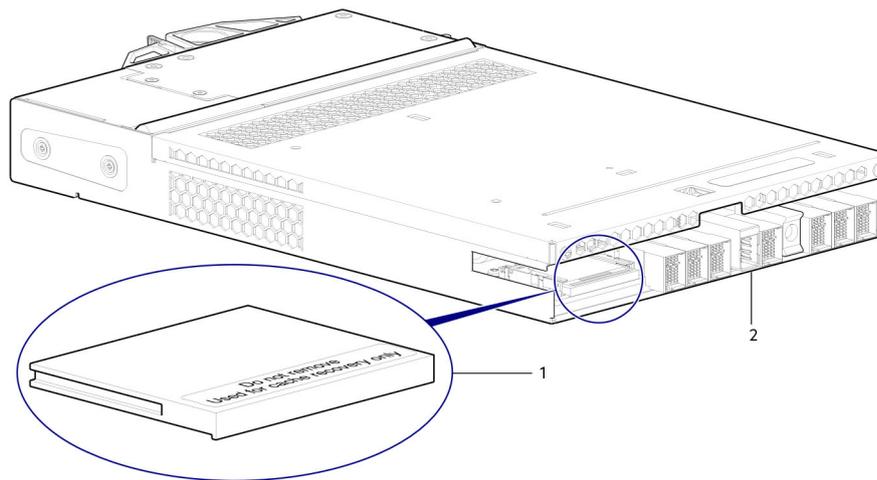
**Figure 56. CompactFlash memory card location**

1. Remove the failed controller module from the controller enclosure.
2. Locate the CompactFlash memory card at the midplane-facing end of the failed controller module.

- a. CompactFlash memory card
- b. Controller module viewed from back

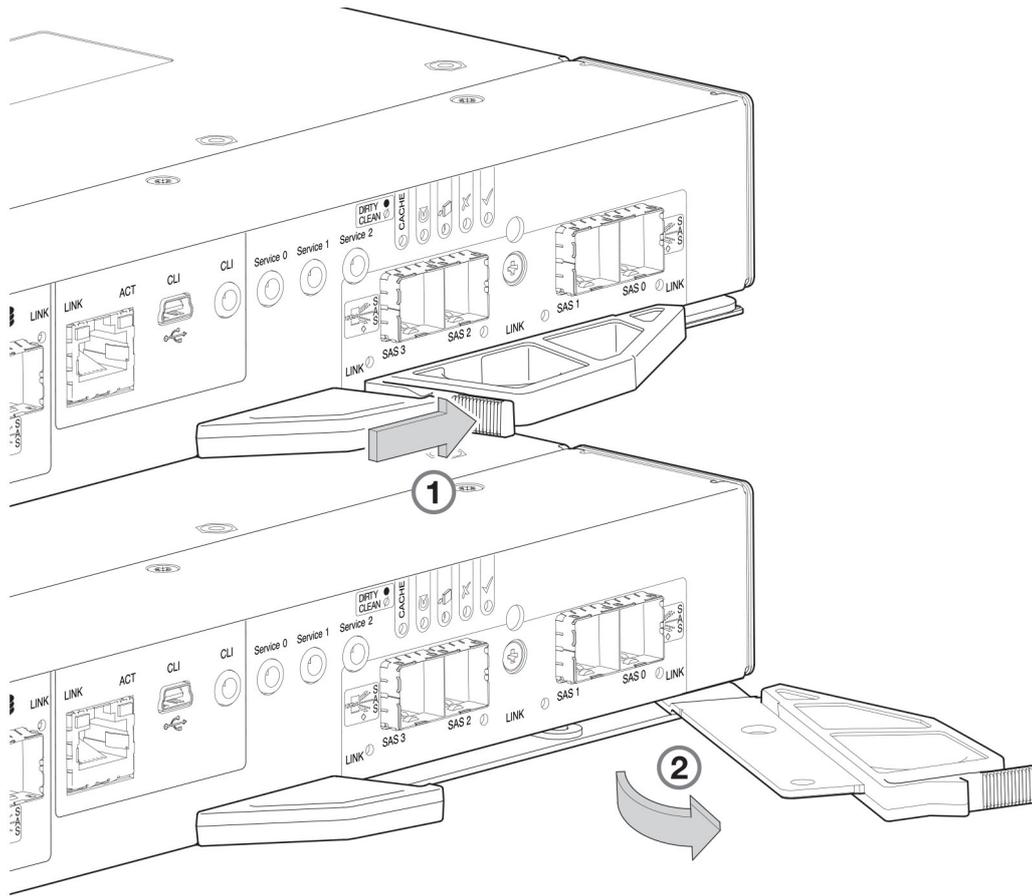
**Figure 57. Removing an IOM from an enclosure**

1. Locate the expansion enclosure containing the IOM that must be replaced. On the enclosure front panel, check for an amber fault condition on the enclosure Ops panel. On the enclosure rear panel, look for amber illumination of the IOM Fault LED.
2. Disconnect any cables connected to the IOM.  
Label each cable to facilitate re-connection to the replacement IOM.
3. Grasp the module latch between the thumb and forefinger, and squeeze the flange and handle together to release the latch handle, and swing the latch handle out to release the IOM from its seated position.

4. **i NOTE: Figure 57. Removing an IOM from an enclosure on page 63 shows a 4-port SAS controller module instead of an IOM. However, an IOM uses the same latching mechanism as the controller module.**
5. Swing the latch handle open, then grip the latch handle and ease the IOM forward from the slot.
6. Place both hands on the IOM body, and pull it straight out of the enclosure such that the IOM remains level during removal.

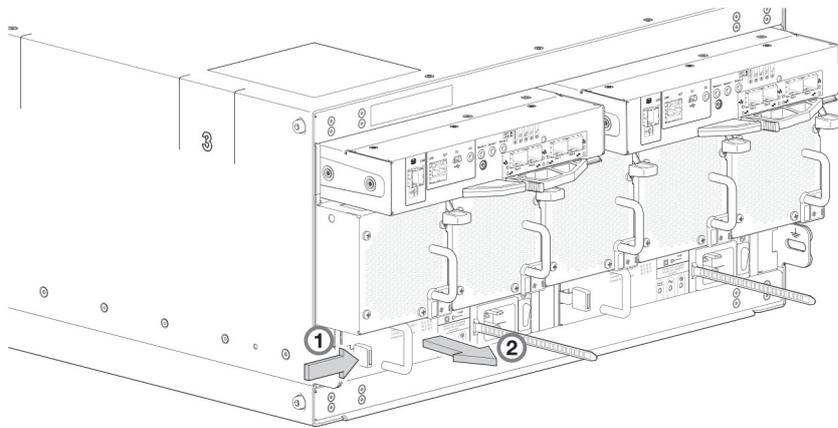
Figure 58. Removing a PSU (1 of 2)

7. Push the release latch to the right and hold it in place (detail No.1).
8. With your other hand, grasp the handle and pull the PSU outward (detail No.2).

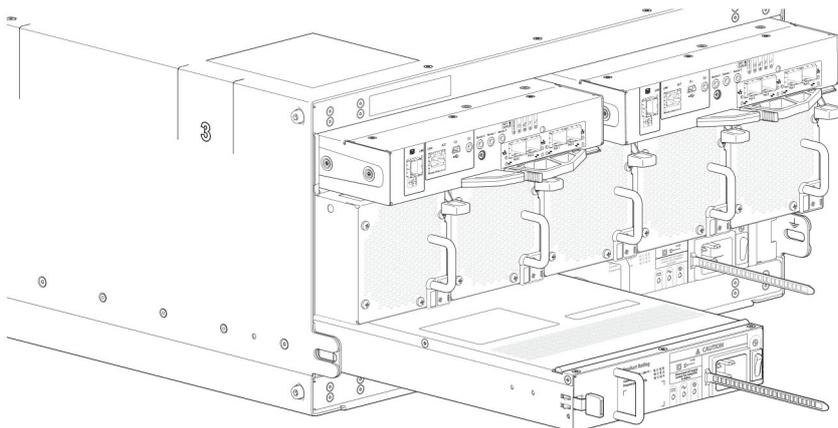
Figure 59. Removing a PSU (2 of 2)

9. While supporting the PSU with both hands, remove it from the enclosure.
10. If replacing both PSUs, repeat steps 5 through 9.  
**NOTE:** The PSU slot must not be empty for more than 2 minutes while the enclosure is powered.

1. Make sure that the PSU is switched off.
2. Orient the PSU for insertion into the target slot on the enclosure rear panel, as shown in [Figure 59. Removing a PSU \(2 of 2\)](#) on page 64.

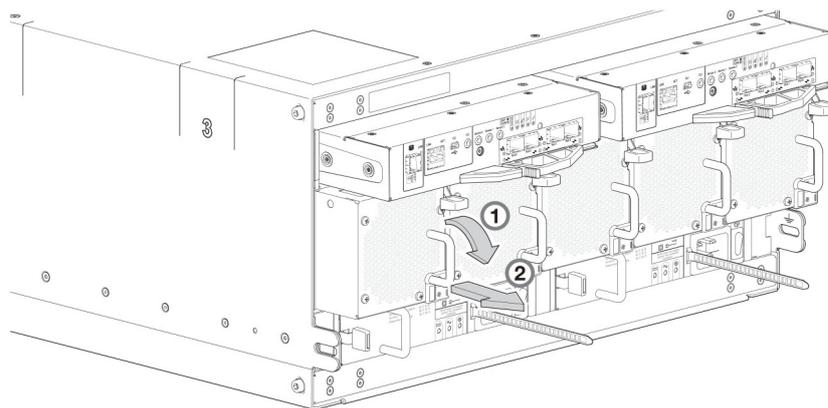
**Figure 60. Removing an FCM (1 of 2)**

1. Identify the fan cooling (FCM) module to be removed. If the FCM module has failed, the Fan Fault LED will illuminate amber. See [Figure 26. Fan cooling module \(FCM\)](#) on page 18.
2. Push the release latch down and hold it in place (detail No.1).
3. With your other hand, grasp the handle and pull the FCM outward (detail No.2).

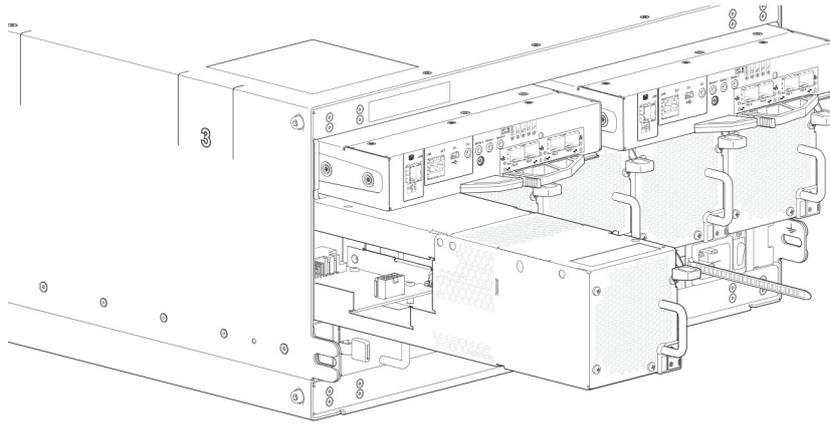
**Figure 61. Removing an FCM (2 of 2)**

4. While supporting the FCM with both hands, remove it from the enclosure.

1. Orient the FCM for insertion into the target slot on the enclosure rear panel, as shown in [Figure 61. Removing an FCM \(2 of 2\)](#) on page 66.
2. Slide the FCM into the slot until the latch clicks home.  
The enclosure should automatically detect and make use of the new module.

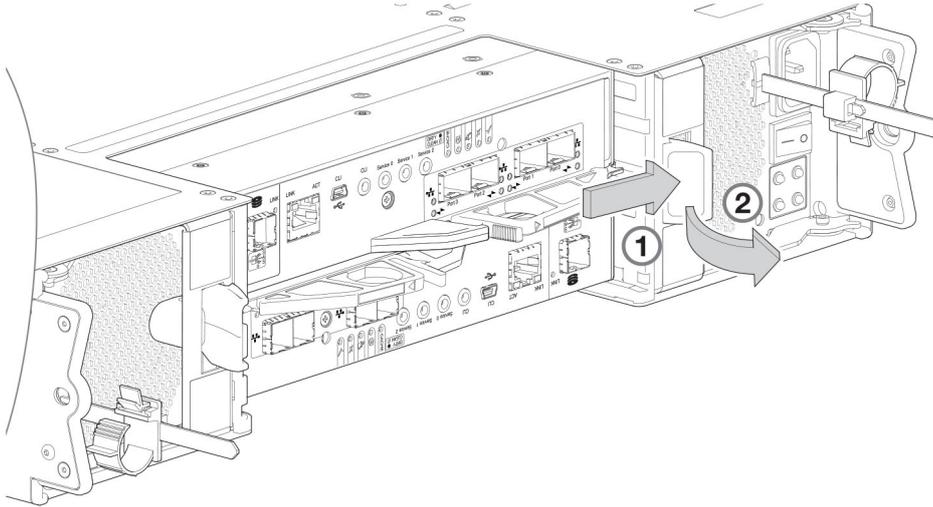
**Figure 62. Removing a PCM (1 of 2)**

7. Grasp the latch and the side of the PCM handle between thumb and forefinger, squeeze together and open the handle to cam the PCM out of the enclosure as shown in the following figure.

**i** **NOTE:** The remove PCM illustrations show a chassis configured as a 4-port FC/iSCSI controller enclosure. The procedure applies to all 2U controller enclosures and expansion enclosures.

Refer to [Figure 62. Removing a PCM \(1 of 2\)](#) on page 67 and [Figure 63. Removing a PCM \(2 of 2\)](#) on page 67 when performing this procedure, but ignore the directional arrows—since you will insert the module into the slot rather than extract.

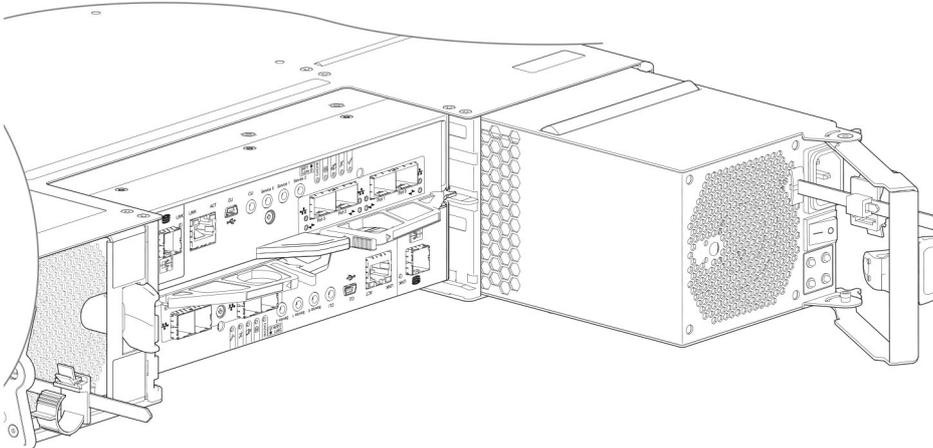
**Figure 63. Removing a PCM (2 of 2)**

8. Grip the handle and withdraw the PCM, taking care to support the base of the module with both hands as you remove it from the enclosure as shown in the following figure.

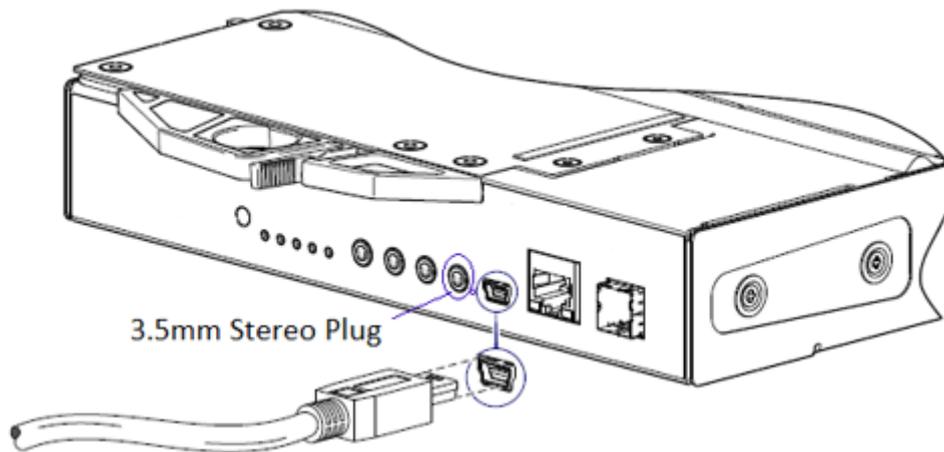
**Figure 64. Connecting a USB cable to the USB CLI port**

1. Connect the 3.5mm/DB9 serial cable from a computer with a serial port to the 3.5mm stereo plug CLI port on controller A. Alternatively, connect a generic mini-USB cable (not included) from a computer to the USB CLI port on controller A. The mini-USB connector plugs into the USB CLI port as shown in the following figure:
