Two very rare issues with certain SLIC models on Dell EMC Unity with OEs < 5.2.1

VOLUME 43

December, 2022

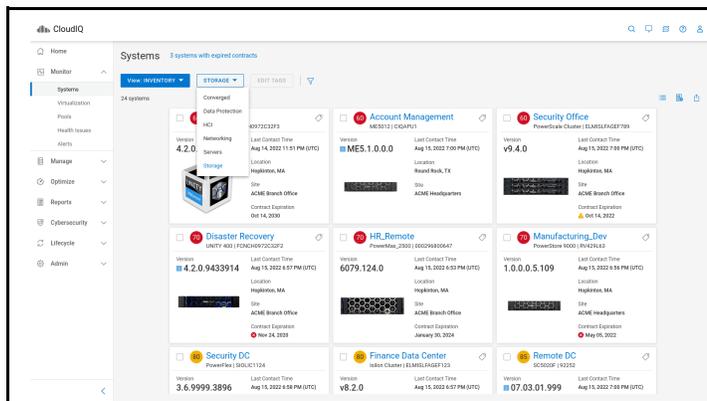
Consolidated Systems View

We've consolidated the various Systems pages into a single view for quicker navigation. You can now use the Systems page to switch between views for Health, Inventory, Configuration, and Performance for each of your products. Your selection within this view will persist between sessions. The current filter options are also cached to facilitate the navigation between the multi-systems view and details pages. We've also updated the Left Navigation bar to consolidate all of the multi-system views into an easy-to-navigate view.

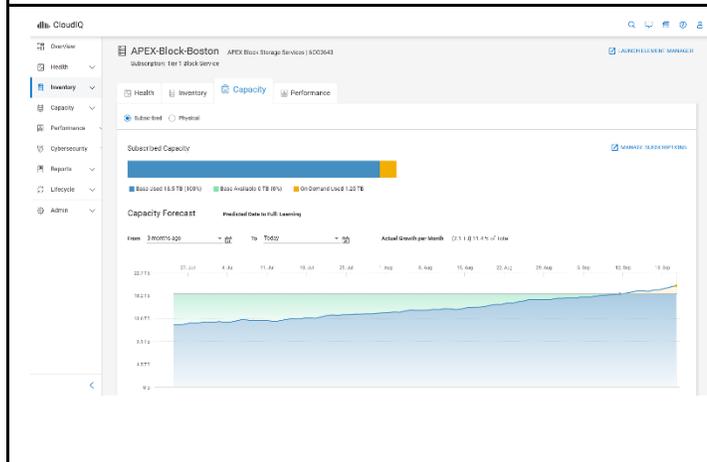
APEX Data Storage Services Capacity updates

We've enhanced the Capacity views for APEX systems to allow you to switch between subscribed capacity for your APEX Service, or Physical capacity for actual capacity consumed on the storage system. You can toggle between these views through a radio button in the system details capacity view. In the Subscribed capacity view, we have streamlined the capacity metrics to show Base Used and Available, and where applicable, On-Demand Used. The Physical capacity view corresponds to the capacity displayed in the Element Manager for the storage system.

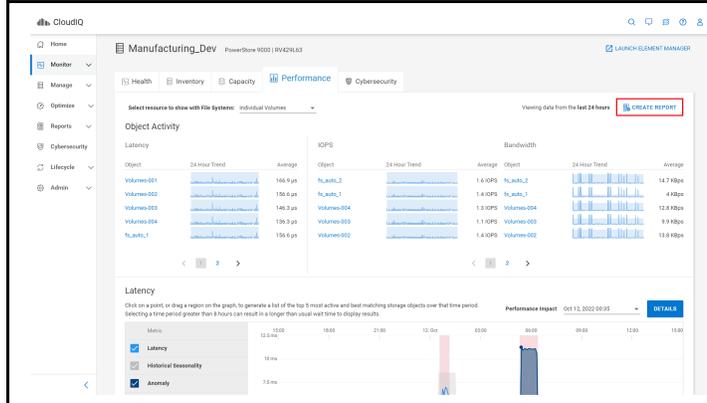
'Create Report' Button Replacing 'Go To All Metrics' Button

We've replaced the 'Go To All Metrics' button in Performance details pages with the 'Create Report' button, which allows you to create a custom report with detailed performance data. You can quickly create custom performance reports and manipulate them by adding other content, including tables, and also schedule and export reports. Existing 'Go To All Metrics' buttons have been replaced, with the exception of PowerVault LUN, XtremIO system, and SC Series system pages where the buttons have been removed for now.
