Dell PowerVault ME5 Series Storage System

Owner's Manual

This guide describes the features and technical specifications of ME5 Series storage systems.

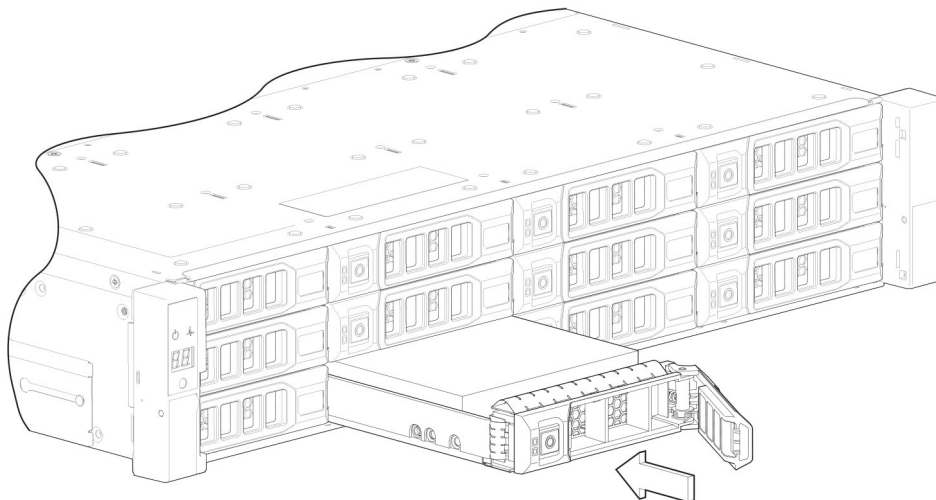
2. Insert the drive carrier module into the enclosure.
3. Gently slide the drive carrier module into the enclosure until it stops moving.

Figure 44. Installing an LFF drive carrier module (1 of 2)
