Foxconn Technology Group.

T24i-30 Simplified service manual for dismantling

Model Name: Lenovo T24i-30

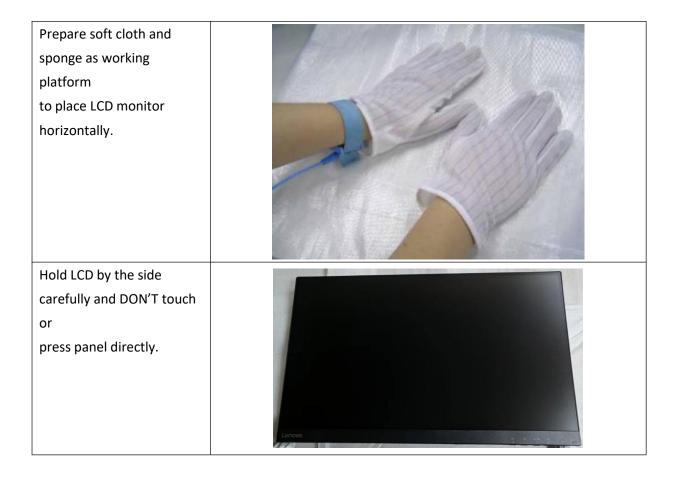
1. Precaution

Please read the precaution as follows to prevent any damages to the LCD Monitor. Make sure all power connector is removed. Be sure that the LCD Monitor is in power off status.

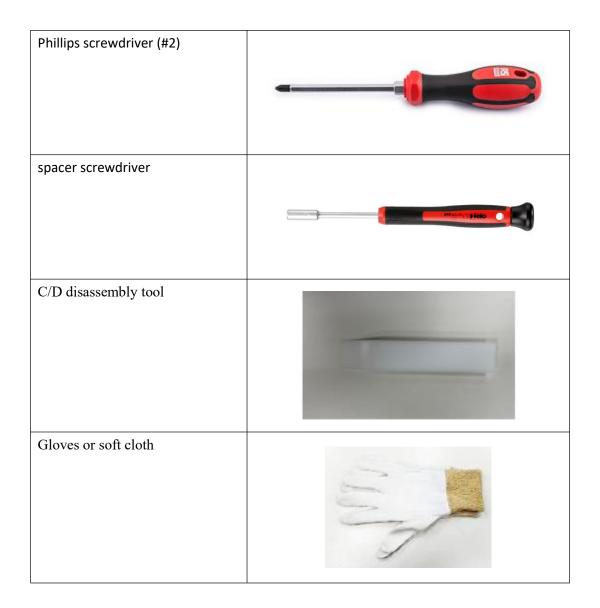
2. Appropriate tools

Select the Appropriate tools for disassembly and re-assembly.

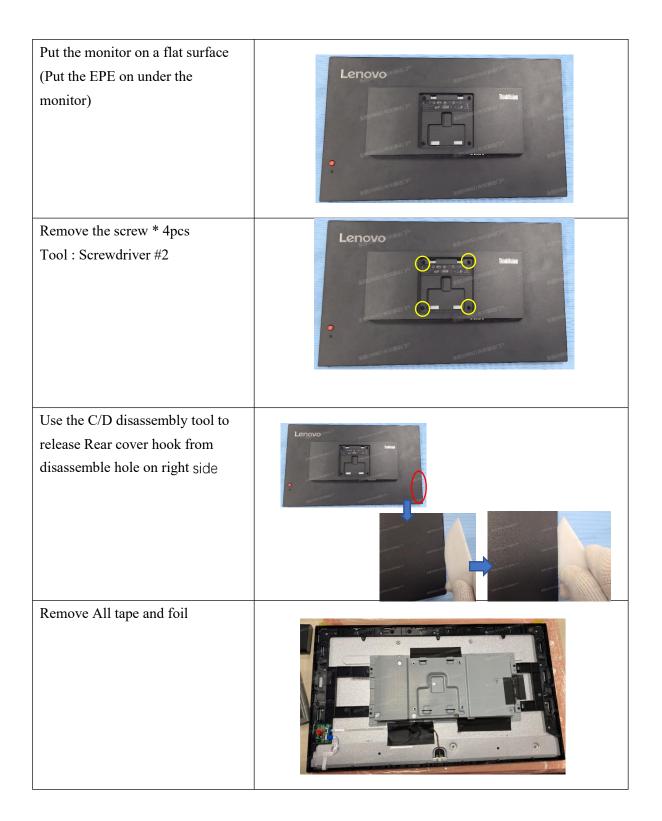
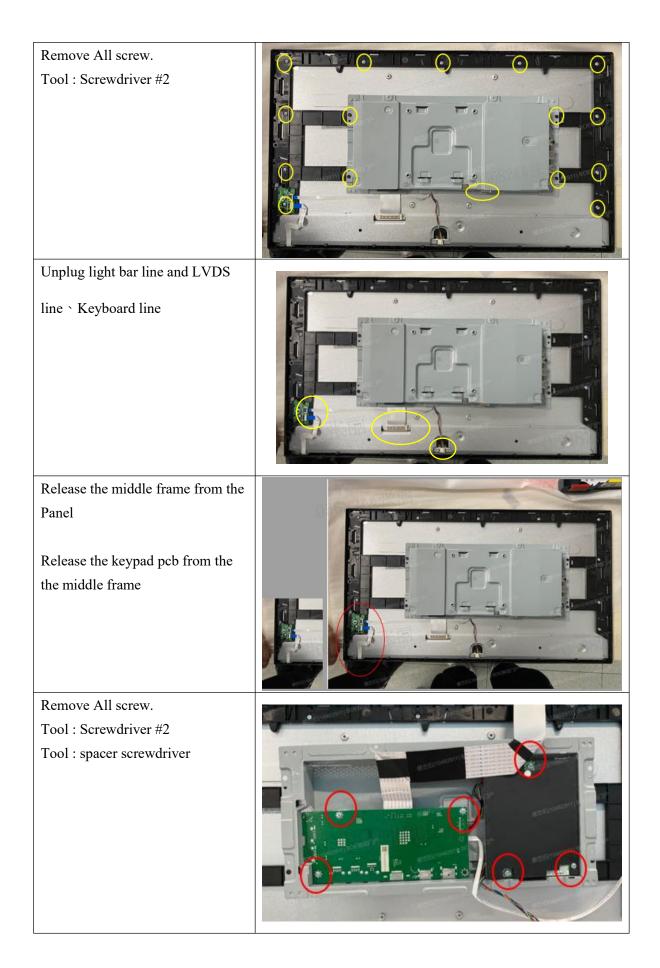
3. Disassembly SOP

Take out the mylar sheet from Main chassis	
Take out PCB and Peel off all mylar.	
Take out the Thermal pads from Power pcb
